# Appomattox County Assessment of County Buildings

July 17, 2023

## FACILITY ASSESSMENT CONDITION

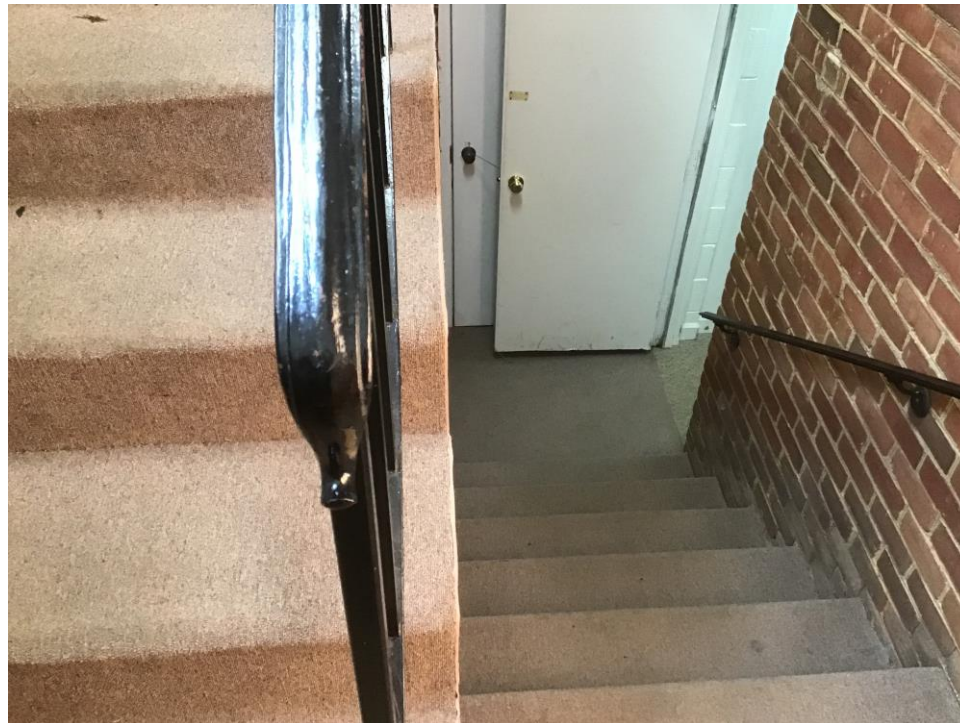
This stair does not meet current Code, as there is a railing on the one side of the stair only (wall side) and not on the opposite side. Additionally, where the stair is open to itself in the center, a handrail and guard are both required. Here, only the railing (no guard) is provided. We recommend reworking the railing in the center of the stair to meet current Code requirements.

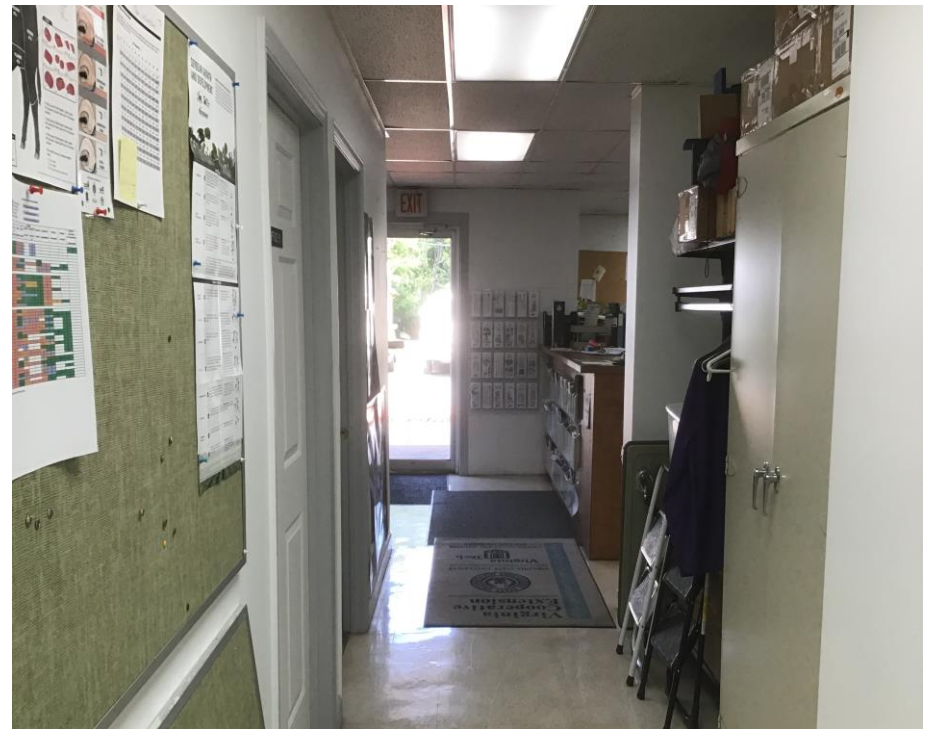
The size of the offices seems tiny and do not appear to meet the office standards that are expected today: larger spaces, brighter spaces, desk space for an individual, small meeting space for 1-2 people within the office and power/data receptacles to support the office being configured in several ways. These expectations are not found in the existing office spaces.

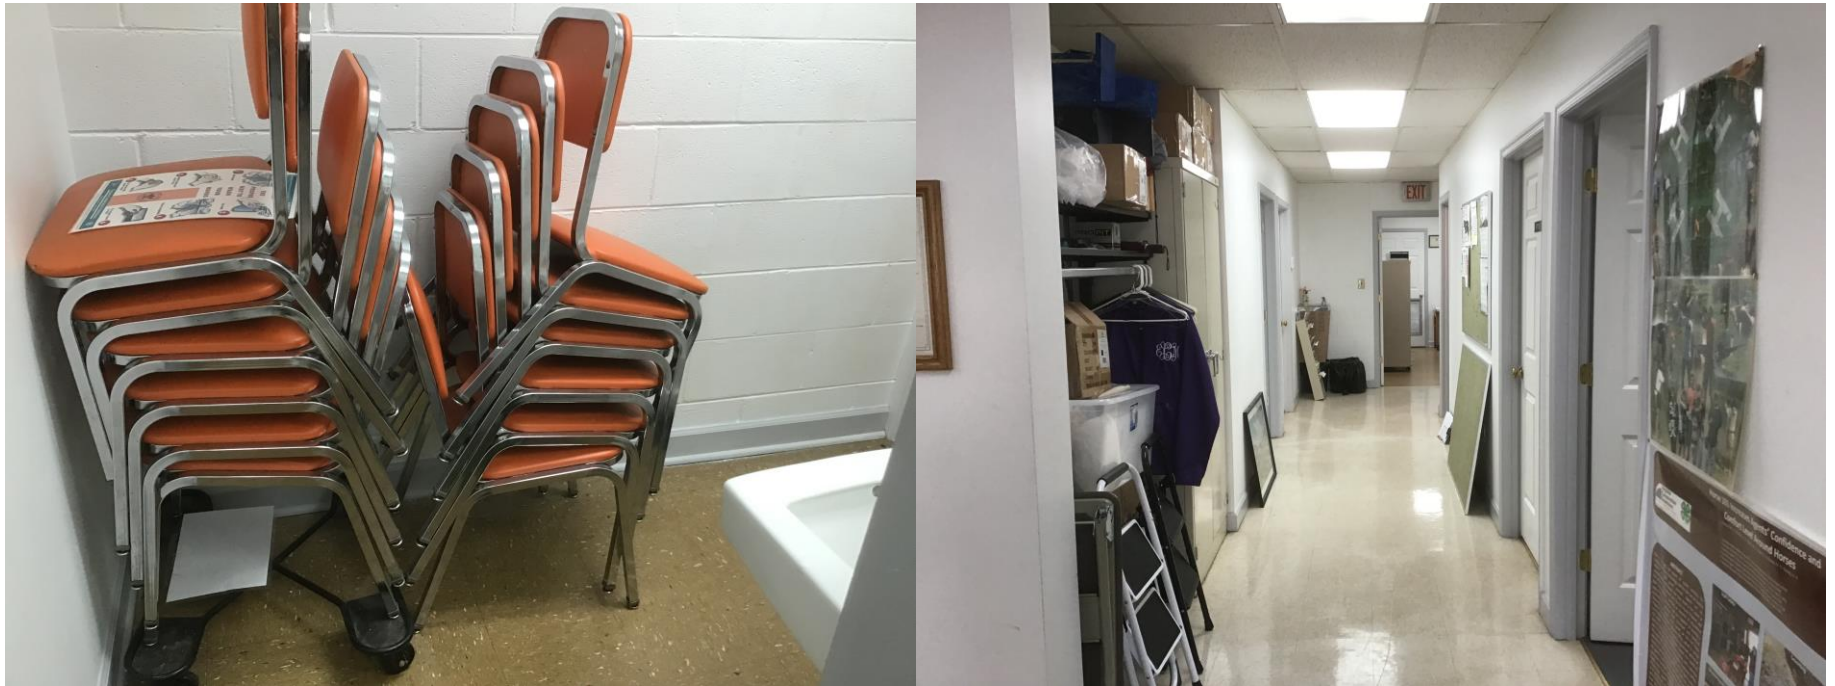
The public and staff areas (breakroom, toilets, service counters, etc.) do not meet current ADA requirements. We would recommend a full renovation to bring this department up to current regulations and provide a fully ADA compliant service counter, break area for staff and public/staff toilet that could be shared. On the day of our visit, chairs were observed being stored within one of the (already tiny) toilet areas. This practice is not sanitary and is not recommended. The chairs should be removed from the toilet area and stored in a better location.

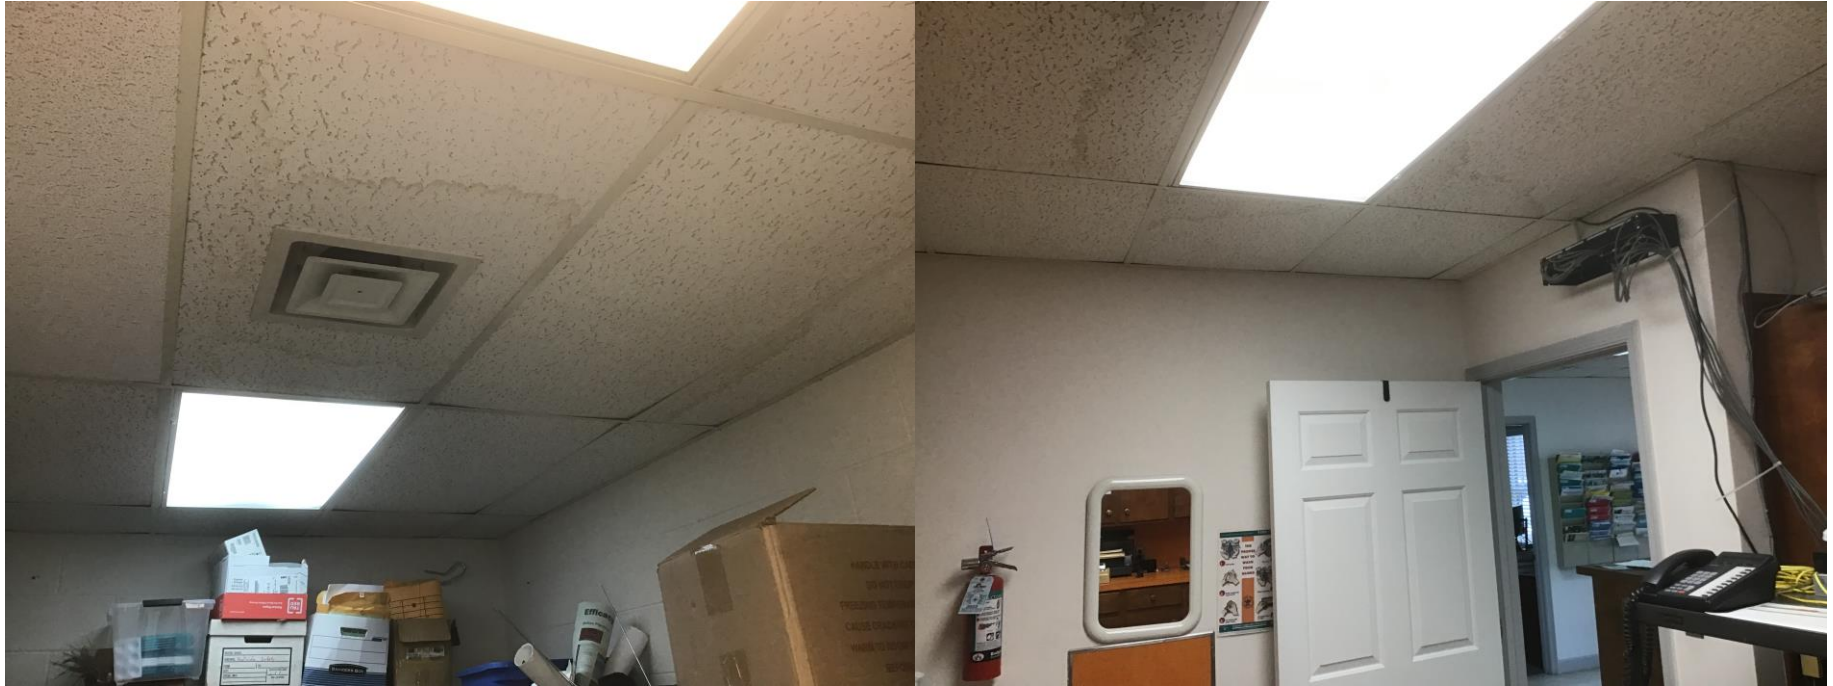
In general, the ceiling tiles have begun to sag and should be replaced. On the day of our visit, there were several areas that had stained ceiling tiles. The source of these stains is unknown, however, based on the location of toilets above, it is assumed that leaks from the upper floor toilets have caused the stains. It is unknown if the leaks have been repaired or not.

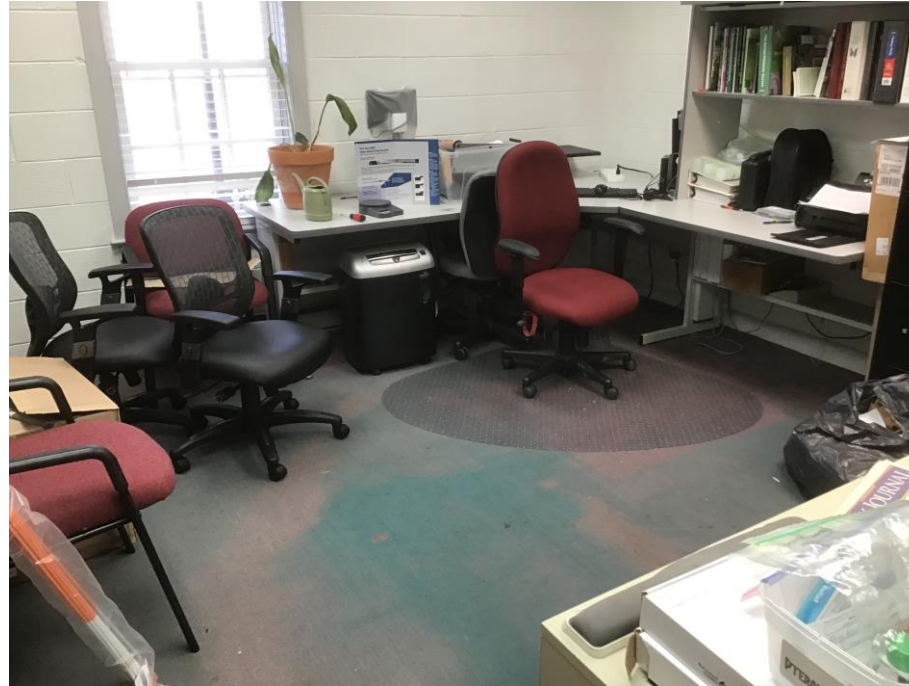
Also noted on the day of our visit were several areas in which the existing carpeting is badly stained/faded. We would recommend that all the finishes be upgraded within this department if this space is to be continued to be used as offices.

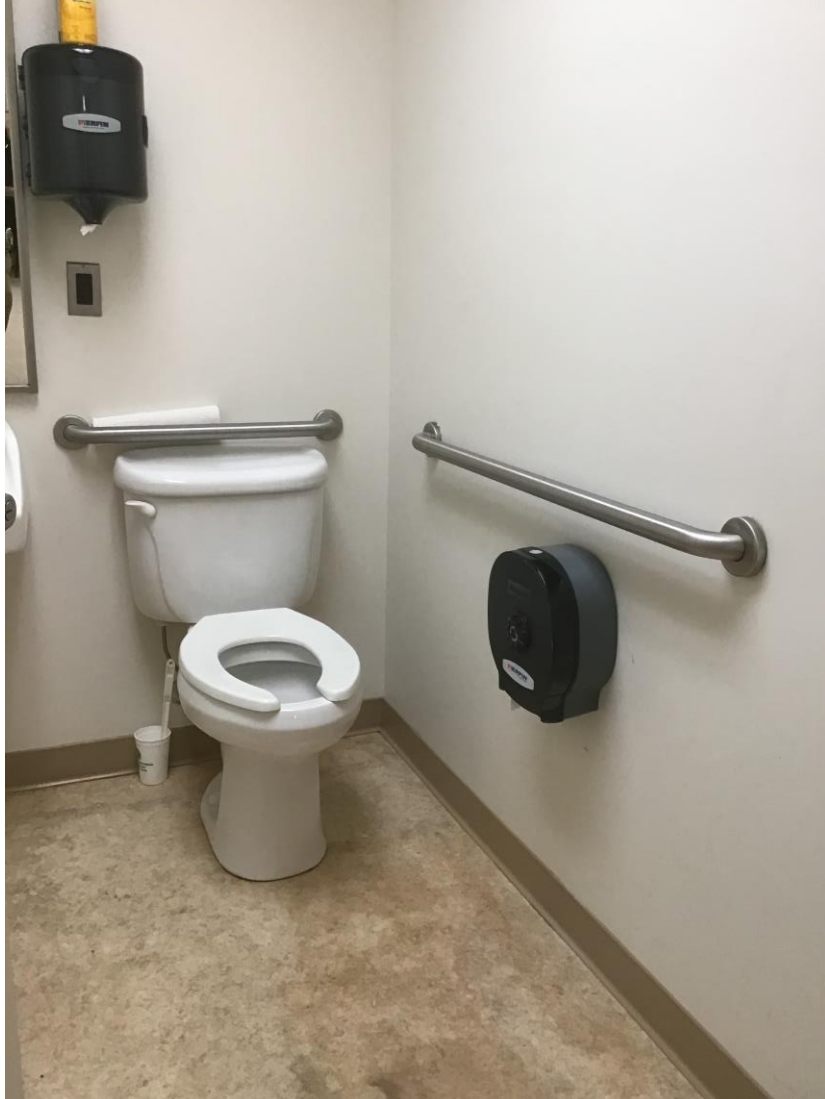
While the spaces within this department are in overall good condition, we did notice some staining of the sheet vinyl flooring in one of the toilets on the day of our visit. The staining appears to be from water infiltration, coming up from below the concrete slab, however, this is an assumption and has not been confirmed as the source of the staining for the bathroom flooring.

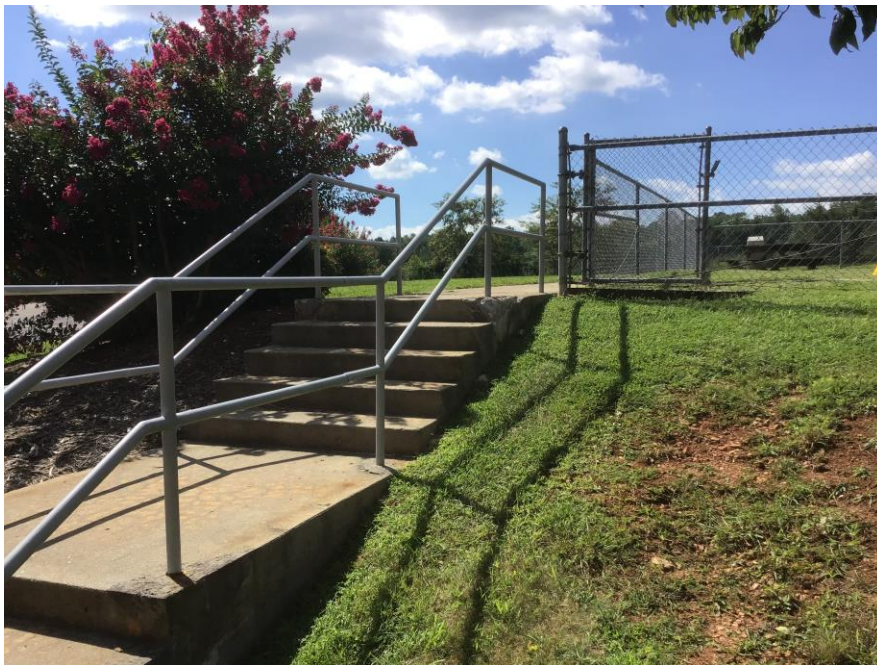
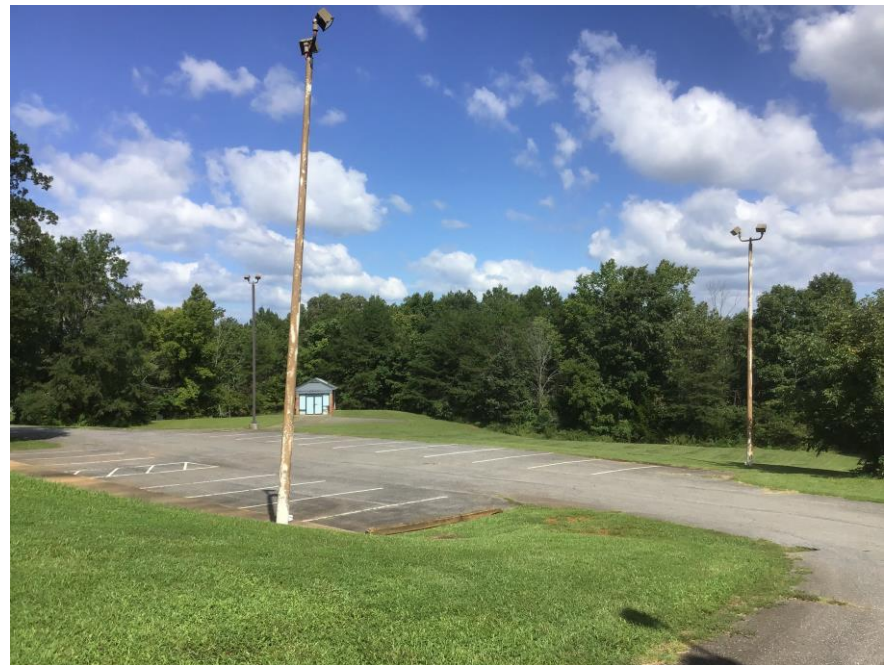
While the site lighting fixtures have been upgraded, not all of the poles have been upgraded. We recommend at a minimum painting the remaining poles if they are not going to be replaced. This will help provide a more unified and welcoming look to the facility.

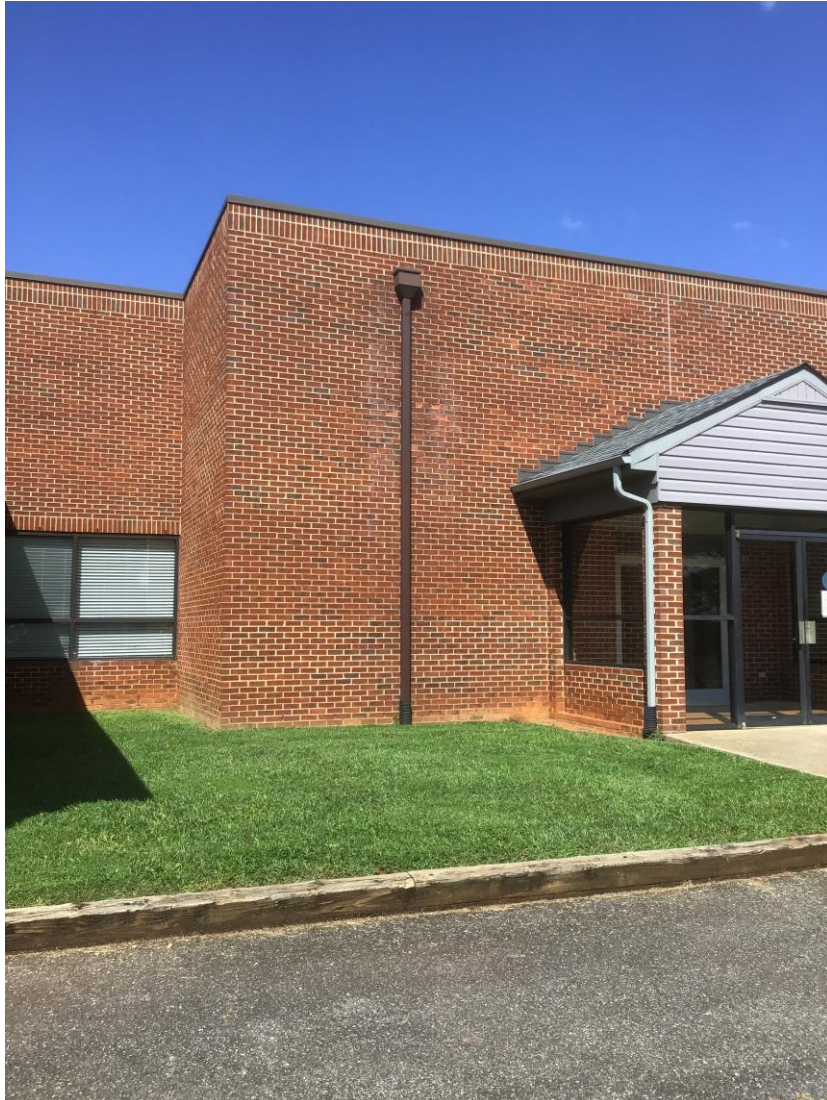
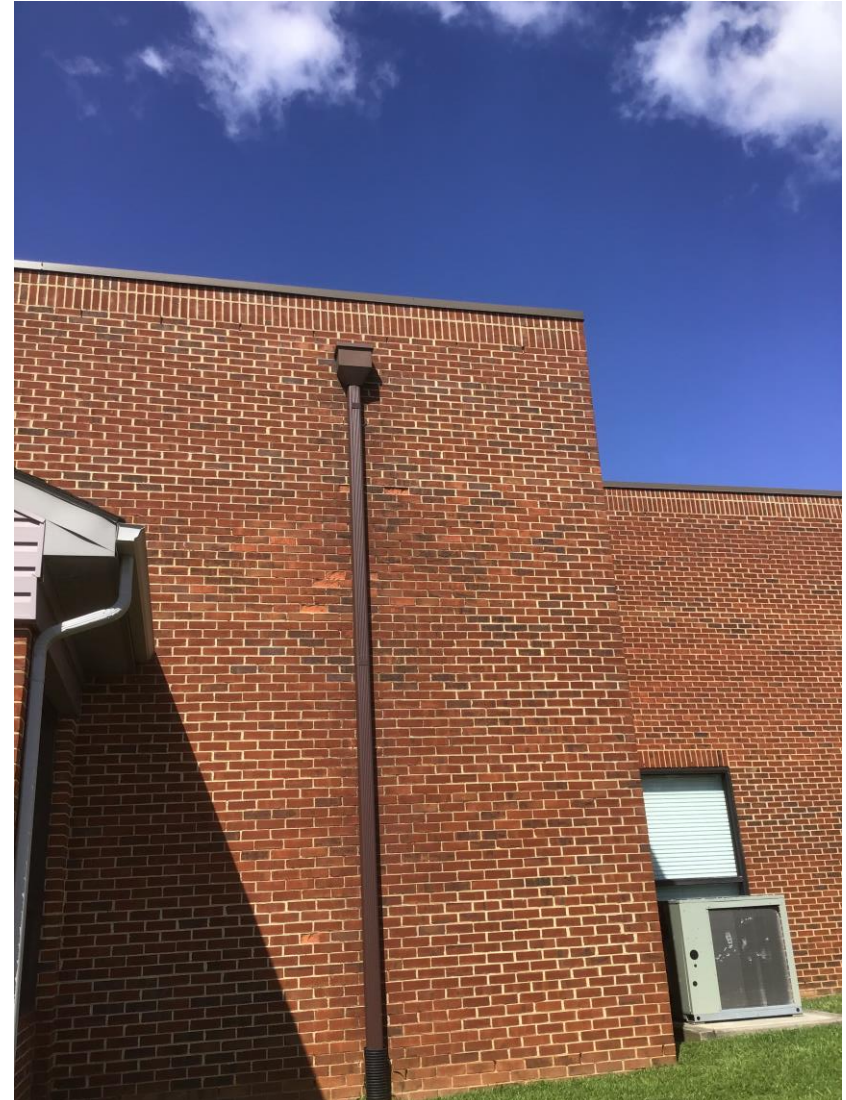
At one of the corners of the building, There are condensate lines that exit the building. The condensate lines have been cut flush with the exterior face of the brick veneer and the result is that the condensate sheets down the face of the brick veneer, which, over time has severely damaged the brick. It is recommended that the repair be made ASAP in order to prevent further damage and more costly repairs.

On the south side of the building, there are scuppers that drain the low-sloped roof. Over time, these scuppers have begun to leak as is evident from the staining on the brick walls. It is recommended to have these scuppers relined when the low-sloped roof is replaced so as to prevent further infiltration of water into the building. In the photo on the right, some of the brick has begun to spall due to the current water infiltration into the walls, presumably from water leaking from the scupper down into the existing walls.

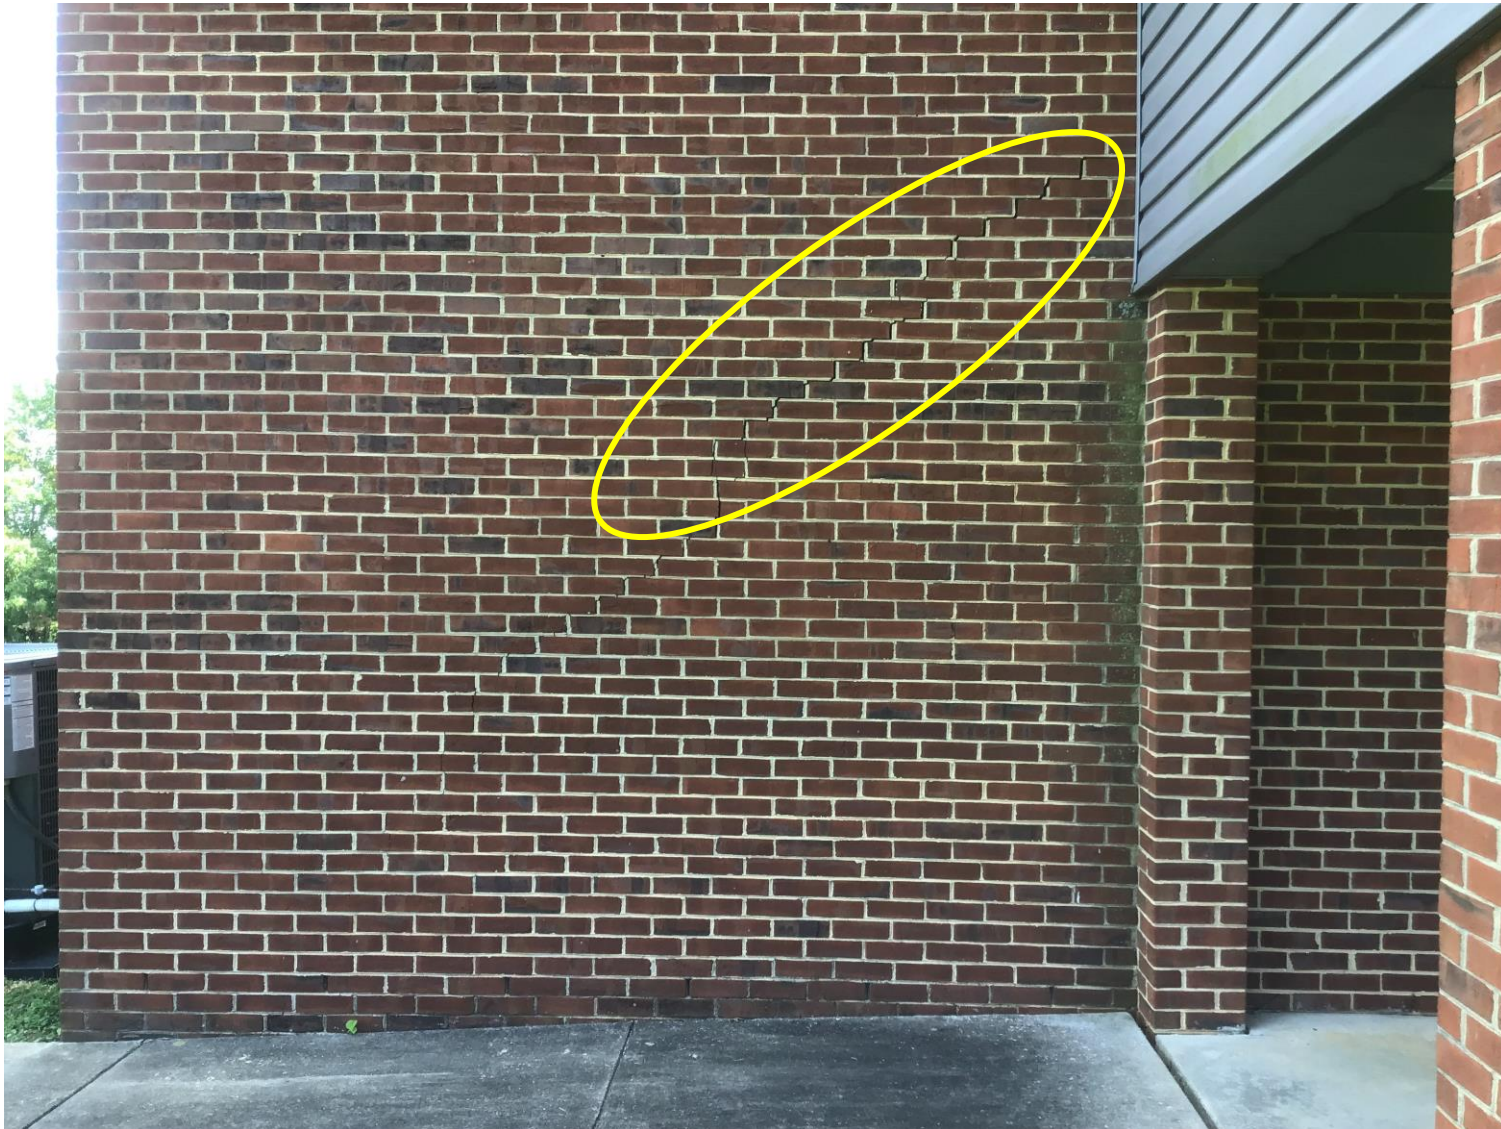
On the north side of the facility, a large stair-step crack was visible in the brick façade. This type of cracking is usually indicative of settlement issues. It is recommended to have a licensed structural engineer visit the site and make recommendations about the repair of this crack and potential settlement issues.

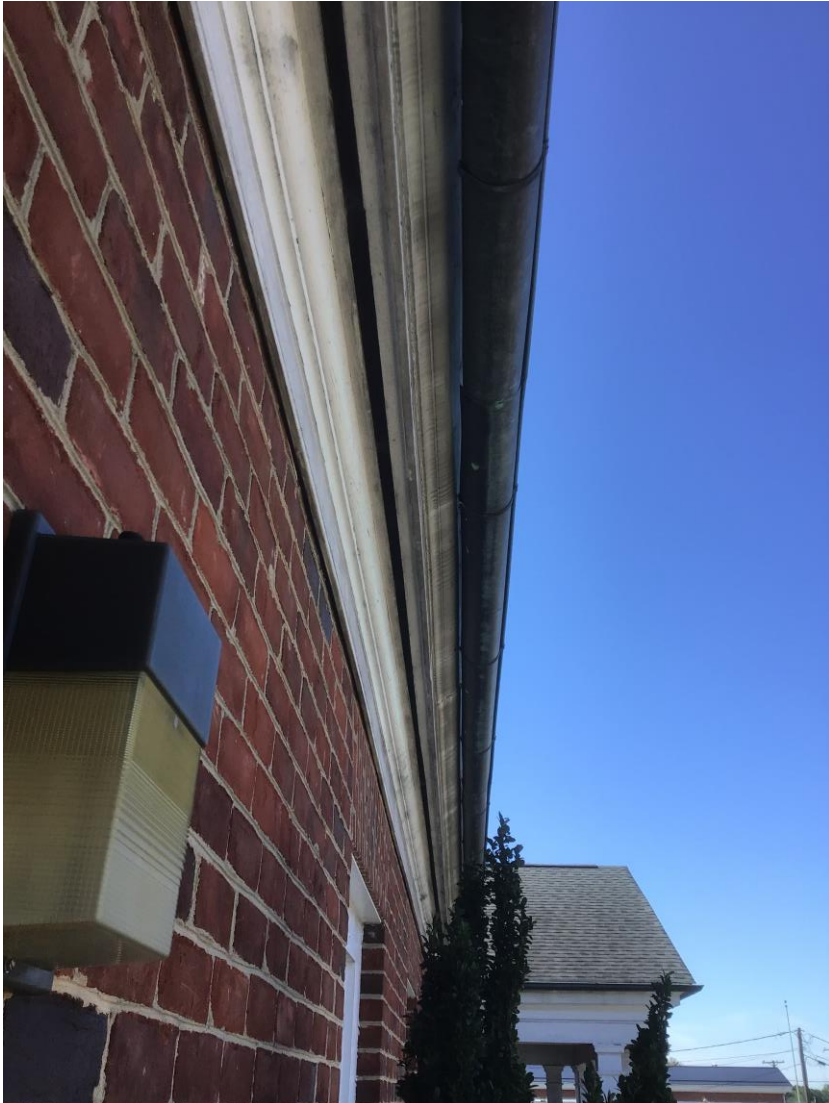
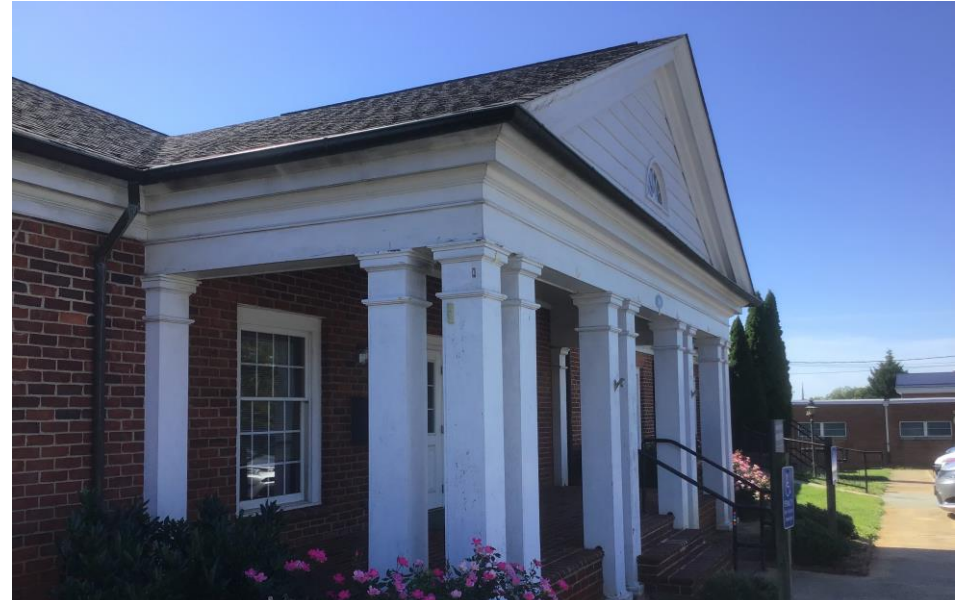
All of the wood trim, cornice and moldings on the exterior is at the beginning stages of having peeling paint. All of the white woodwork is dirty and has mildew present. The woodwork should be thoroughly cleaned, and a fresh coat of paint added at a minimum. We would also recommend having all the joints in the wood caulk so as to prevent any water infiltration.

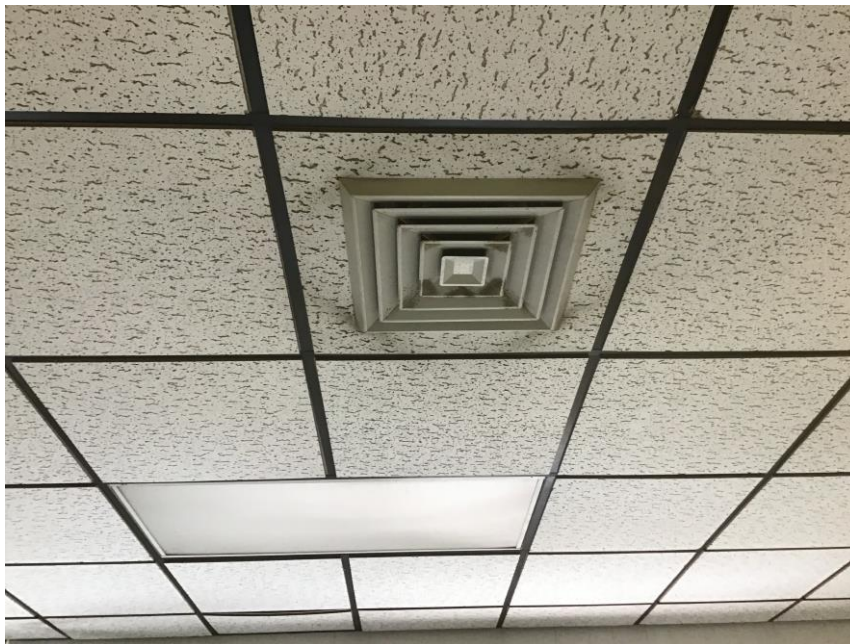
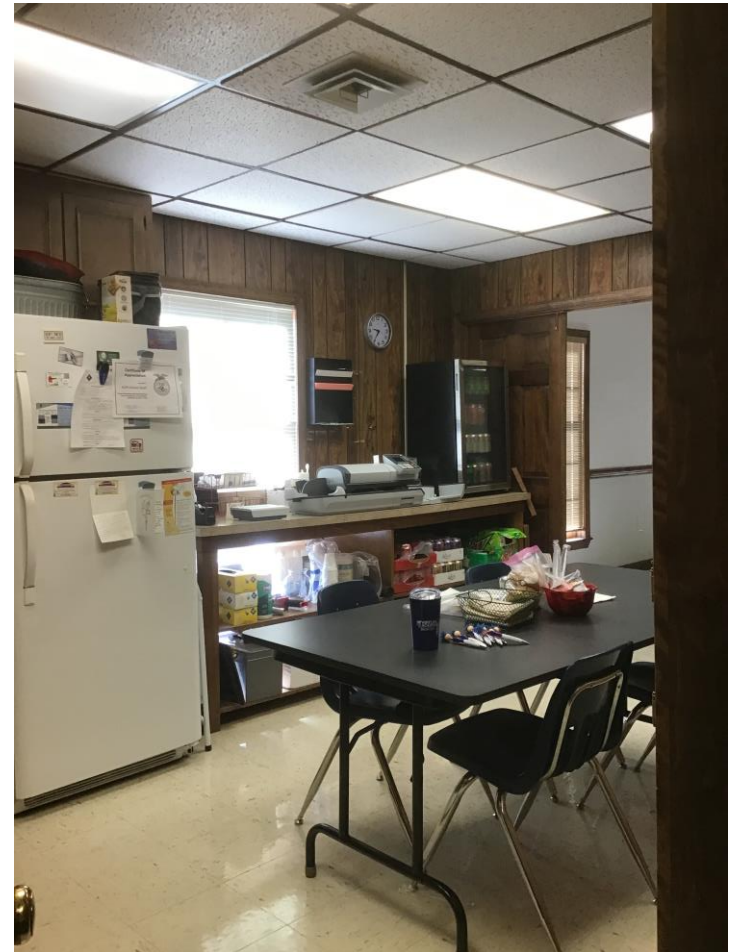
There is some concern about the frequency of HVAC filter changes at this location. On the day of our visit, dirty supplier air diffusers were observed.

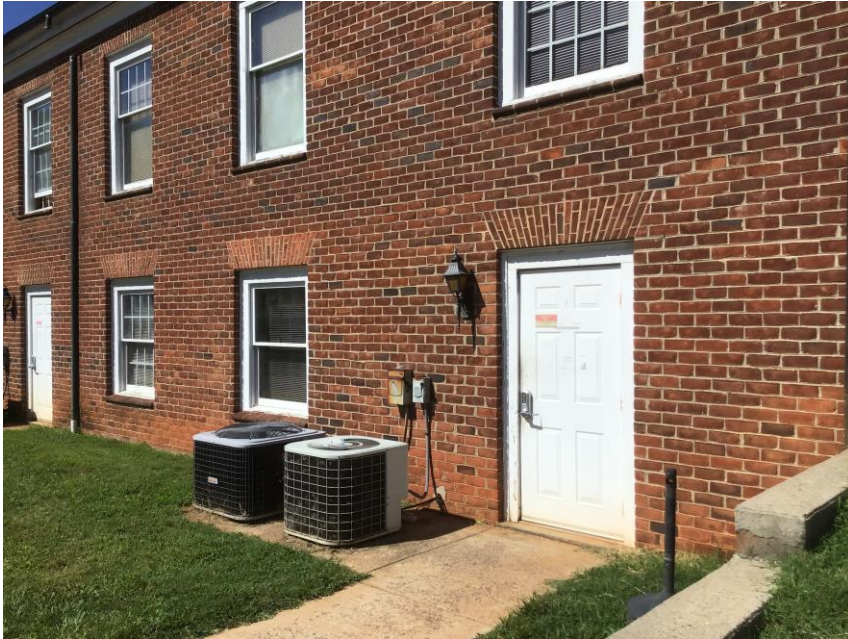
The exterior of this facility is in fair shape for a building of this age. The exterior windows and doors are all exhibiting peeling paint and beginning to fall into a state of disrepair. If the County intends to keep Social Services at this location, it is recommended to replace all windows and exterior doors. Newer products will have higher thermal properties and will provide better insulating qualities for the building. This will cut heating and cooling costs and save the County operating expenses.

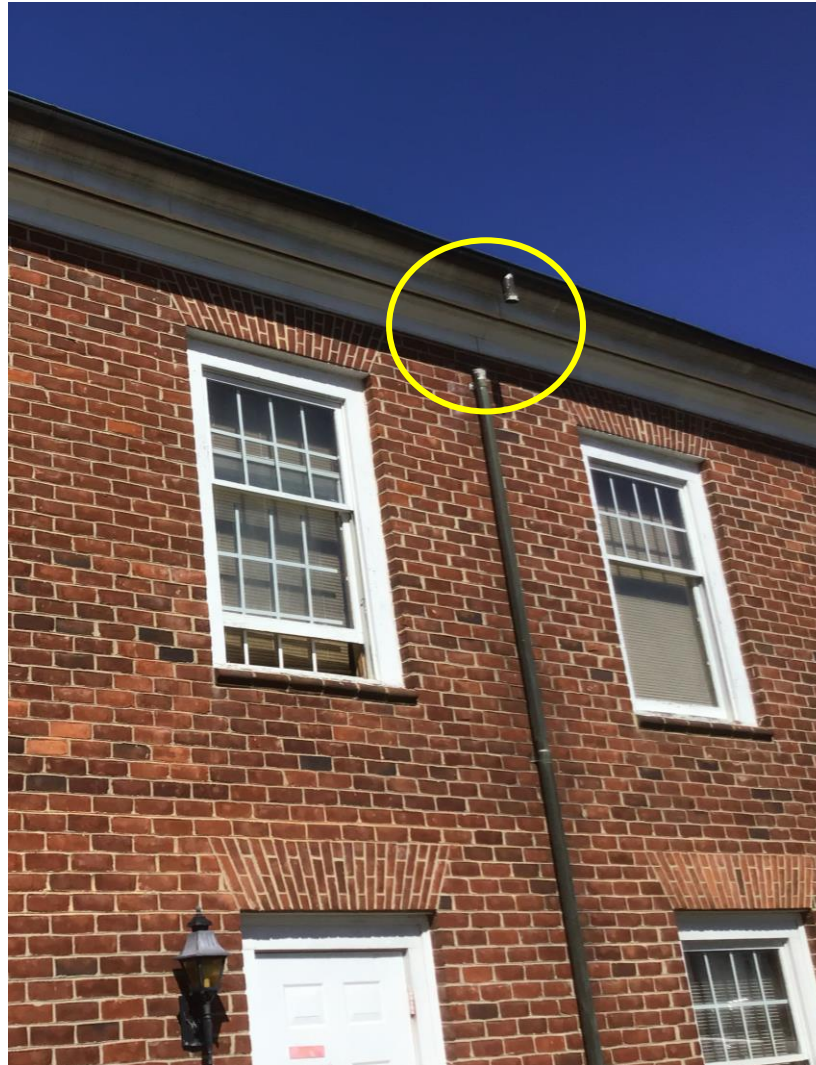
At one of the downspouts on the rear of the building, the elbow that connects the leader from the roof to the leader that runs vertically is completely missing. Anytime it rains, all this water that is flowing through the downspout from the roof just gets dumped onto the grade, right at the building. This is not ideal in that this practice can get water into the building.

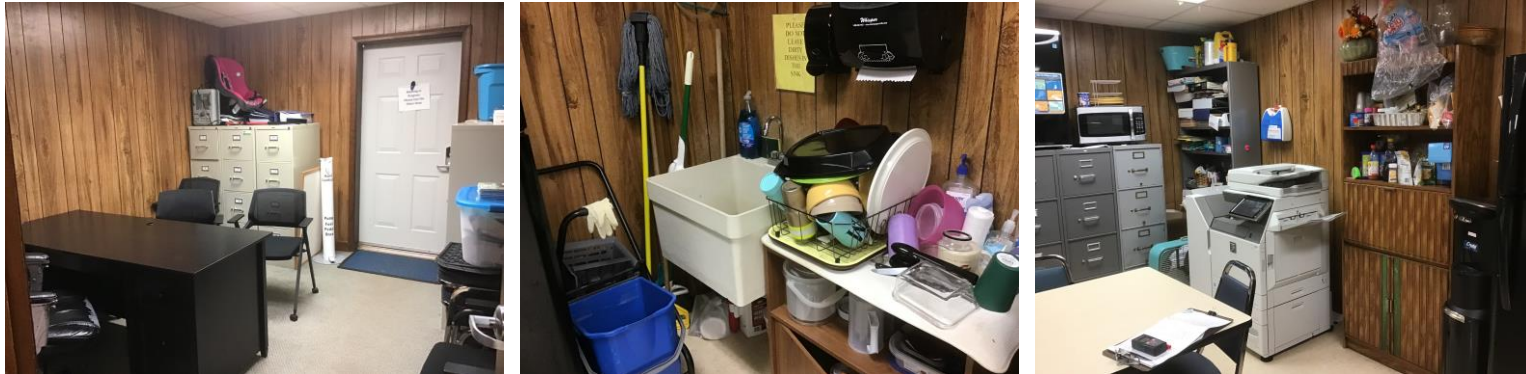
This department is located on the basement level of the Courtland Building. Less than half of the offices have a view, window or natural light. This is not an ideal work environment for the Social Services Department. The interior walls have wood paneling, making the spaces even darker. These spaces have not been updated since the 1970s.

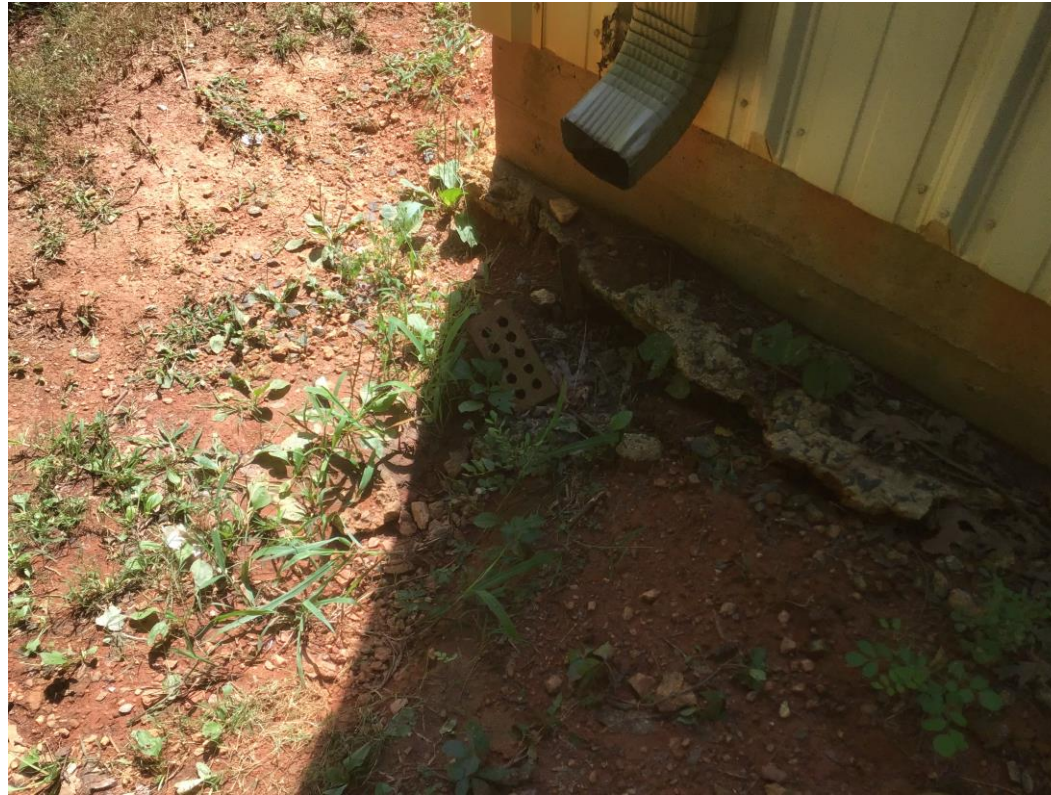
The existing downspouts dump onto grade which is not ideal. At the rear of the building, there is severe erosion of the site as no splashblock is present for the downspout at that location. The flow from the downspout has eroded the soil away from the foundation to the point that the existing footing can be seen. This is not preferred as the footing is subject to freezing if it is exposed as is the case.

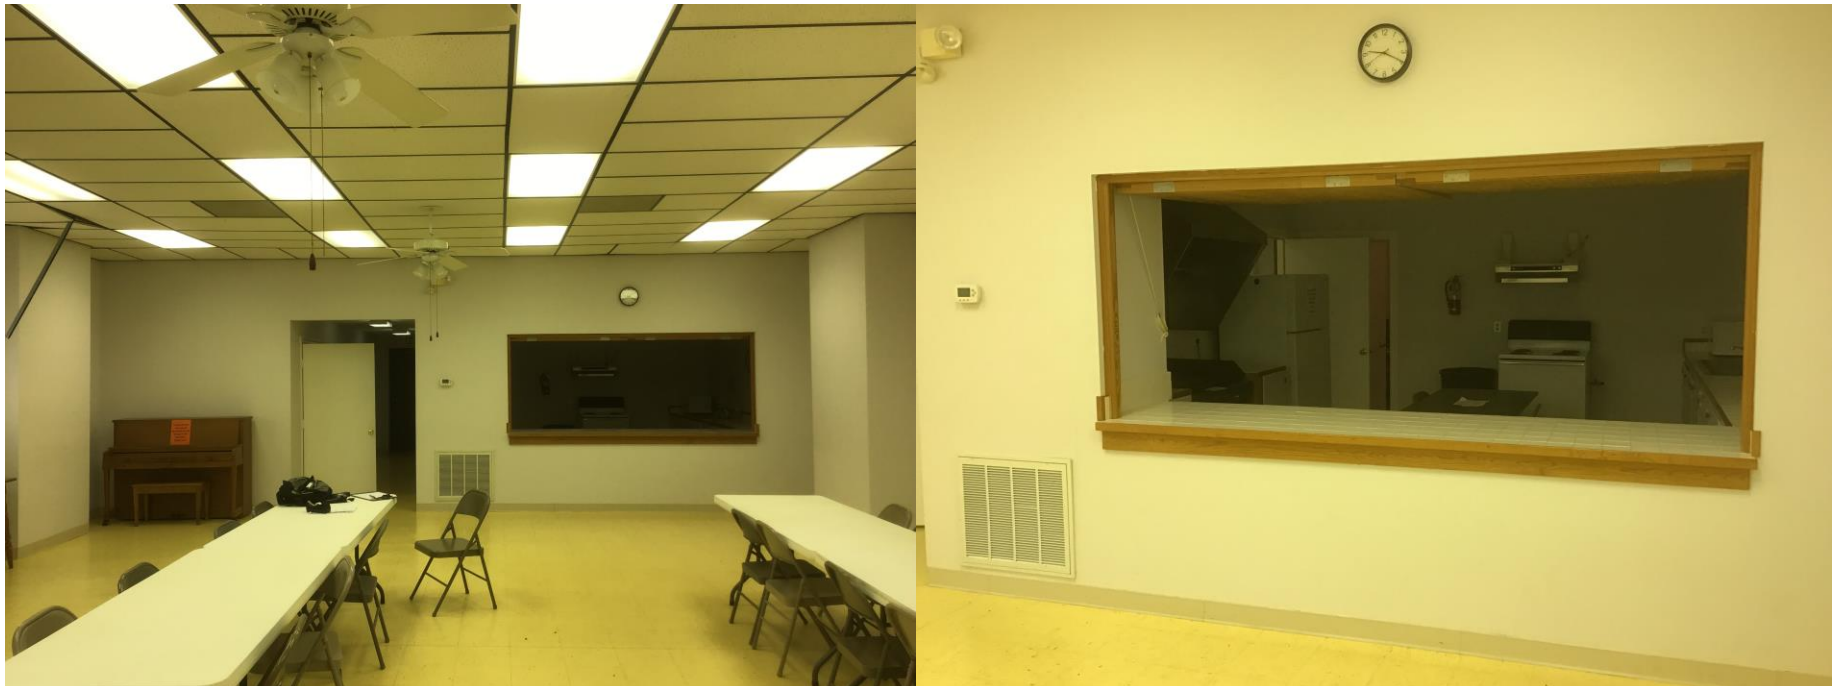
The existing service counter does not meet current ADA requirements and is installed too high. Furthermore, the opening for the service counter is closed by two door leaves that swing down and are locked into place. This approach is not ideal in that these doors could swing down and hit or hurt someone. When open, the door leaves are held open by thin rope that is tied to a cleat on the adjacent wall. It is recommended to remove these swinging door leaves and instead have an overhead coiling counter door installed. This would be a much safer application for public use.

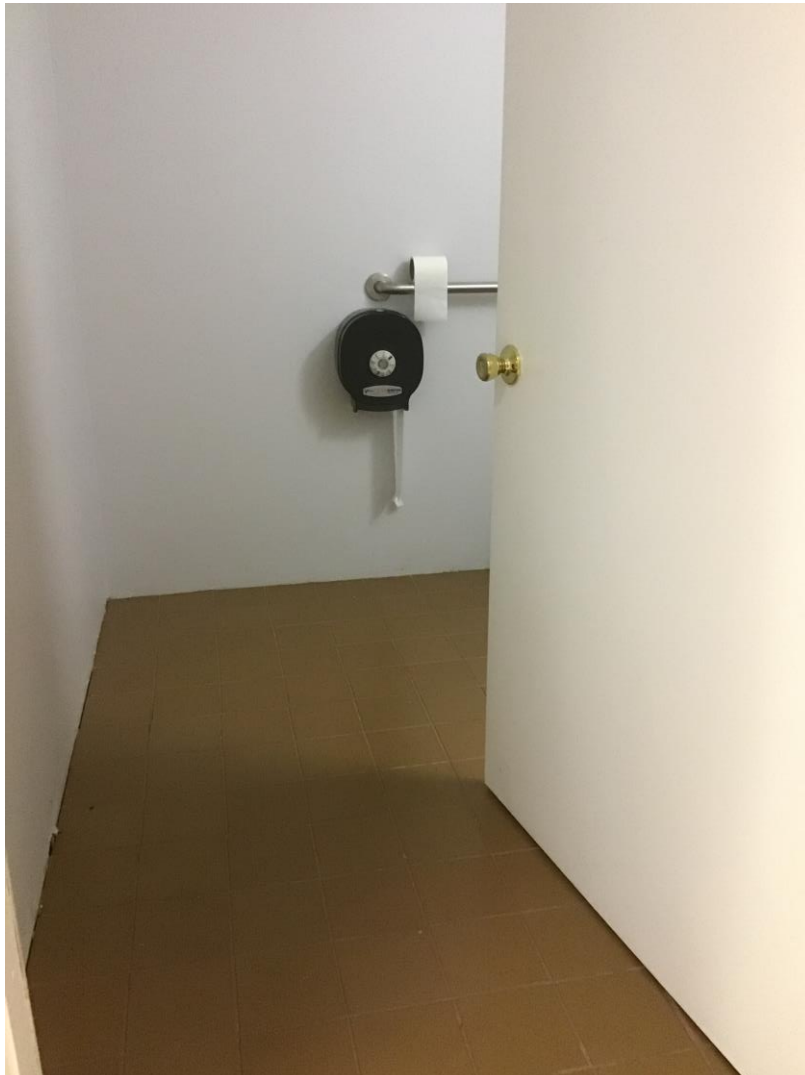
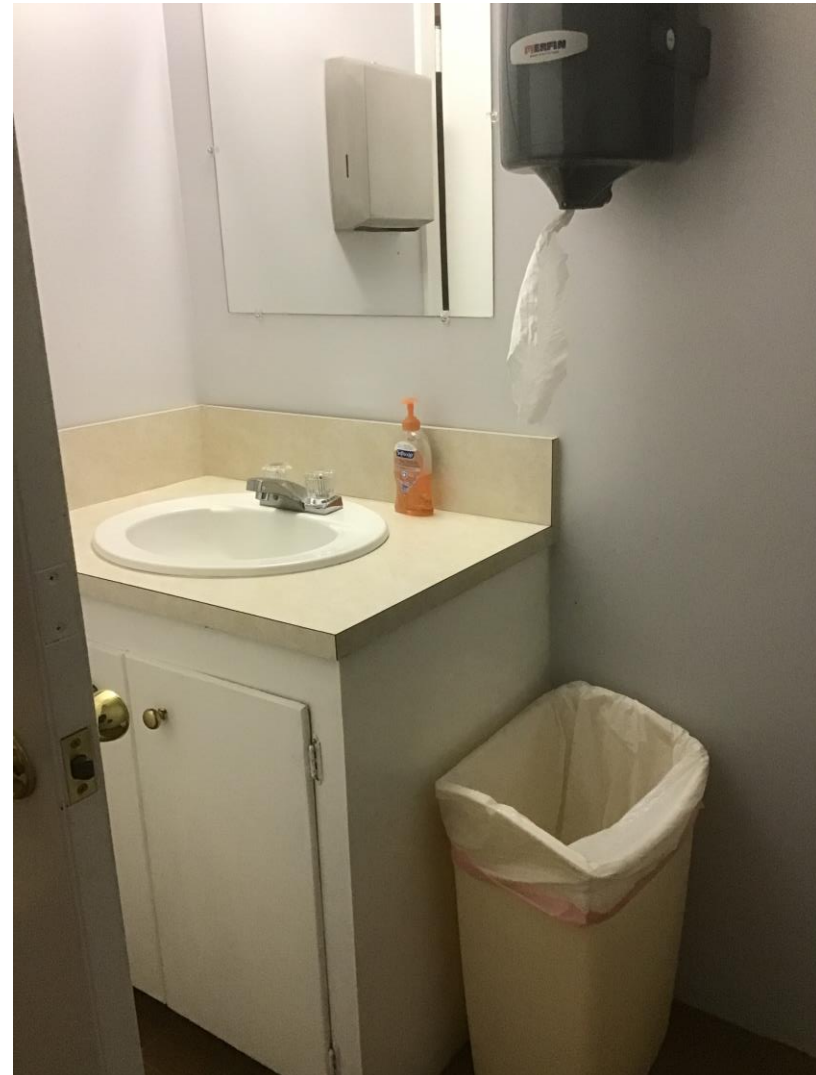
While the toilets are larger, there are some concerns. The toilet facilities have grab bars installed, yet the sink is not fully ADA compliant as someone in a wheelchair cannot roll under the sink as the sink is set into a cabinet. This setup does not meet ADA regulations. Also, the floors in the toilets are tile, however, no base has been installed, so there is a gap visible between the floor and wall. This is not ideal in that trash and debris will accumulate in this gap over time. It is recommended to have a base installed and to rework the sinks so that they meet ADA regulations if this facility is to be continued to be used.

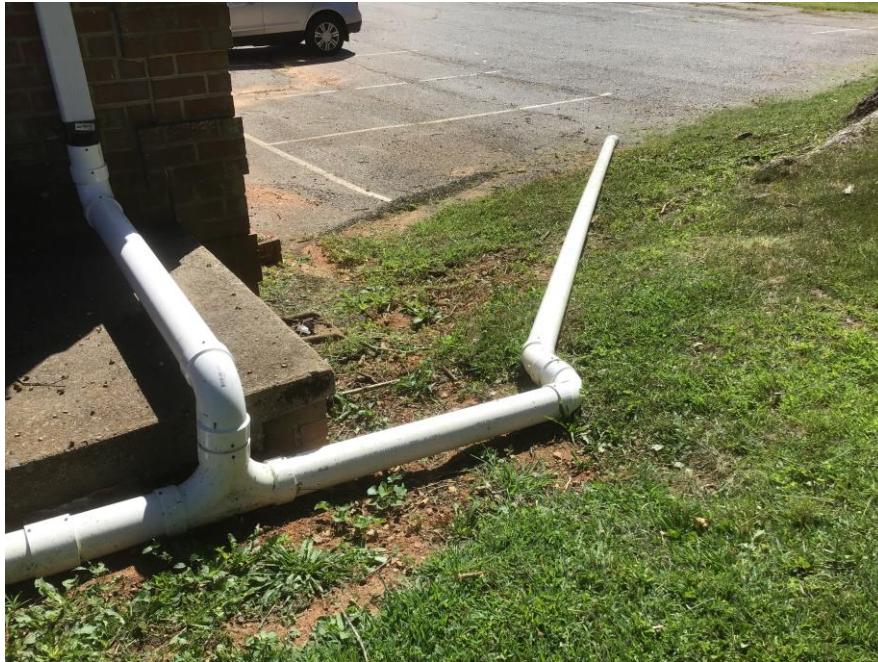
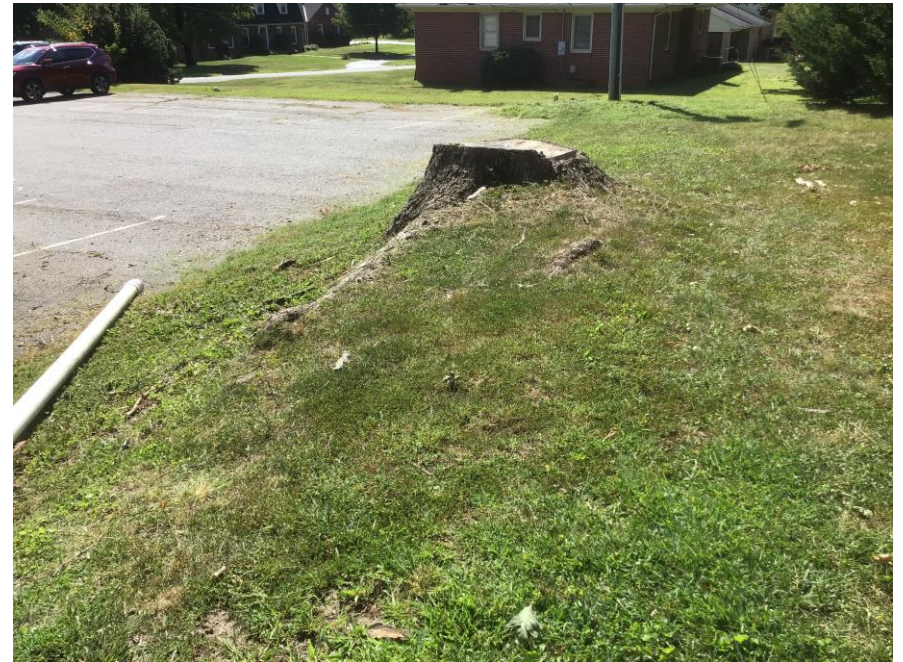
At the rear of the building, there is a large stump. This stump should be removed and the area adjacent should be regraded. This would aide in getting water from the north side of the building to flow away from the building at the rear. Currently, since the downspouts dump on grade, above ground PVC piping has been installed to route the water that would dump on grade on the north side, around to the rear of the building and have it sheet flow across the parking lot.
