# Appomattox County Assessment of County Buildings

July 17, 2023

## FACILITY ASSESSMENT CONDITION

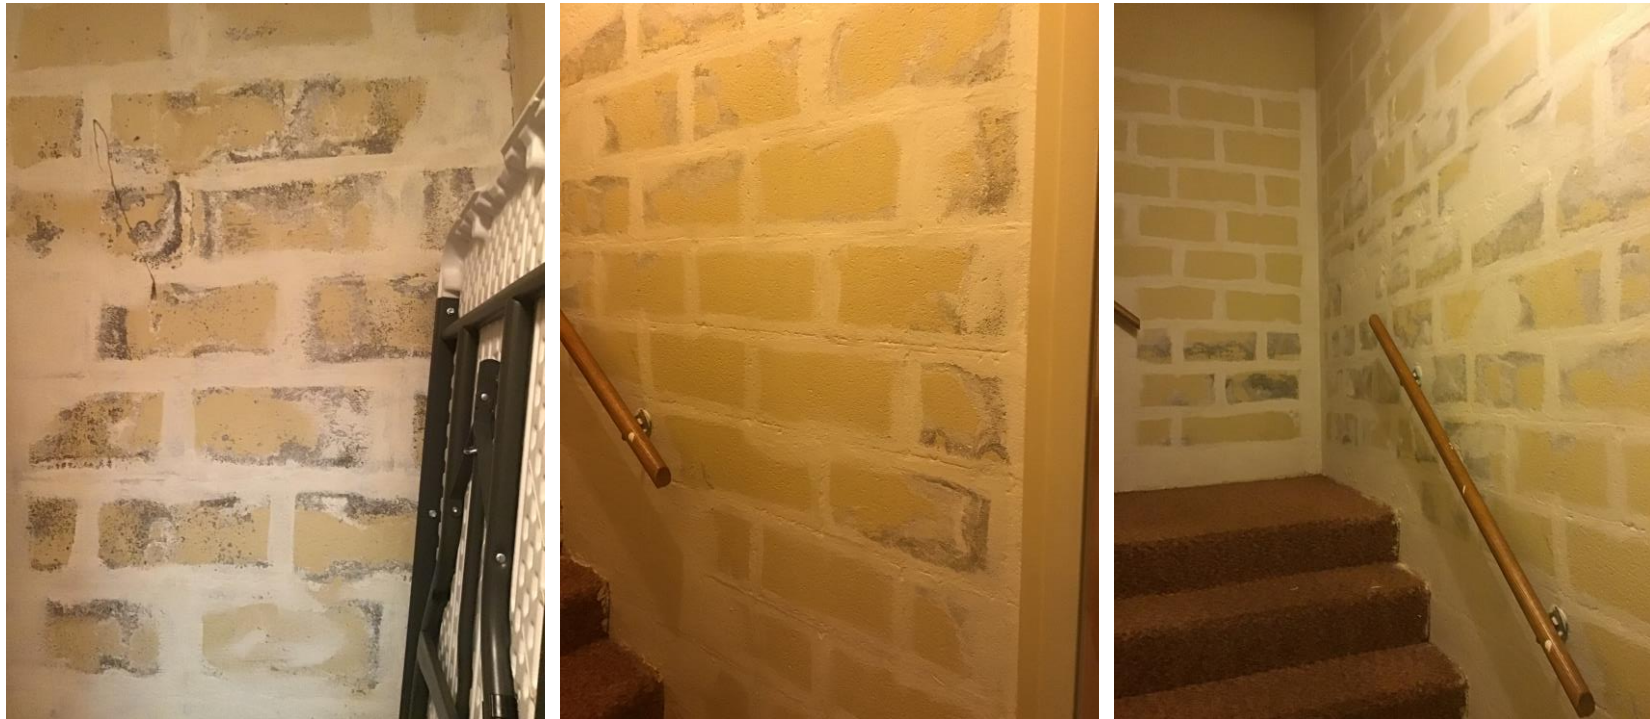
At the far rear of this space, there is a stair that connects to the Health Department above. There is mildew present on the block (CMU) wall. This is evidence of water infiltration into the building. It is assumed that there is no foundation waterproofing on the foundation walls and that is the cause of the water infiltration into the building. It does not help that the parking lot slopes toward the building, sending water toward the building any time it rains.

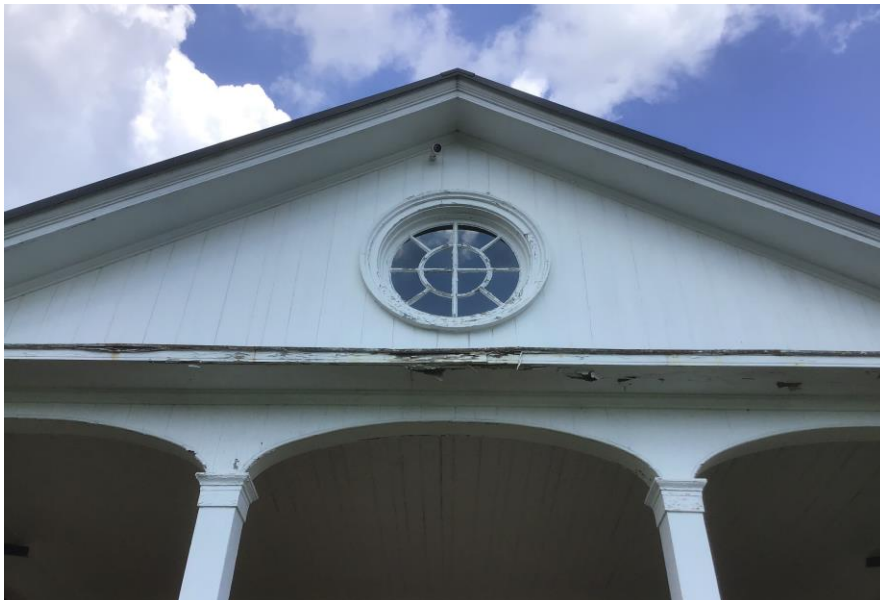
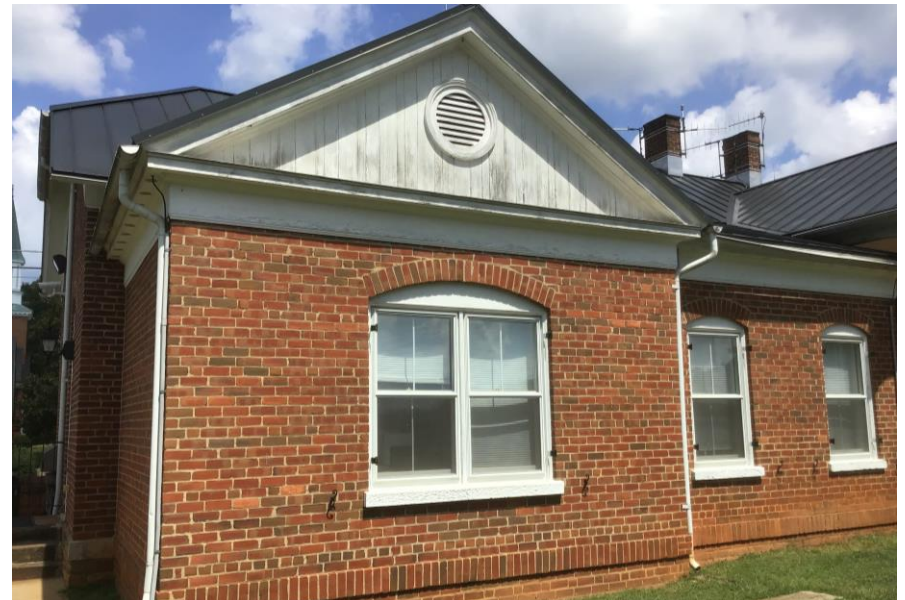
The joints in all of the historic wood trim on this structure are beginning to fail and open up. If not addressed soon, this can lead to water infiltration within the building and further damage, not to mention more costly repairs in the future.

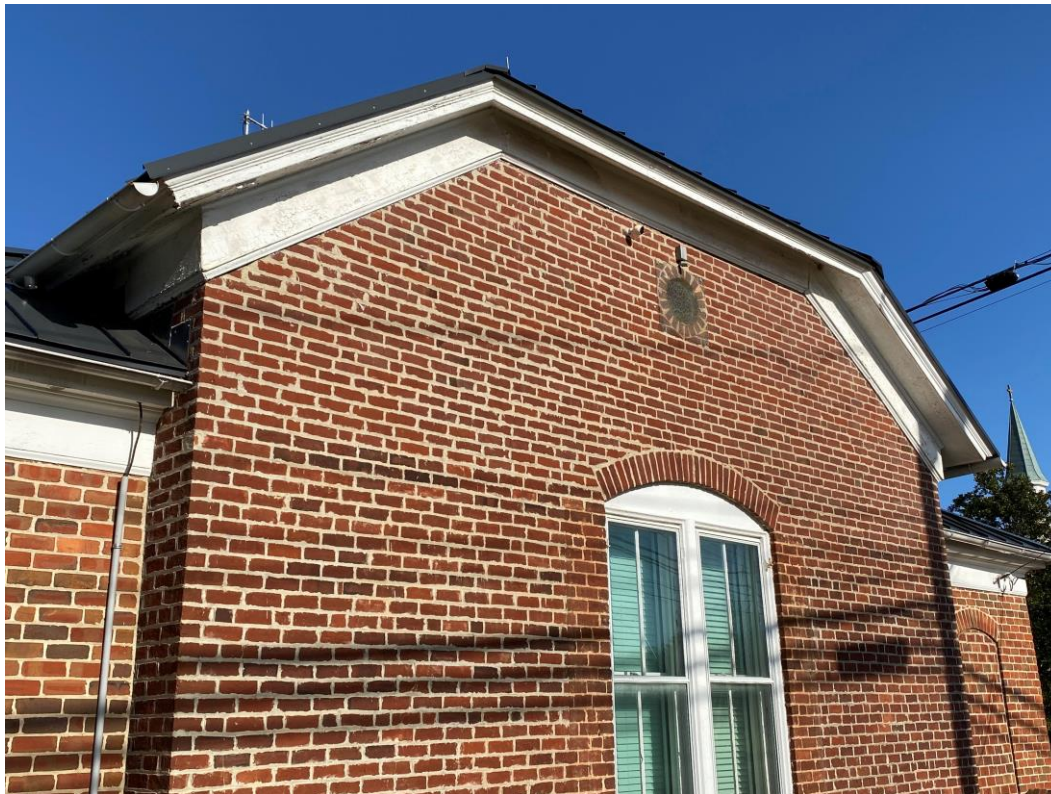
An additional masonry problem is rising damp which is a capillary movement of moisture from the ground up through the walls. As moisture is wicked up the walls damaged to the masonry occurs as well as any interior finish (plaster or paint). This is noticeable in several locations in the original section of the building.

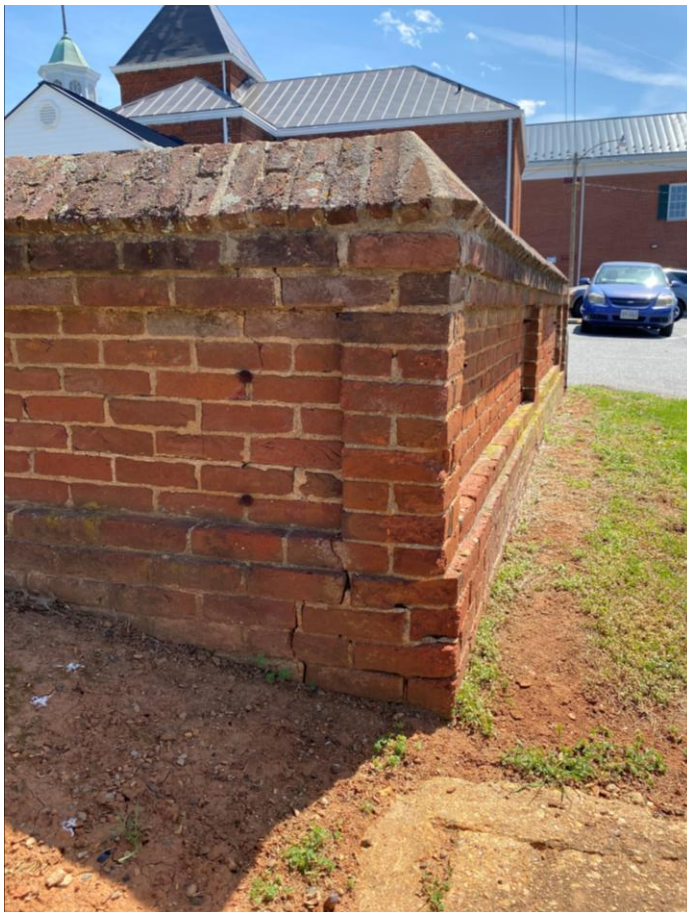
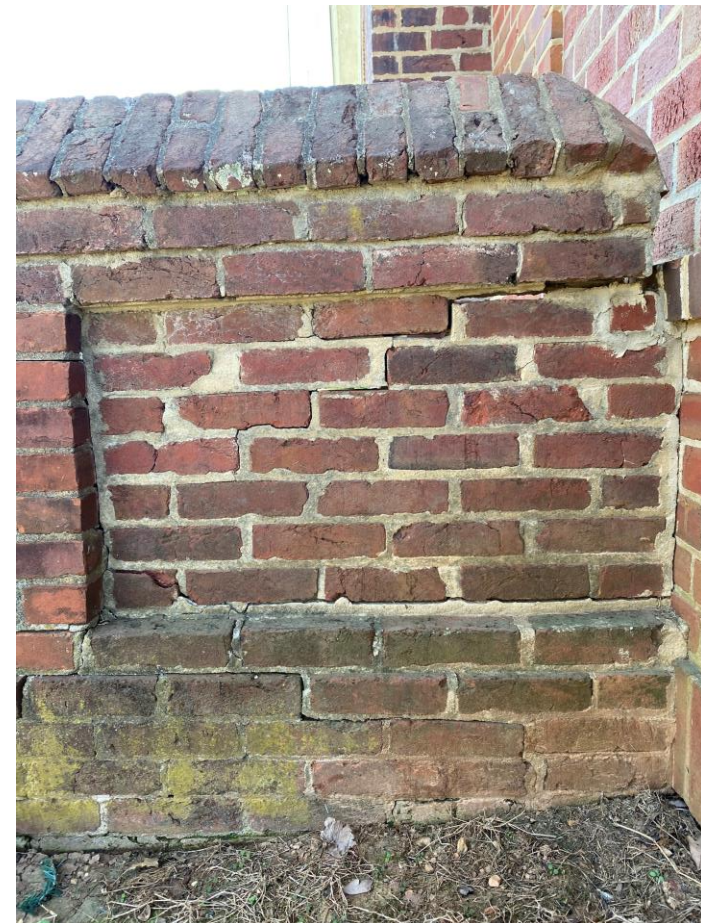
It is not part of our study, but the condition of the brick fence (constructed in 1935) is very poor in certain locations. This would be high priority item to repair. Note that the fence is part of the downtown historic district, and its preservation is important. The two pictures shown below are example of the cracking that has occurred. Both are located adjacent to the Public Safety Building.

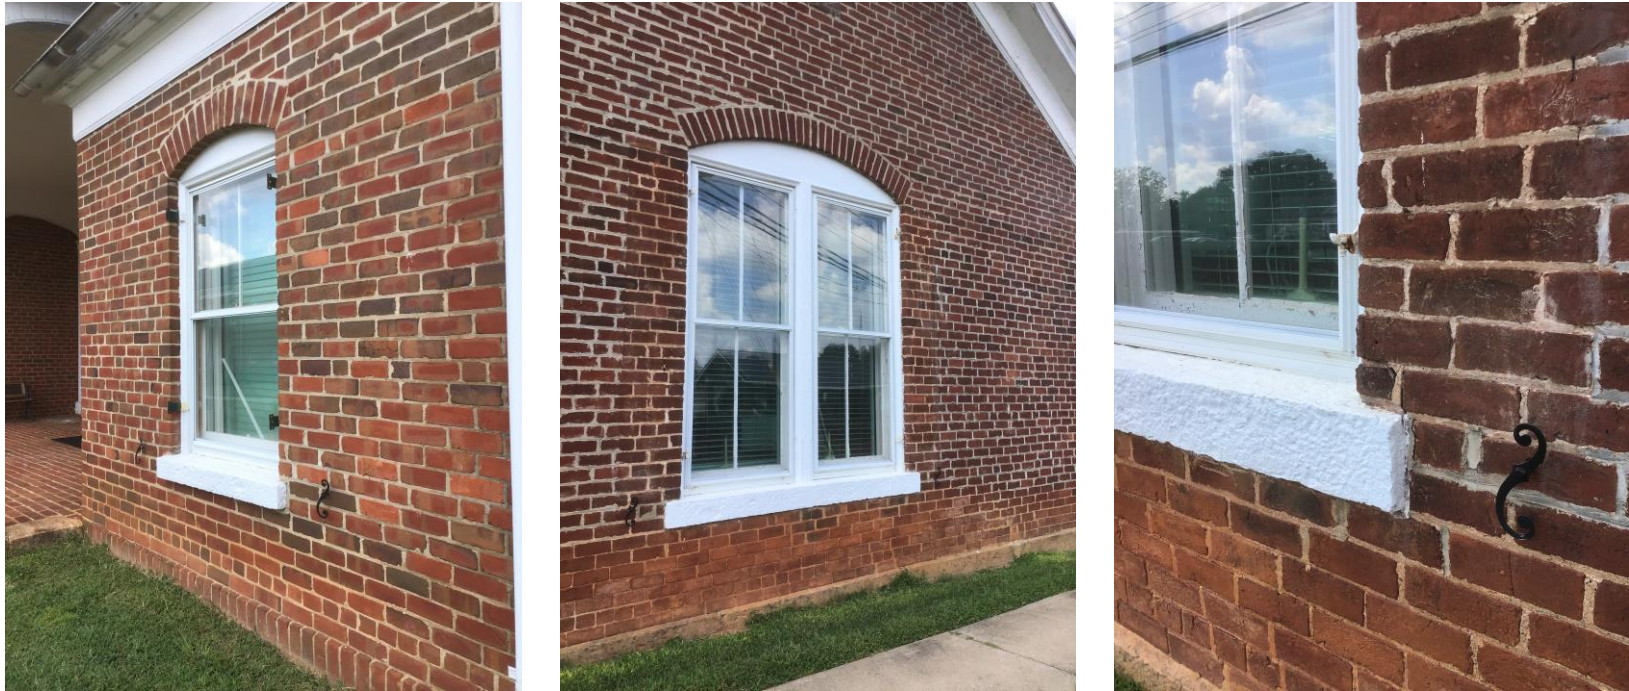
It was noted that the operable shutters have been removed, but the hardware for the shutters remains. We assume that the shutters were removed for repair and repainting. They should be replaced with the repaired/repainted original shutters.

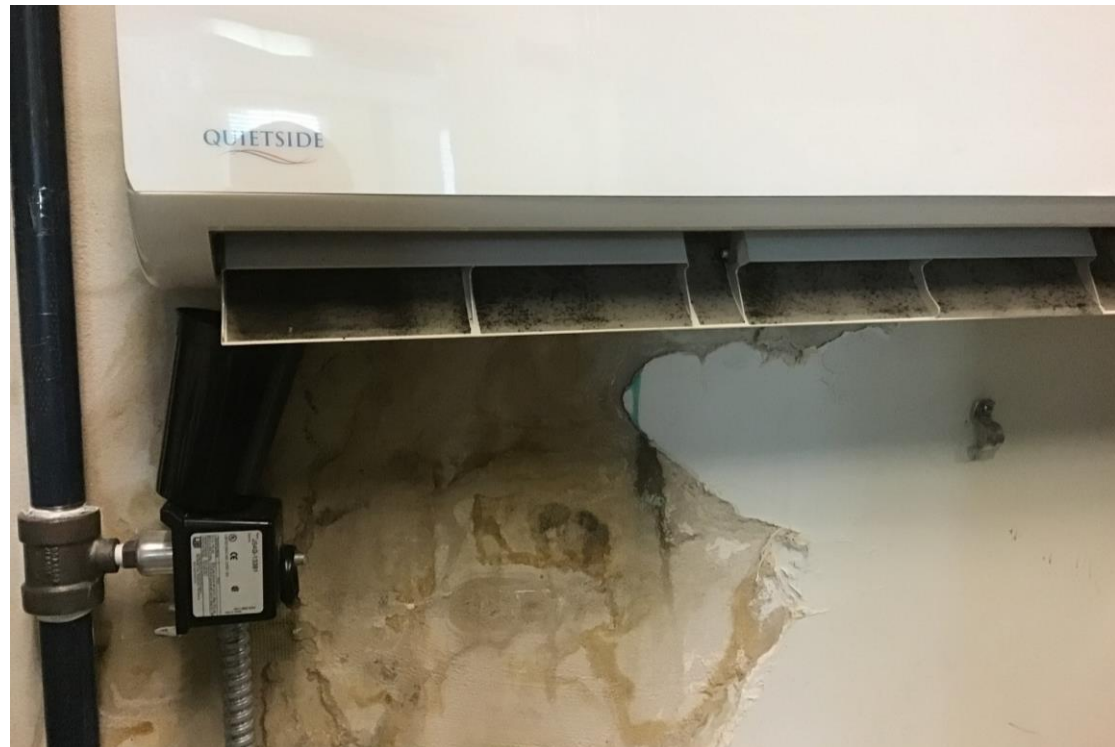
In an adjacent mechanical room, where the cooling equipment is located, there are two mini-split units located within this space. These units keep the mechanical room cool as the amount of equipment in that space generates a lot of heat. The condensate drains for both of these units were not piped as they should have been. The result is severe plaster damage to this area. We recommend having this repair completed ASAP as to not cause further damages.

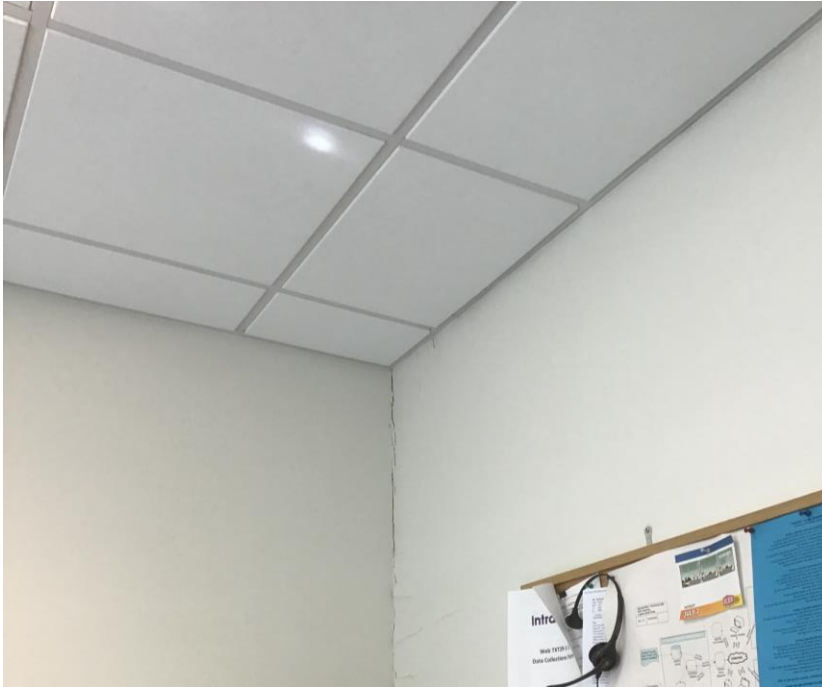
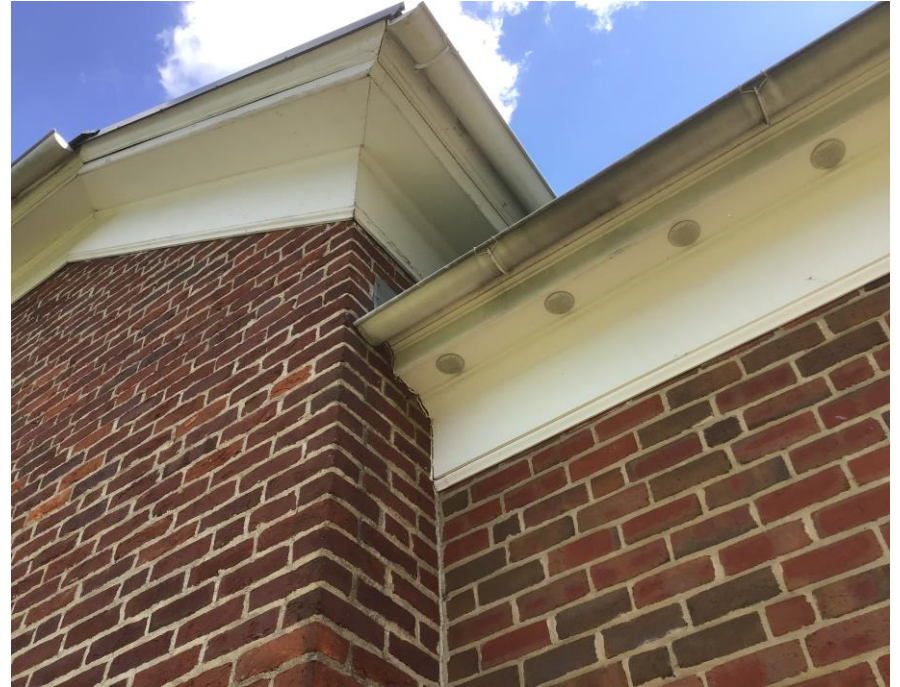
Some vertical cracking of the plaster in the Director's office was noted. In talking with staff, this crack opens up and closes seasonally. While repairs have been attempted in the past, the seasonal cracking is still a problem. The crack also occurs on the exterior of the building at the rear.

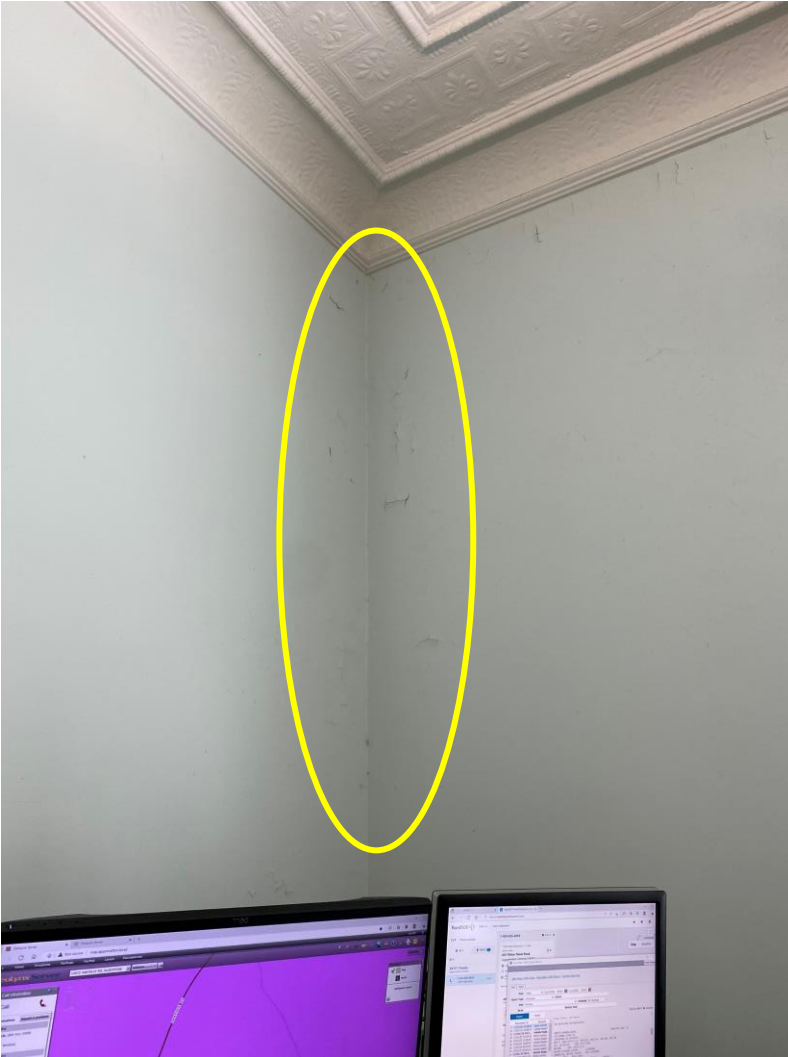
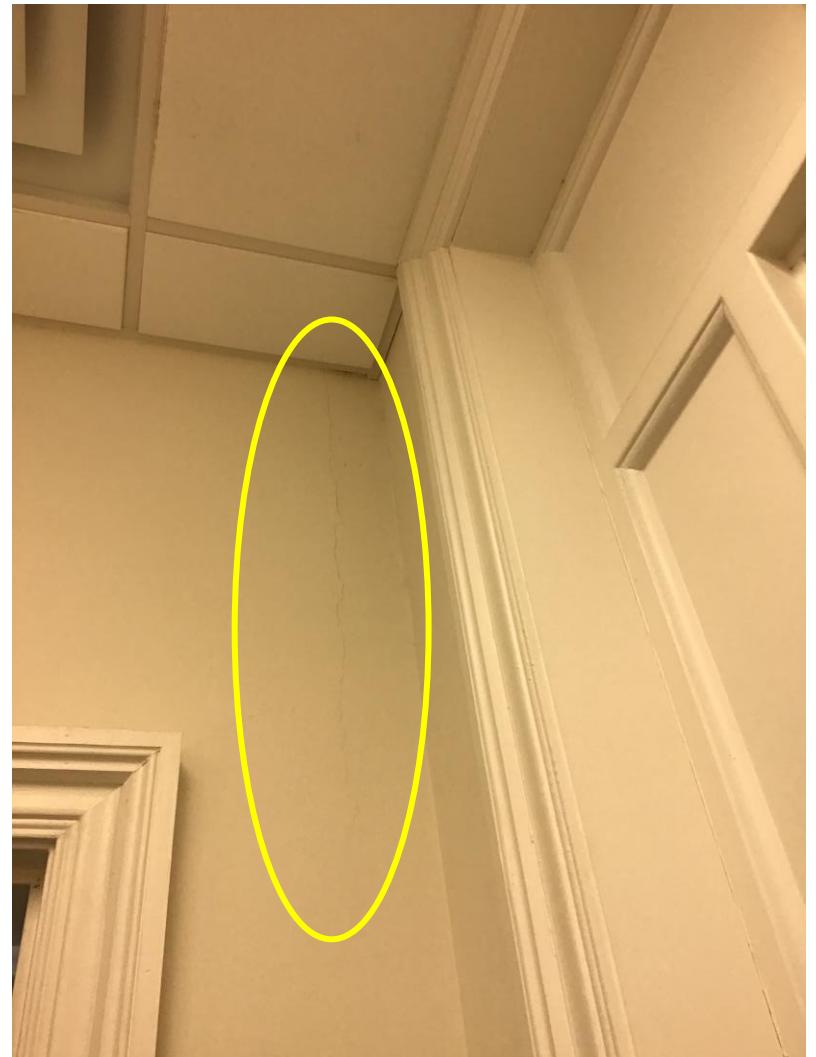
There are additional cracks and generalized damage to the plaster in the building. The plaster for this vintage building is a combination of lime, sand, animal hair, and water and is fragile and susceptible to moisture infiltration.

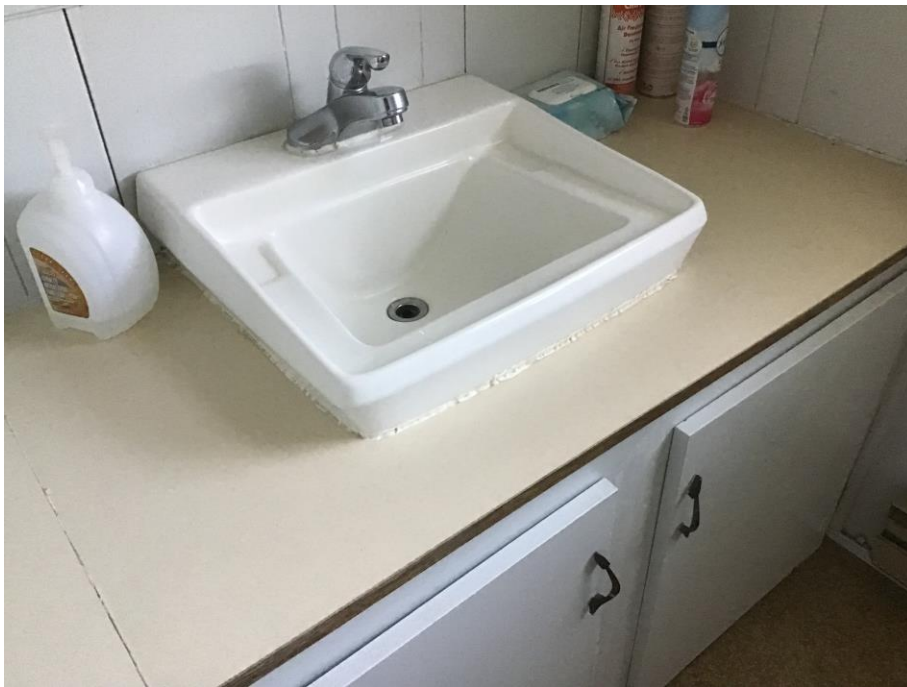
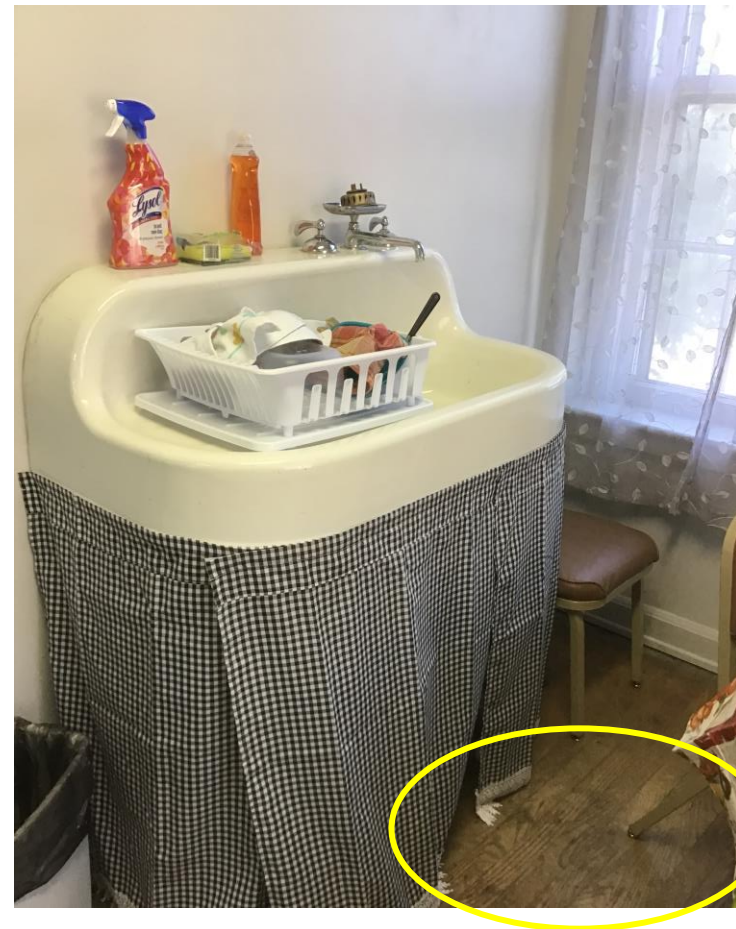
The Break Room sink is original to the building. The wood floor is stained and damaged from water.
