Historic Structures Report

**APPOMATTOX DEPOT**

APPOMATTOX, VIRGINIA

JANUARY 8, 2019

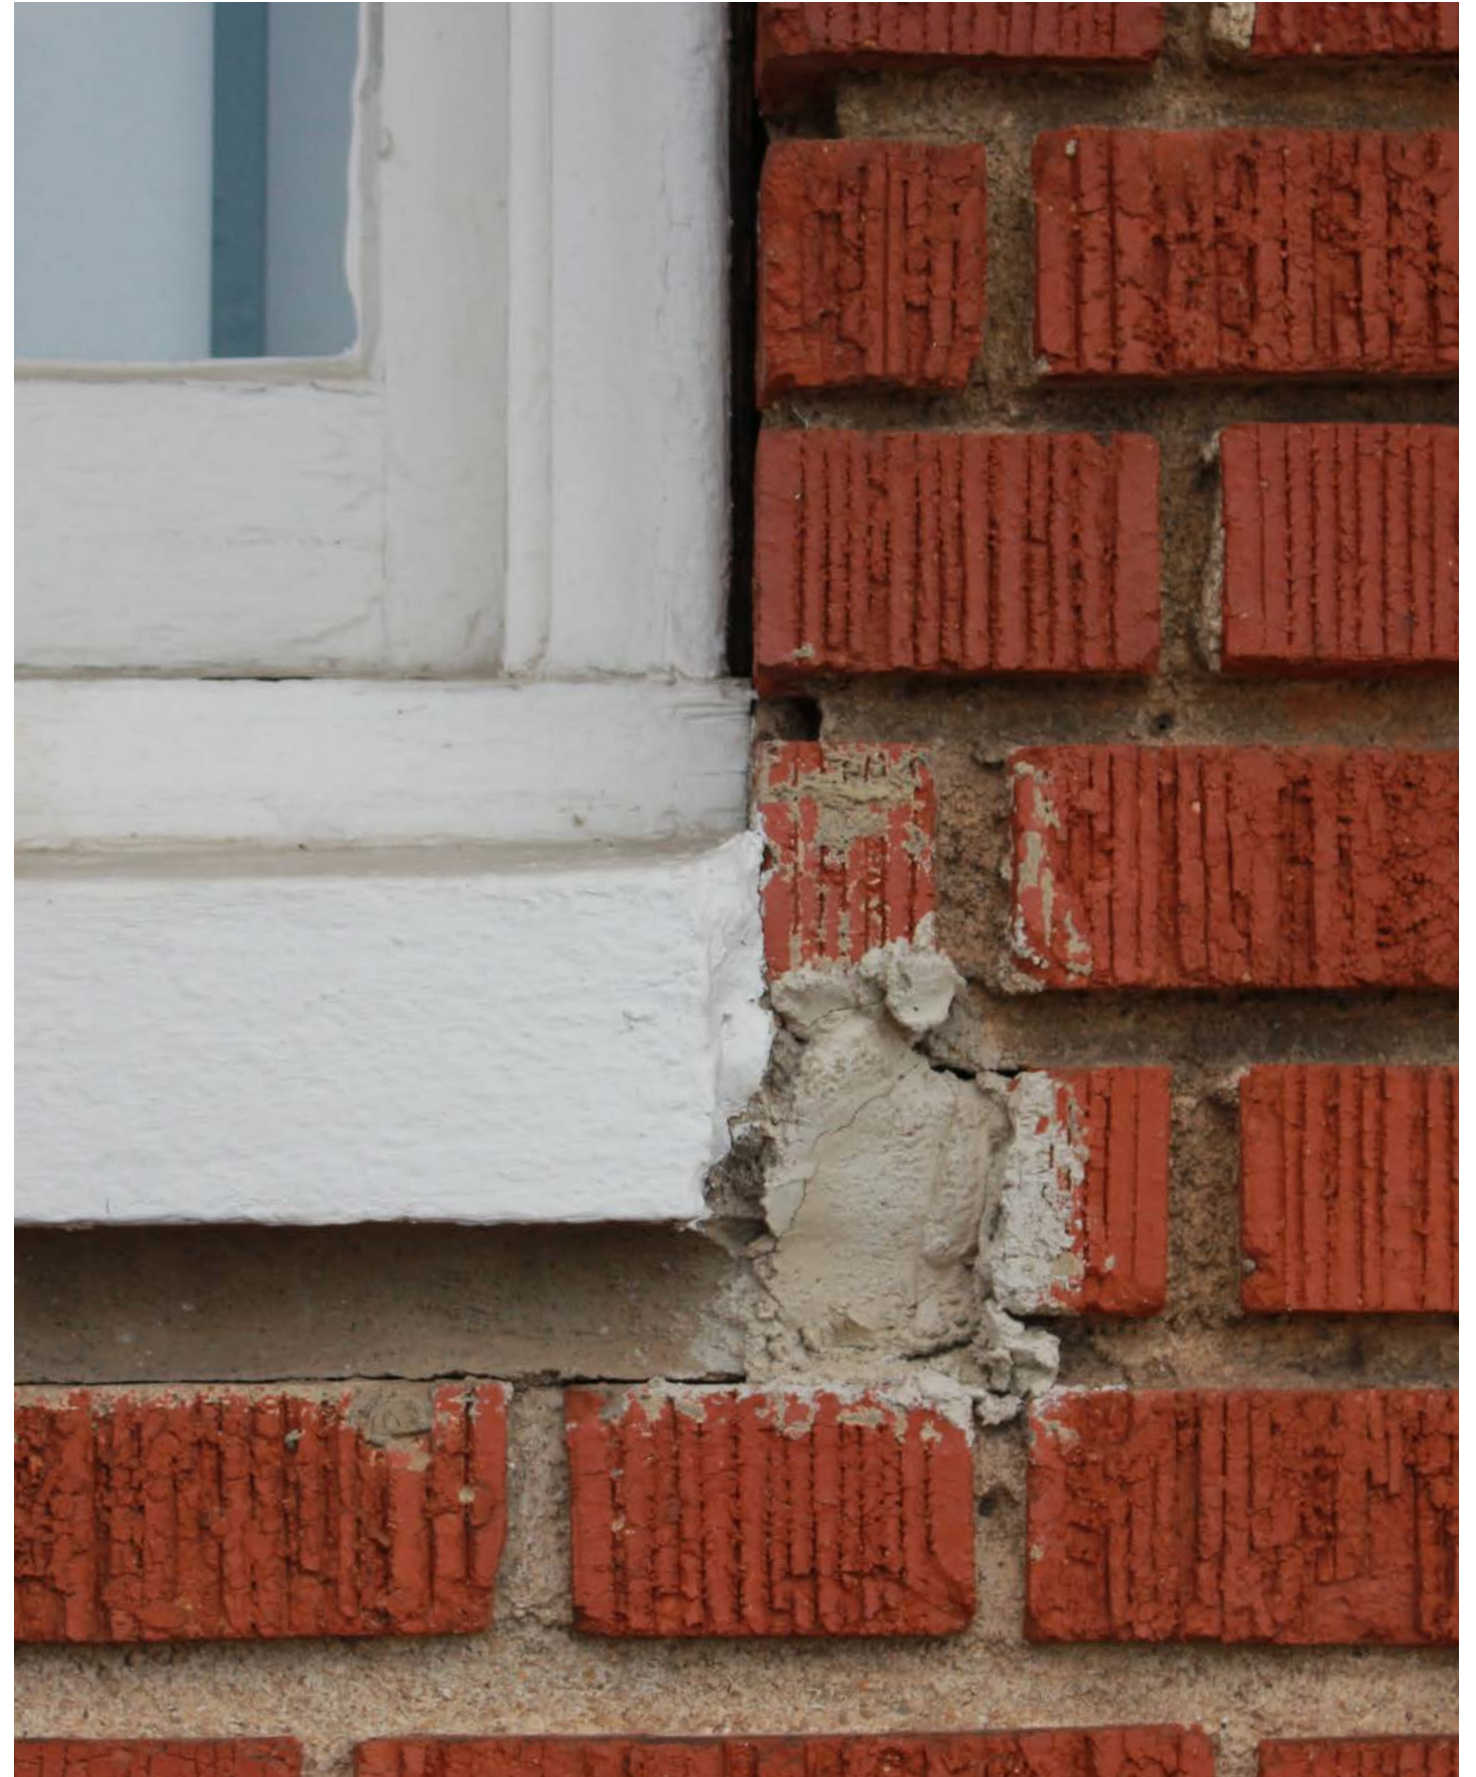
## Staining of Previous Repairs

### DEFICIENCIES

Poor previous mortar repairs are visually incompatible in color. Following the removal of inappropriate mortar, as described in the “Inappropriate Mortar” section above, it is likely that remnants of said mortar may remain, particularly on brick faces.

### RECOMMENDATIONS

Stain areas of visually incompatible mortar with a mineral masonry stain to match historic mortar and/or brick color as accurately as possible. It should be noted that this process should not take place until the masonry is cleaned as described in the “Cleaning” section of this document. This will help ensure that an accurate color match is achieved.

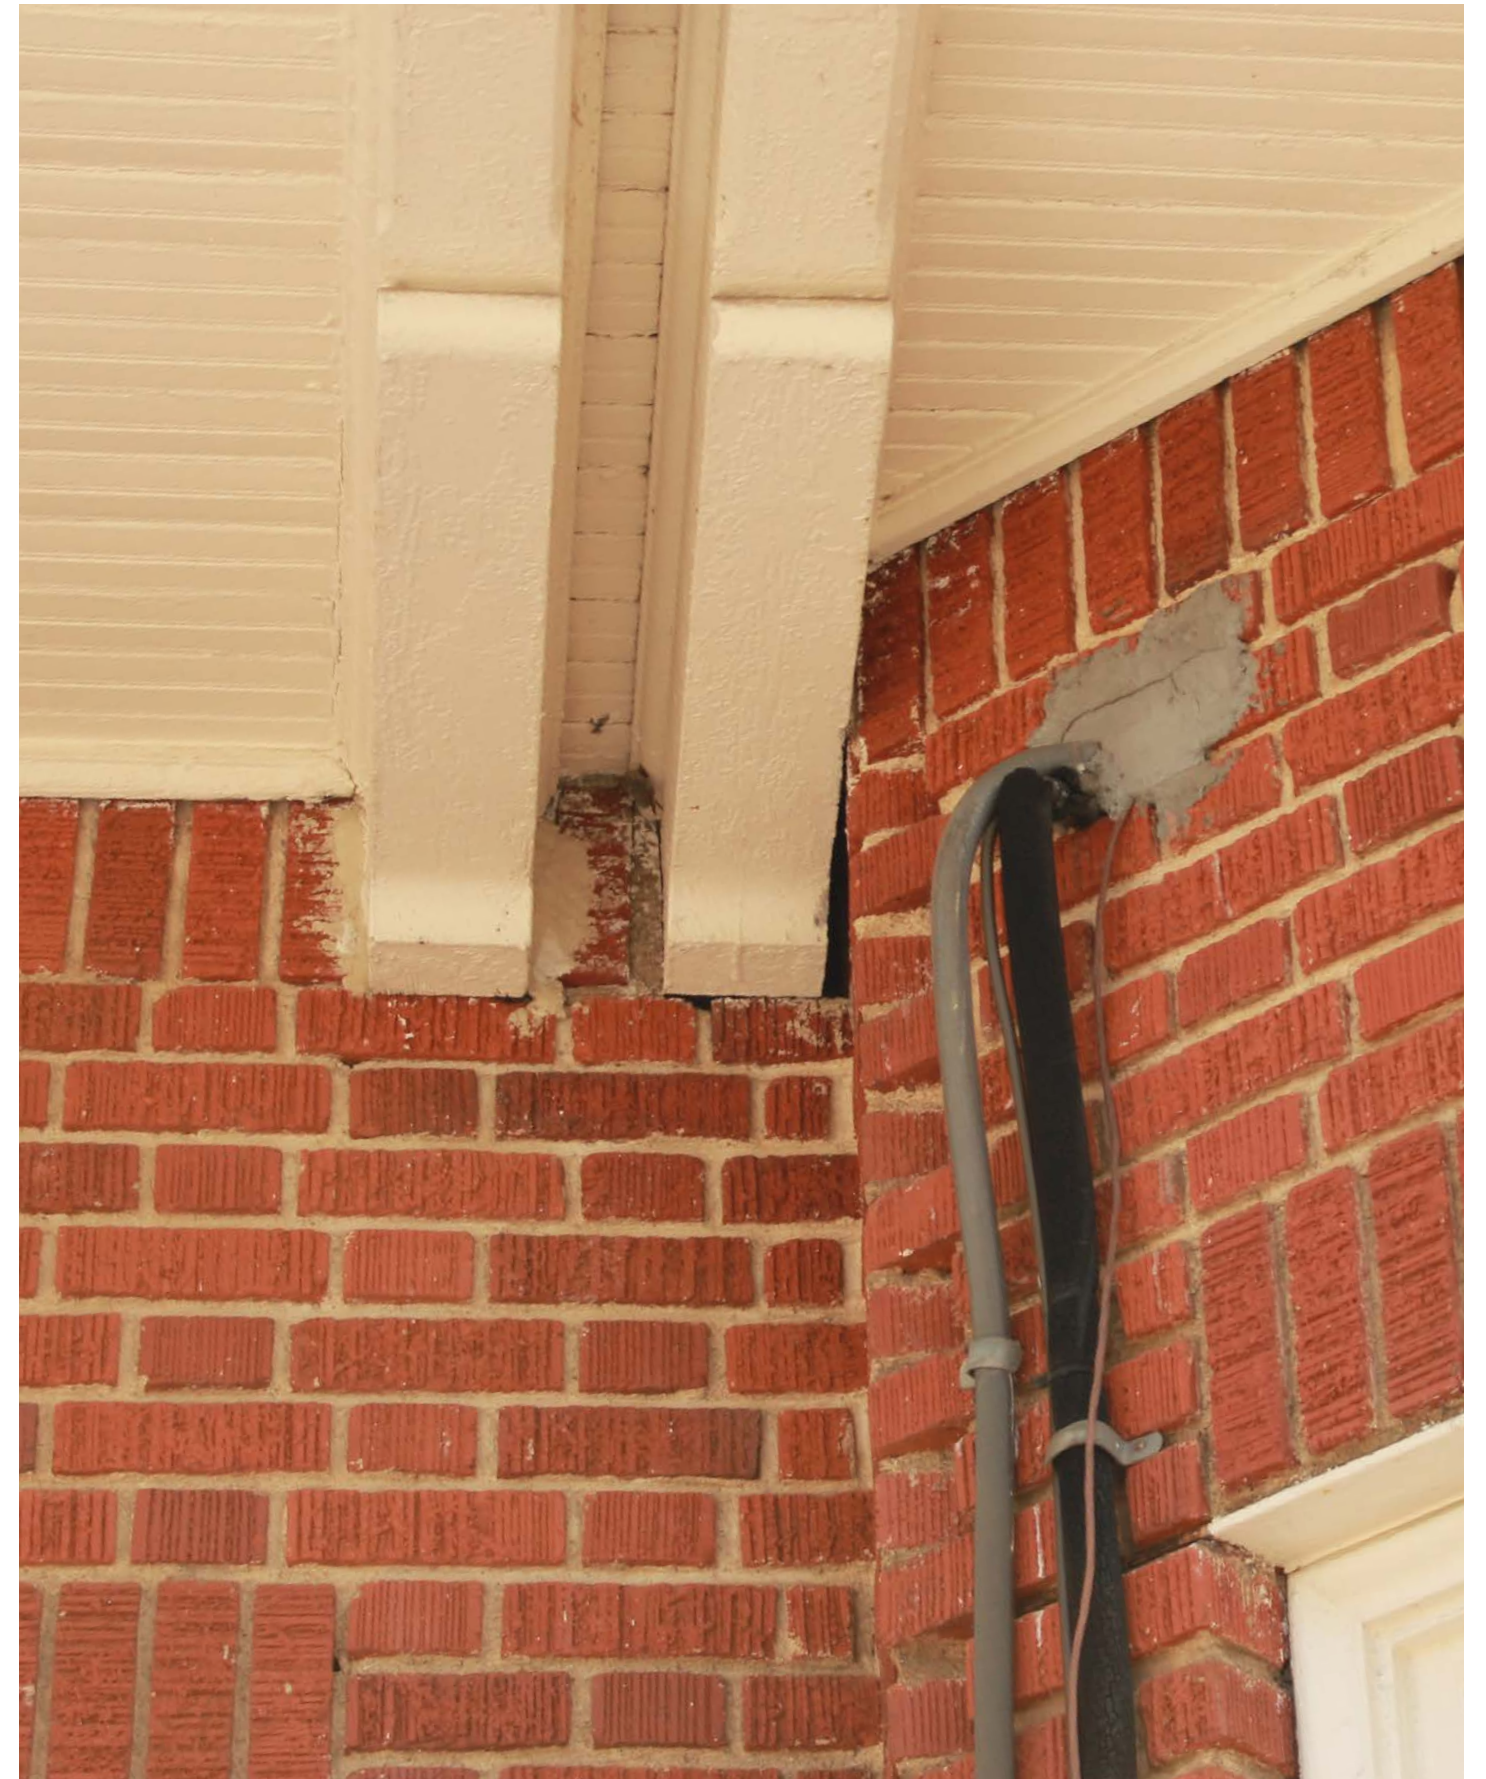
### DEFICIENCIES

Areas of moderate mortar degradation and/or loss are present on all elevations, resulting in the settling of bricks and possible water intrusion into the masonry substrate. It should be noted that deterioration will accelerate if left un-checked, causing further serious damage to the structural integrity of the building.

### RECOMMENDATIONS

Areas of failed and missing mortar should be re-pointed to ensure soundness. Failed mortar should be carefully removed to a minimum depth of one and one-half times the width of the joint to achieve a solid substrate. Great care should be taken not to damage the brick faces. Repointing should ensue as required using in-kind mortar. New mortar should match existing historic mortar in compressive strength, texture, color, and joint profile as closely as possible. The mortar joint should retain its raked profile. Once repointed, masonry should be cleaned with Prosoco Enviro Klean Masonry Cleaner to remove residual mortar staining.

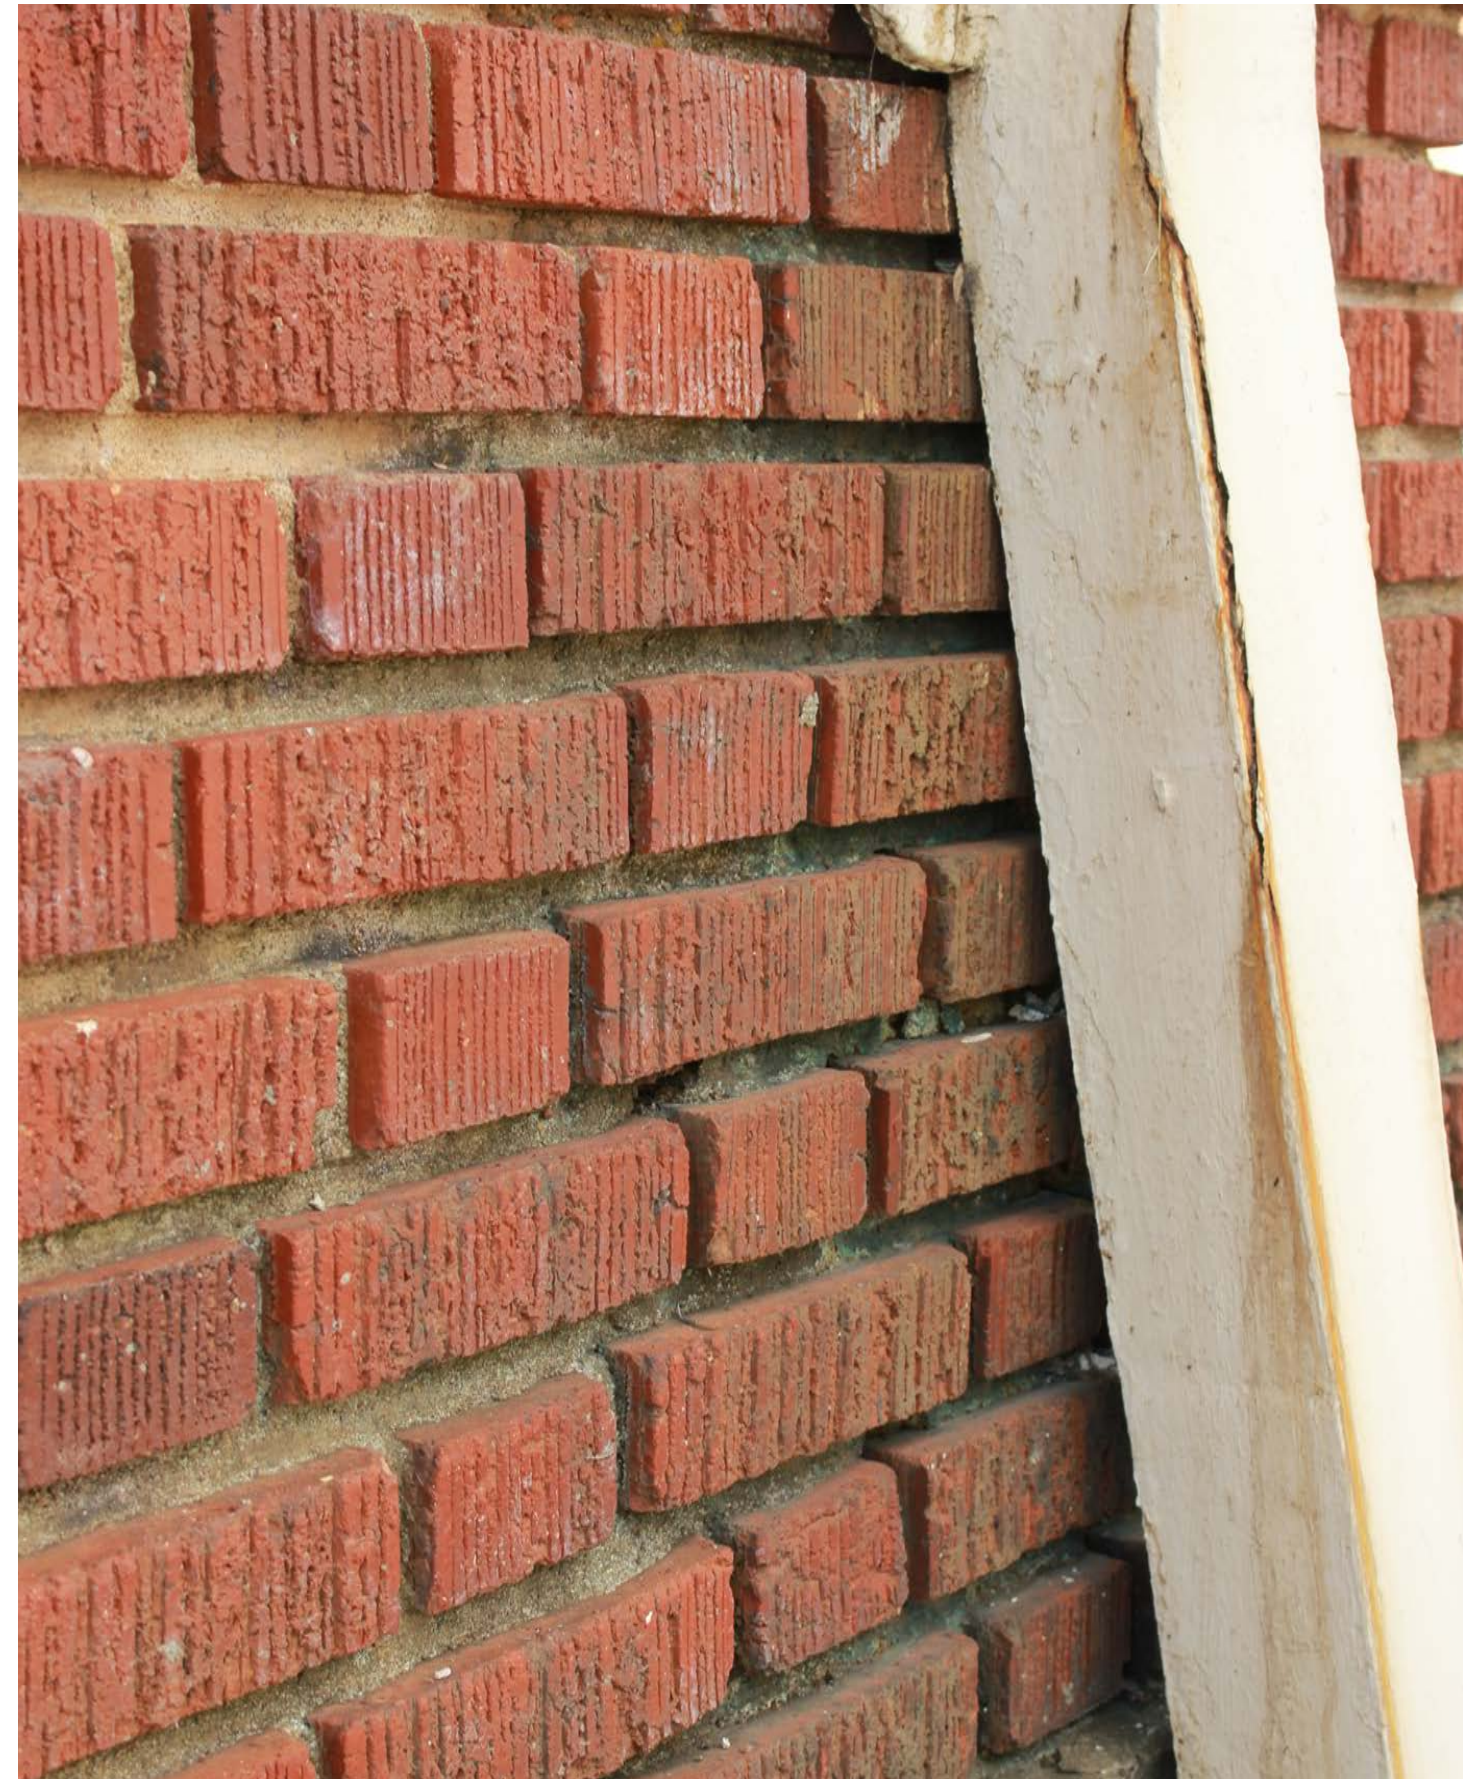
## Crack Repair

### DEFICIENCIES

General masonry cracking is present in multiple locations on all elevations. These cracks are generally caused by mortar failure, water intrusion, structural deficiencies, etc.

### RECOMMENDATIONS

Deficient mortar at crack locations should be carefully removed to a minimum depth of one and one-half times the width of the joint to achieve a solid substrate. Great care should be taken not to damage the brick faces. Cracks narrower than 3/16" should be stabilized using Jahn M30 Micro Injection Grout. Cracks between 3/16" and 9/16" in width should be stabilized using Jahn M40 Crack Injection Grout. Significant vertical and step cracks should be repaired using stainless steel stitching, which should be placed within the mortar joint at appropriate intervals. The stitching should span the cracks and be mortared into place beneath the surface so as to not impact the masonry's historic appearance. Apply in-kind mortar in missing mortar joints. Mortar should possess compressive strength, texture, color, and joint profile to match adjacent existing material as closely as possible.

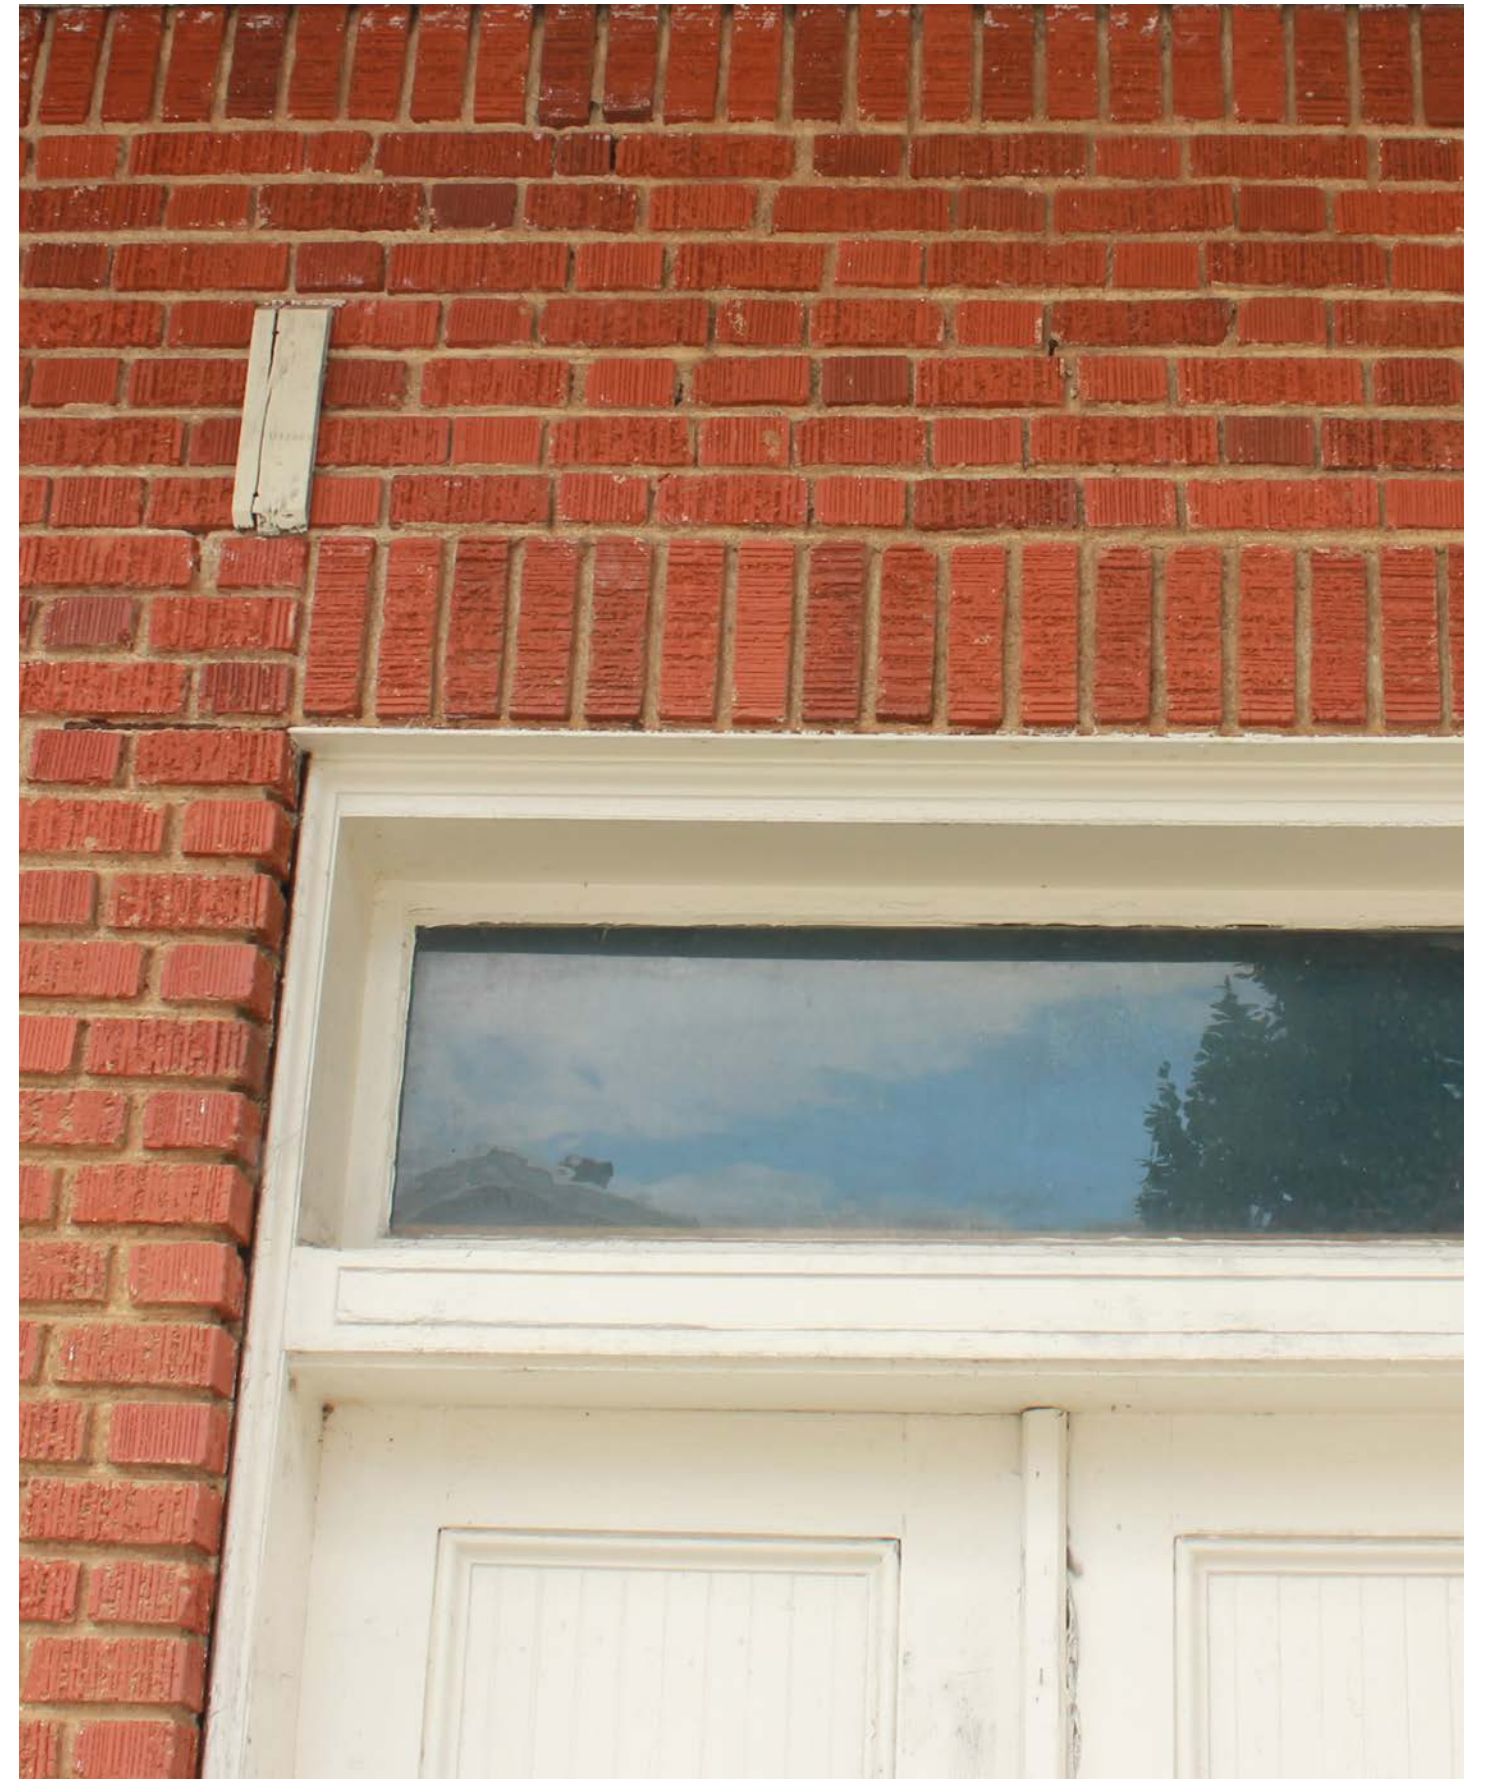
## Brick Repair / Replacement

### DEFICIENCIES

At various locations indicated on notated elevations, bricks have been damaged due to general wear, inappropriate penetrations (i.e. for condensate lines, electrical wiring, venting, etc.), cracking, etc.

### RECOMMENDATIONS

Bricks with minor damage should be repaired using appropriate repair mortar (Jahn M100 - Terra Cotta and Brick Repair Mortar, or equivalent) that matches existing bricks in color and compressive strength as accurately as possible. Repairs should be finished in a manner that matches the existing profile and texture of the bricks as accurately as possible. Severely damaged bricks should be replaced where required using a compatible replacement. New bricks should match existing brick in dimension, color, and texture as accurately as possible. Bricks should then be pointed as described in "Selective Repointing" section above.

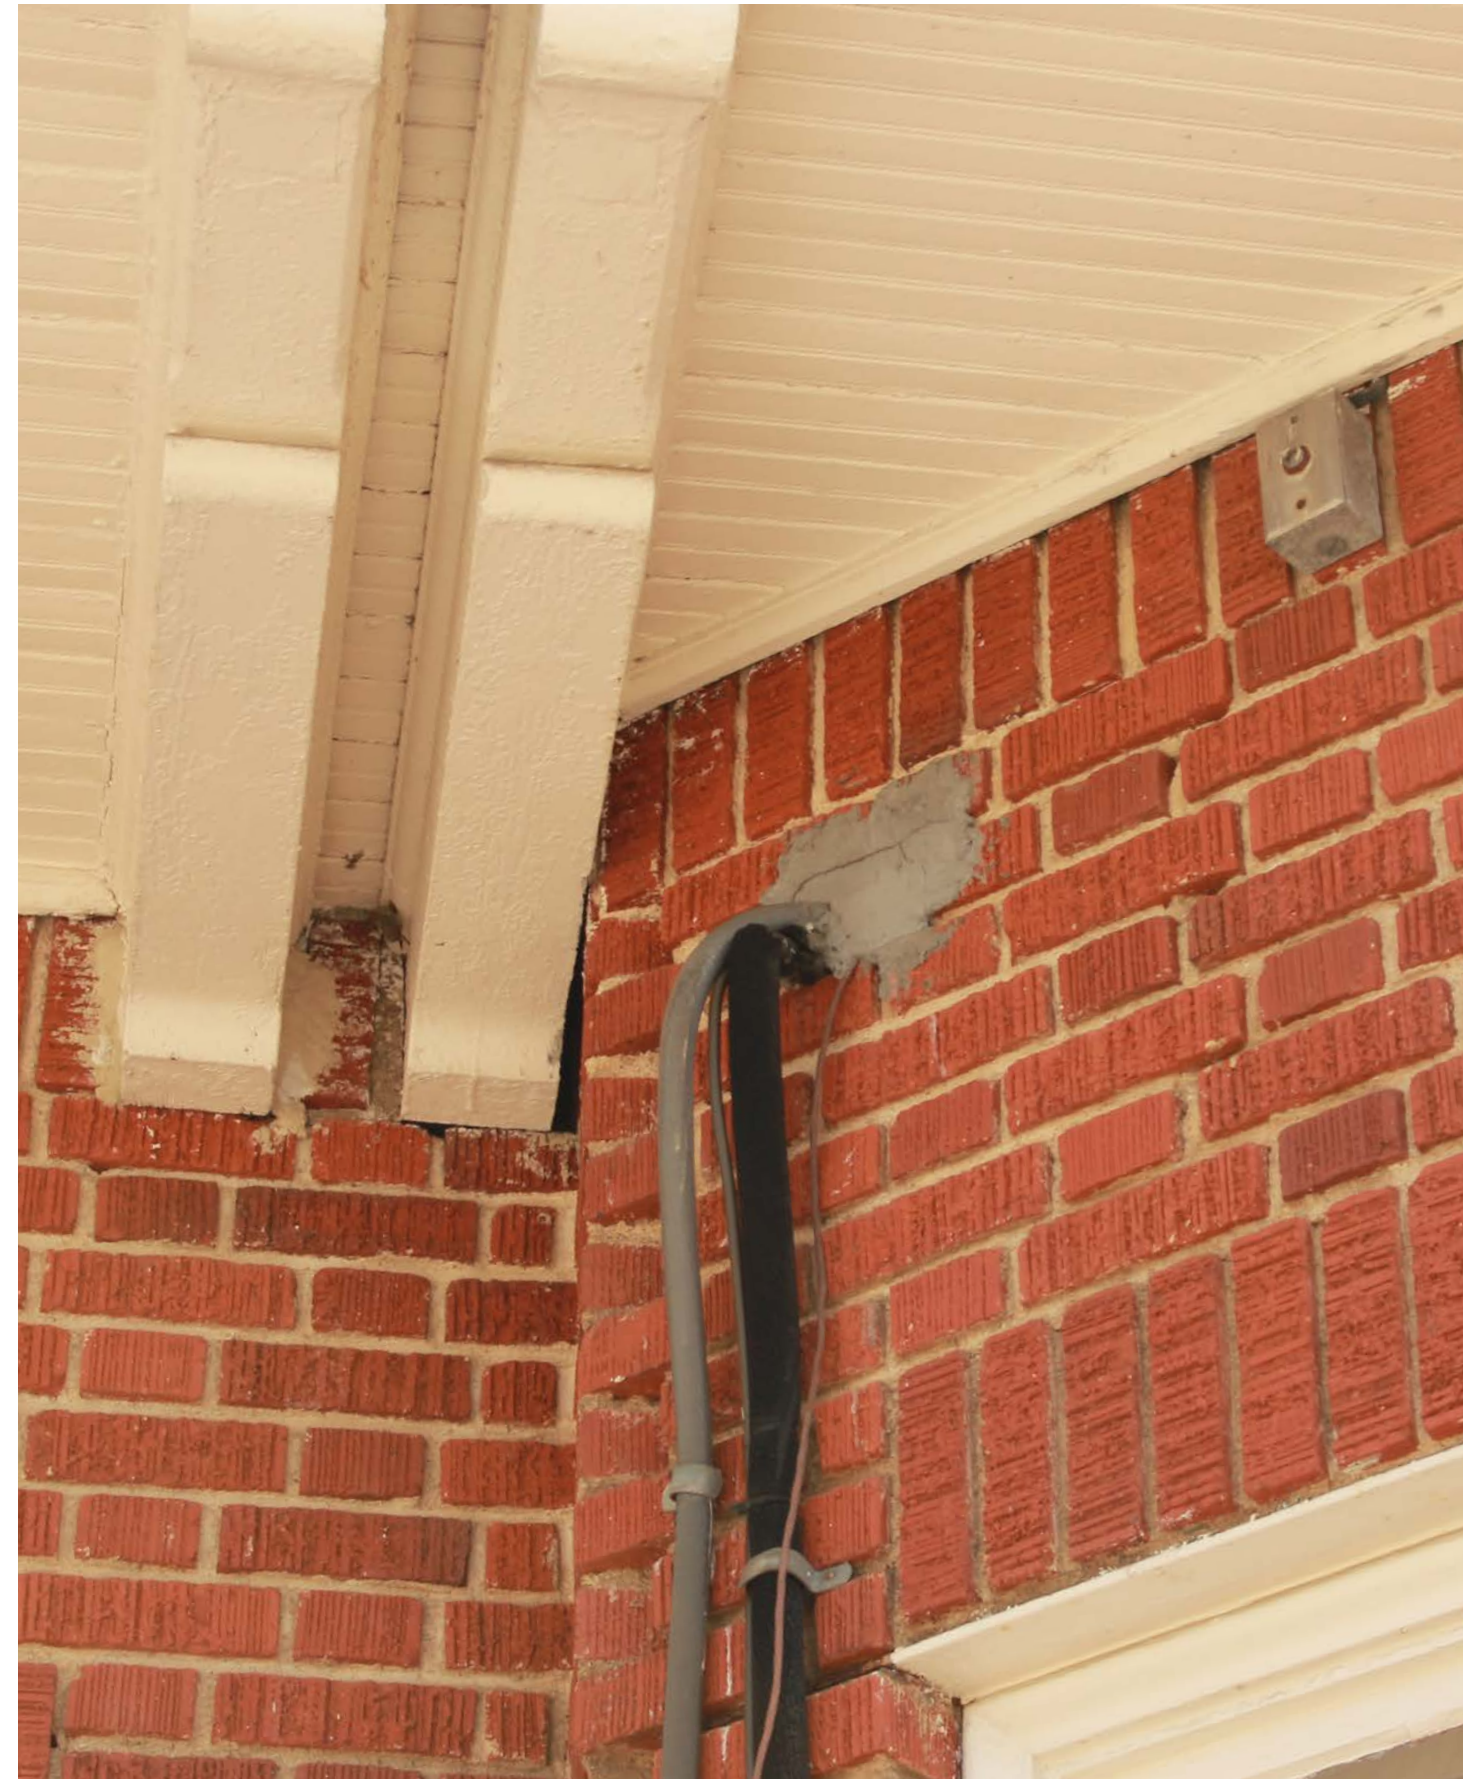
## Abandoned Fasteners / Hardware

### DEFICIENCIES

Abandoned, inappropriate, non-historic fasteners are in place in various locations on all elevations. Abandoned, non-historic fasteners pose a threat of oxidation, damage to adjacent masonry, and possible water intrusion.

### RECOMMENDATIONS

Remove non-historic fasteners on east and north elevations, where possible without causing damage to adjacent masonry. Repoint masonry using in-kind mortar as necessary as described in masonry treatment sections above. Mortar will possess compressive strength, texture, color, and joint profile to match adjacent existing historic material as closely as possible. Any remaining historically significant fasteners (i.e. attachment points for window grilles on north elevation) should be treated with a rust converting/arresting treatment (Ospho or equivalent), coated with a rust inhibiting primer, and finished with two coats of finish (Sherwin Williams DTM or equivalent).

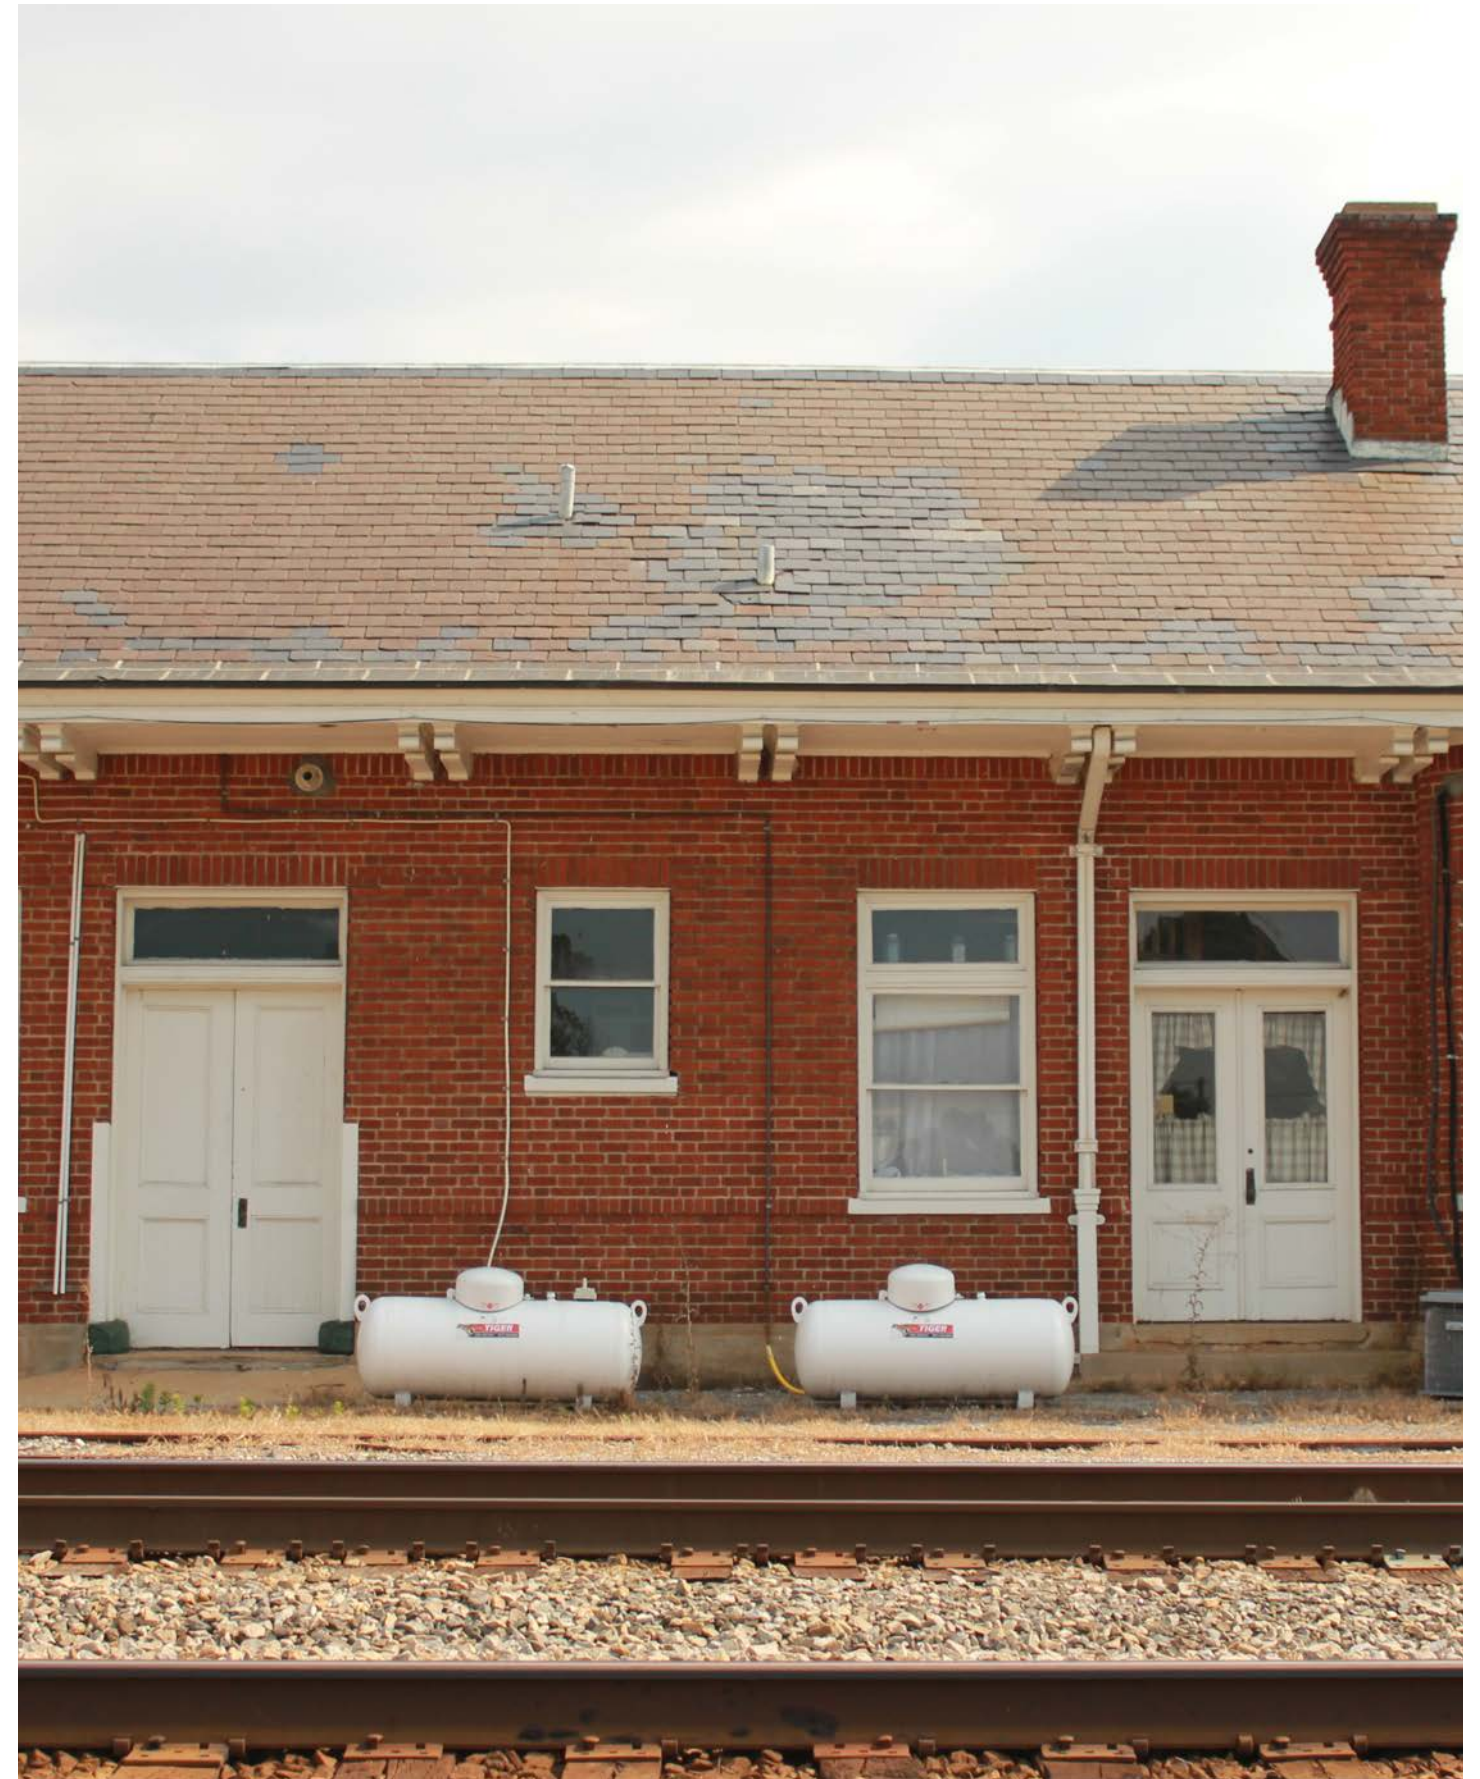
## Windows & Transoms

### DEFICIENCIES

Window glazing and paint finish on most windows and transoms on all elevations exhibits widespread deterioration and loss of integrity. Numerous sashes exhibit deterioration and failing joinery. Previous repair attempts are visible which include the inappropriate application of wood filler, flexible sealant, etc. Many lower window sashes have been painted/sealed shut and no longer appear to function. The north window of the Women's Retiring Room (White) no longer possesses obscured glass, as indicated on the original 1923 architectural drawings. Broken and inappropriate glass is present in numerous transoms.

### RECOMMENDATIONS

Cut paint and/or sealant from perimeter of lower sashes and deteriorated upper sashes to ensure they can be opened and/or removed for proper repair. Document, label, and remove all lower window sashes and any deteriorated upper window sashes. Install temporary protection to prevent weather intrusion into building during restoration of sashes. Remove failed glazing where required. Clean frames and glass to remove all dirt deposits, residue, etc. Prepare wood window members to remove loose paint, scaling, etc. Hand sand to feather paint remnants and to ensure sound, paint-ready surface. Repair deteriorated sash, frame, and sill members where required in an in-kind manner. Repair should include consolidation and infill with wood epoxy where areas are smaller than one cubic inch in size, or in areas of thin material loss over a sound existing substrate. Areas larger in size should be repaired with a Dutchman fabricated using Sapele (or equivalent). Significantly deteriorated members should be replaced using Sapele (or equivalent). All repairs, Dutchmen, and replacement members should match existing historic members in dimension and profile as accurately as possible. All bare wood should be treated with a wood consolidant. All wood surfaces should be primed with an alkyd-based primer. Replace any broken panes of glass using double-strength glass. Re-glaze where required using DAP 33 Glazing Compound. Once glazing compound has "skinned over" (approximately three weeks), window glazing can be primed and painted as described herein. The interior and exterior surfaces should then be painted according to the results of the historic finish analysis (see "Historic Paint Analysis" section for further details). Install spring-bronze weather stripping into window openings in a manner that will not be visible when the sashes are in their closed positions. All sashes should then be re-installed into their respective, original openings. Lower sash windows should be weighted with existing weights and bronze sash chain. Existing, historic pulleys should be stripped of paint and returned to serviceable condition. Ensure that all sash locks are stripped of paint and properly functioning. All hardware should be installed with slotted screws. In no event should Phillips-head screws be implemented. Any required replacement screws should match their respective historic hardware in material. In no event should lacquered brass be implemented.

**Glass in the north window of Women's Retiring Room (White) should be replaced with obscured glass as indicated in 1923 architectural drawings.**
