# Appomattox County Assessment of County Buildings

July 17, 2023

## FACILITY ASSESSMENT CONDITION

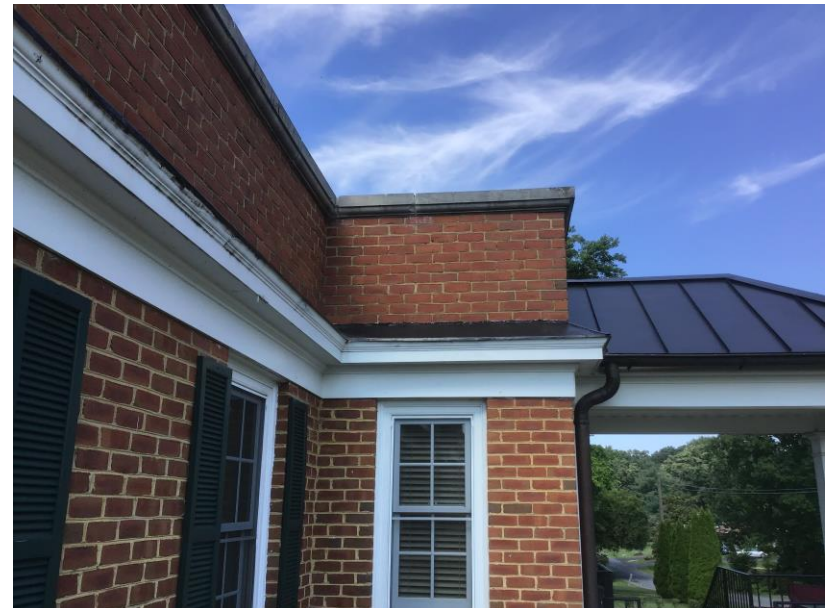
The building has a fair amount of precast coping stones. The joints between these sections of stone need reworking. We would recommend to have the joint material (mortar or sealant) removed and new backer rod and urethane sealant installed. A 20-year warranty is available with the urethane sealant and the color can be selected to match the stones. A professional caulking contractor should do this work and not a roofer, in order to have an aesthetically pleasing caulk joint.

We also recommend having the precast stones cleaned as there is a fair amount of black staining visible.

The metal flashing that seals off the top of the cornice needs to be reworked. Also, the wood cornice is starting to deteriorate. We would recommend at a minimum to have the cornice joints caulked and a fresh coat of paint on all the woodwork in addition to reworking the flashing. A better long-term solution would be to have the cornice reconstructed of a non-organic material (fiber cement, fiberglass or aluminum) which are more durable to the elements than the painted wood.

The composite columns and shapes at the porches are separating and failing. These areas should be remediated or replaced.

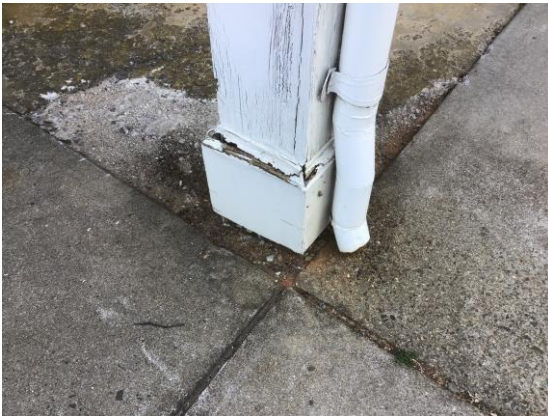
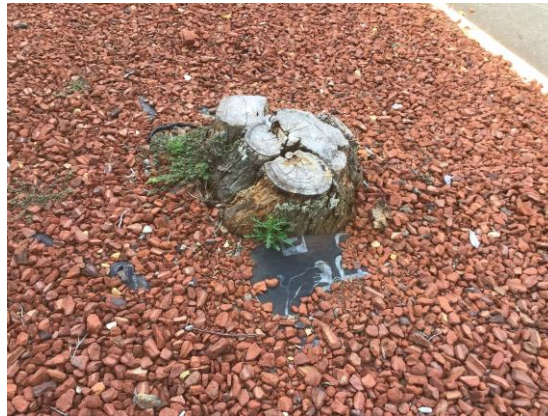
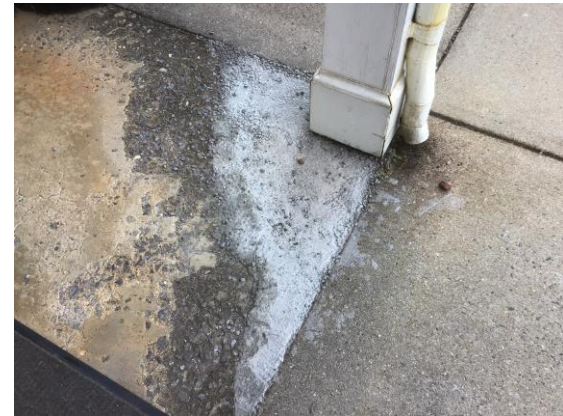
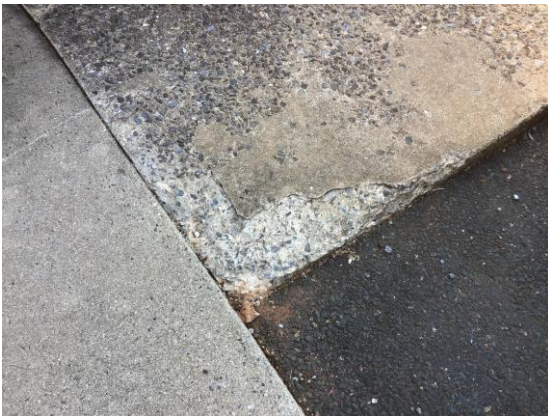
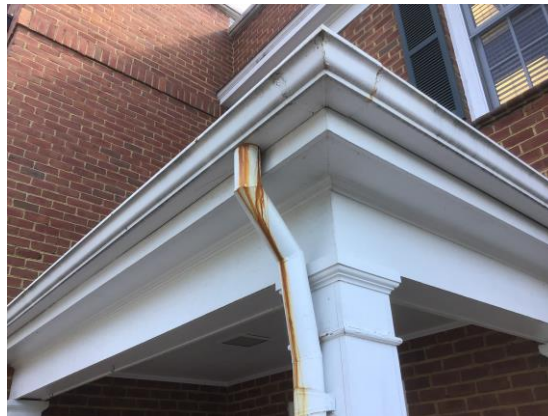
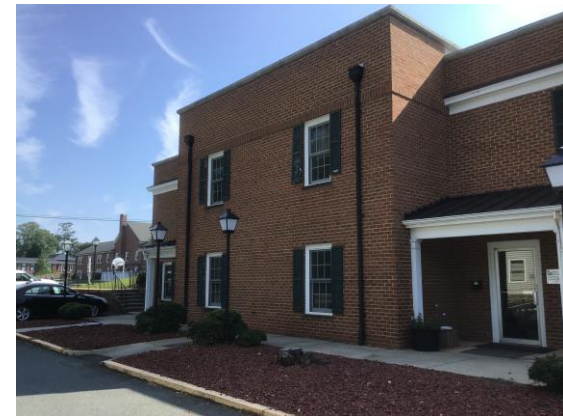
There are wood columns on both the east and west elevations of this building. While the columns on the east elevation at the main entry are in decent shape, the columns on the west side are beginning to rot, particularly at the column bases. Also, on this façade, the concrete has been patched or repaired at the column base locations, however, at the repair, it appears that Quik-rete was used instead of concrete. The sidewalks along this lower elevation are also beginning to deteriorate. We recommend the following repairs along this side of the building:

- Replace wood columns with composite material.
- Caulk joints and repaint remaining wood fascia and rack.
- Cut out and remove spalling concrete sidewalks and at entrances and replace with new air-entrained concrete.
- Reroute downspouts on entrance canopies to tie into existing roof downspouts that are piped underground.
- Grind stumps where landscaping was removed.

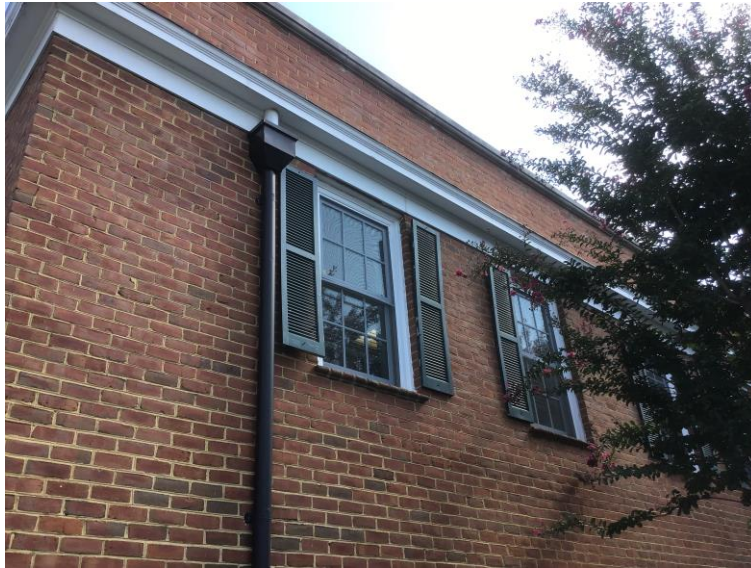
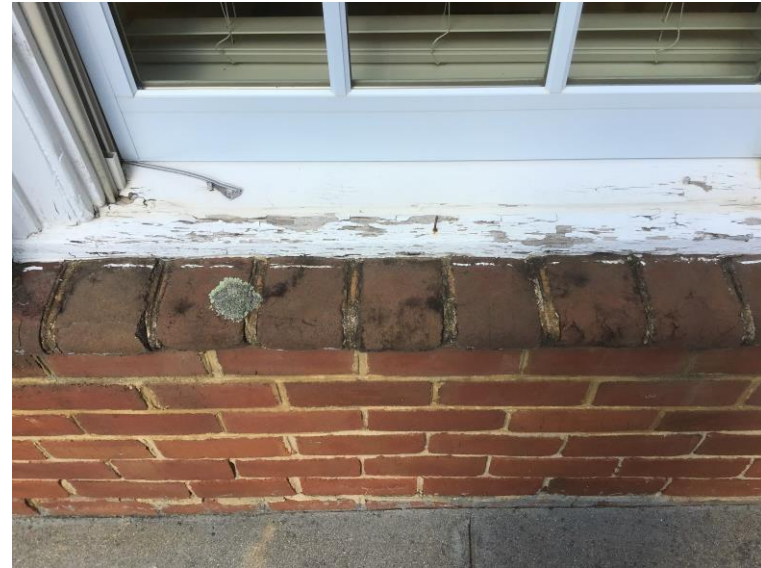
Many of the existing shutters are in need of repair. Several are beginning to detach from the building and almost all of the shutters have peeling paint. We recommend replacing all of the shutters with a high-quality composite or fiberglass product to match the existing design.

The existing wood windows have been replaced with vinyl replacement sashes. The wood exterior and interior trim remain and need repainting. The County is currently performing maintenance on the replacement sashes. An unwanted guest pushed a sash inward and entered the extension office. The shutters are wood and have started to warp. Some are missing and all need to be painted.

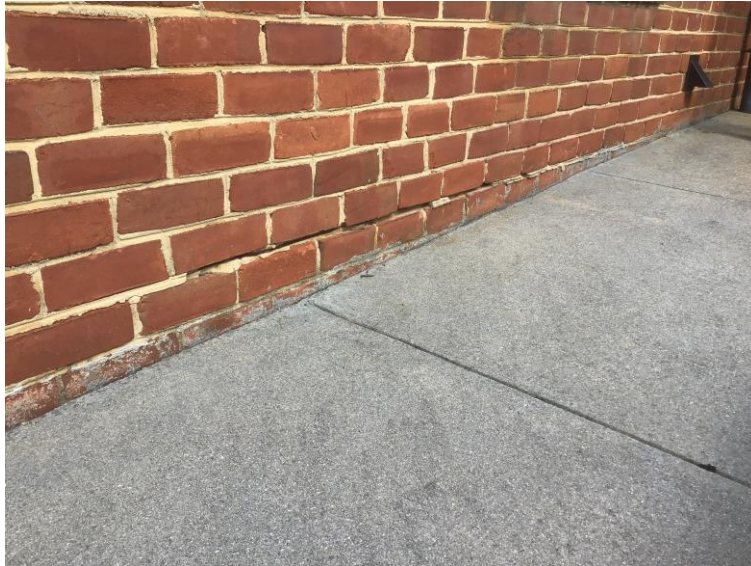
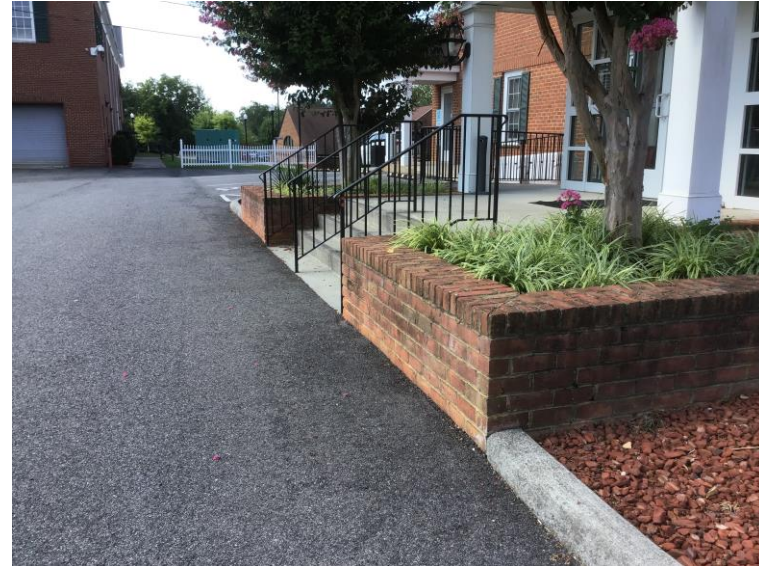
Along the east elevation, there is a ramp for ADA access from the parking lot. At the brick course that coincides with the floor level along this ramp, the mortar has separated from the brick and this could be a potential entry point for water into the building. It is recommended to rake out and remove this mortar completely and have the joints re-pointed with new mortar to match the existing.

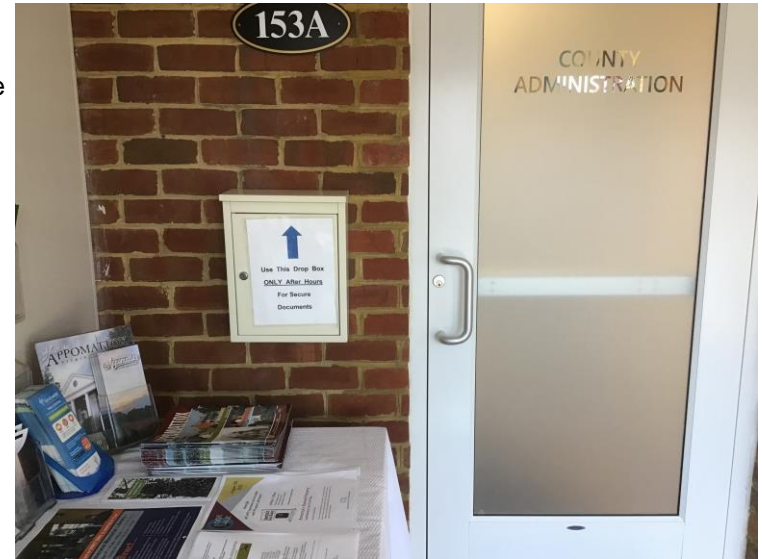
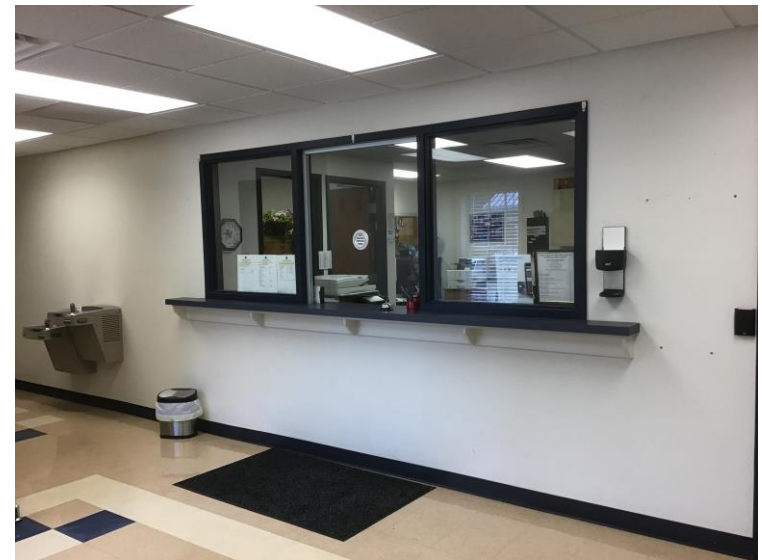
Recently, window film has been added to the main entry door. This window film restricts visibility on both sides of the glass. This is not desirable. It is recommended to have the window film at least partially removed from the glass so as to aid in visibility for persons entering and exiting the building so that no one inadvertently gets hit by the door, because the person on the other side failed to realize someone was trying to use the same door at the same time. Additionally, the table in the vestibule impedes on the required clearance needed on the latch side of the main entry door, making the main entry door non-compliant for ADA accessibility.

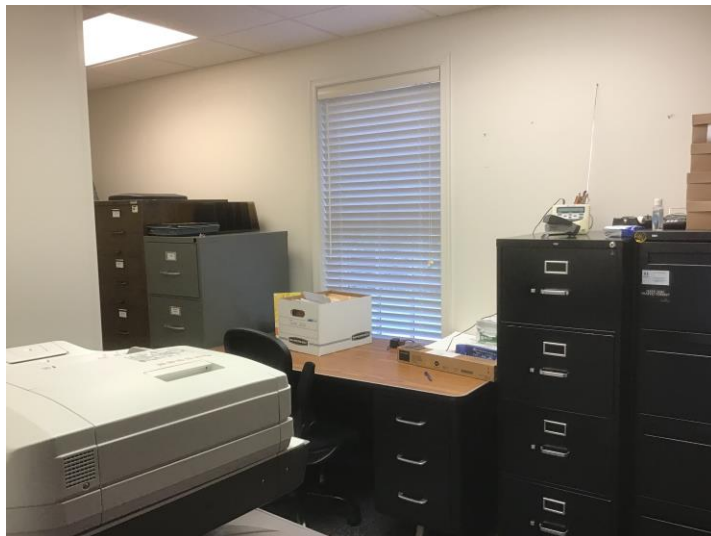
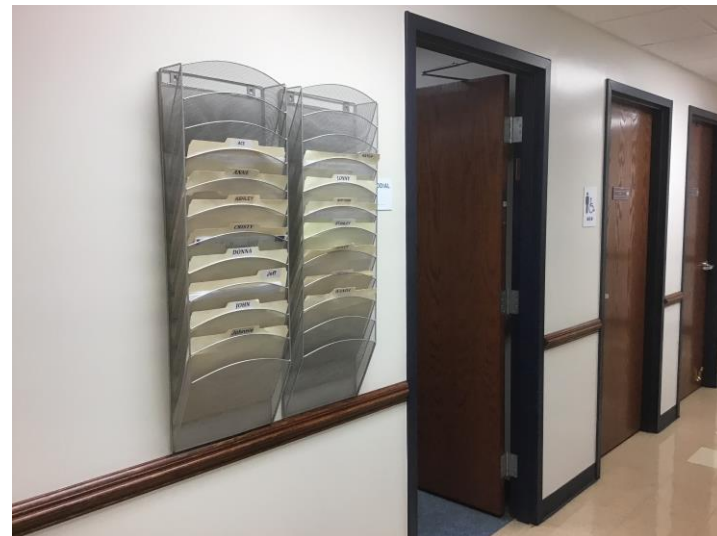
The interior of the offices, corridors and other spaces appears to be in good condition, although, some staining of ceiling tiles was noted. It is unknown if roof leaking or condensate from the mechanical units are the cause of these stains.

Some carpet staining was noted, although that is expected in heavily used buildings such as this one.

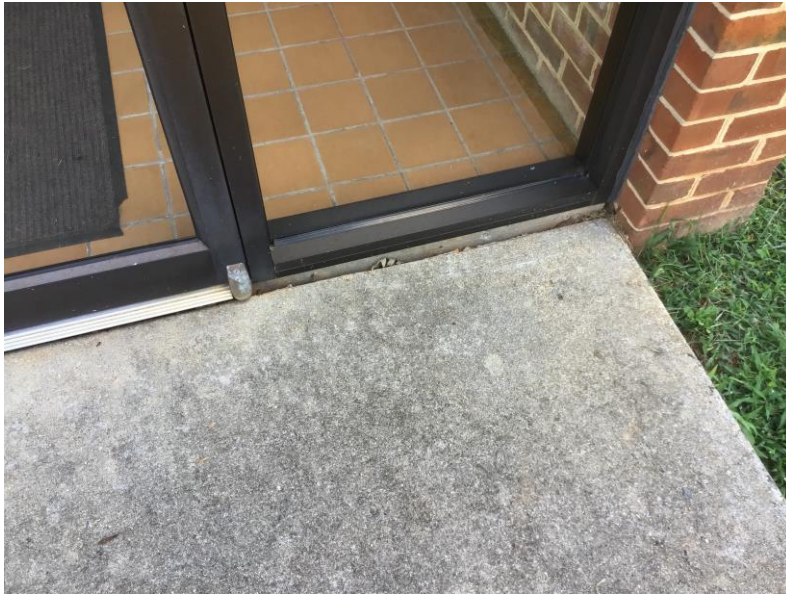
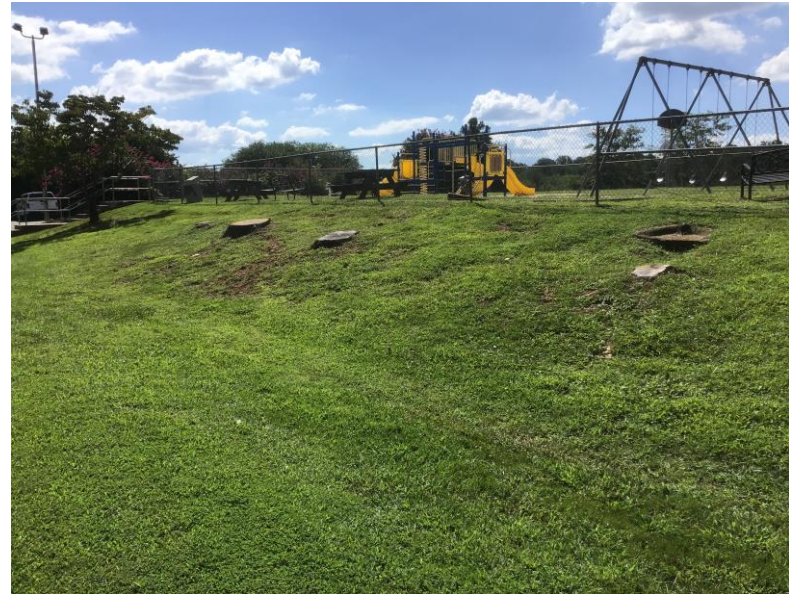
There is a horizontal gap at the main entry most likely due to some minor settling of the concrete entry slab. This should be monitored and if this slab continues to settle, it should be repaired as required.

There are several stumps located on the hillside adjacent to the playground. We recommend having these stumps ground.

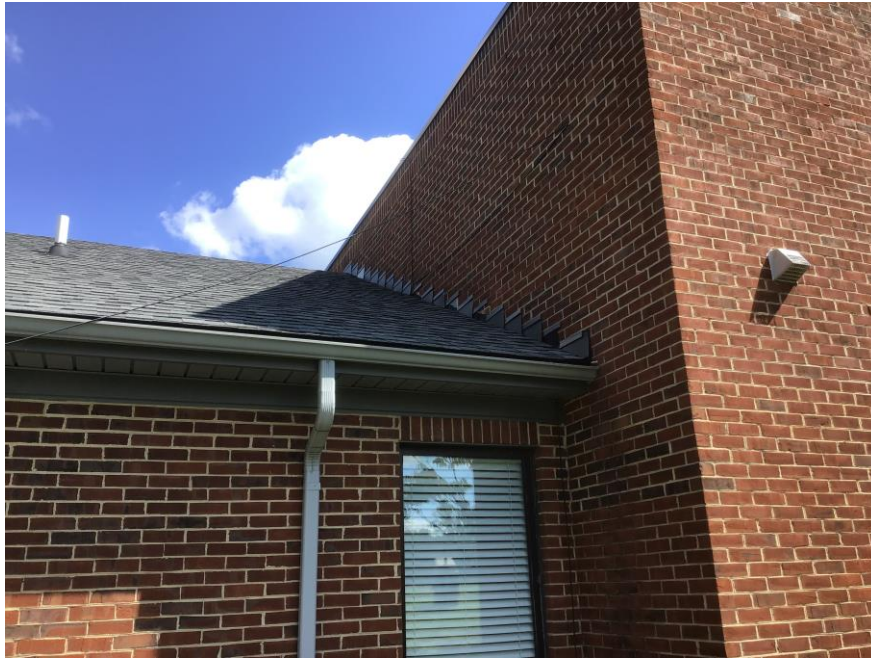
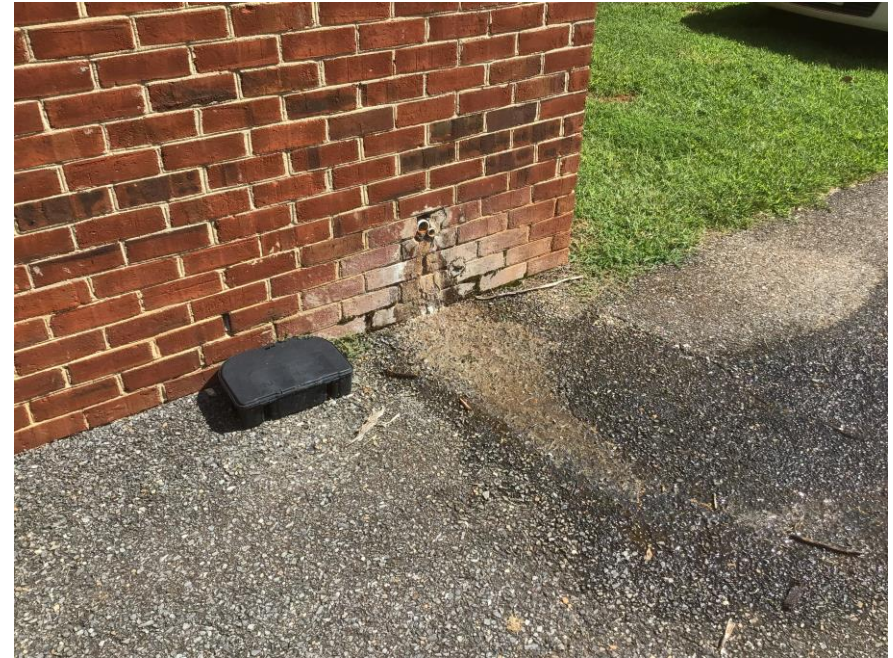
At one of the corners of the building, There are condensate lines that exit the building. The condensate lines have been cut flush with the exterior face of the brick veneer and the result is that the condensate sheets down the face of the brick veneer, which, over time has severely damaged the brick. It is recommended that the repair be made ASAP in order to prevent further damage and more costly repairs.

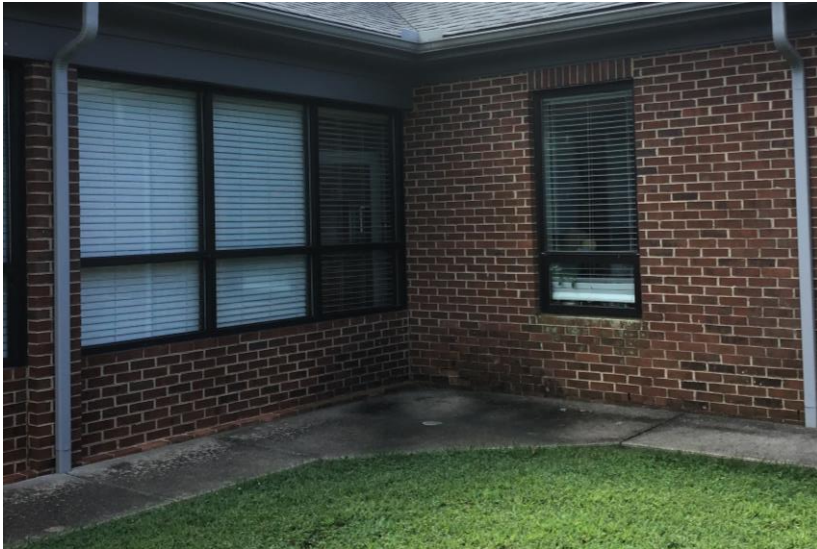
At the intersection of the roofs, there is evidence of rainwater overflowing the gutter at the valley, as there is staining on the brick due to the water splashing up on the brick. A valley deflector has been installed in the gutter to divert the flow into the gutter. It is unclear if the overflow of the water is still a problem or not. This area should be monitored during heavy rainfall to better ascertain if the valley deflector has completely fixed the problem or if further measures need to be taken.

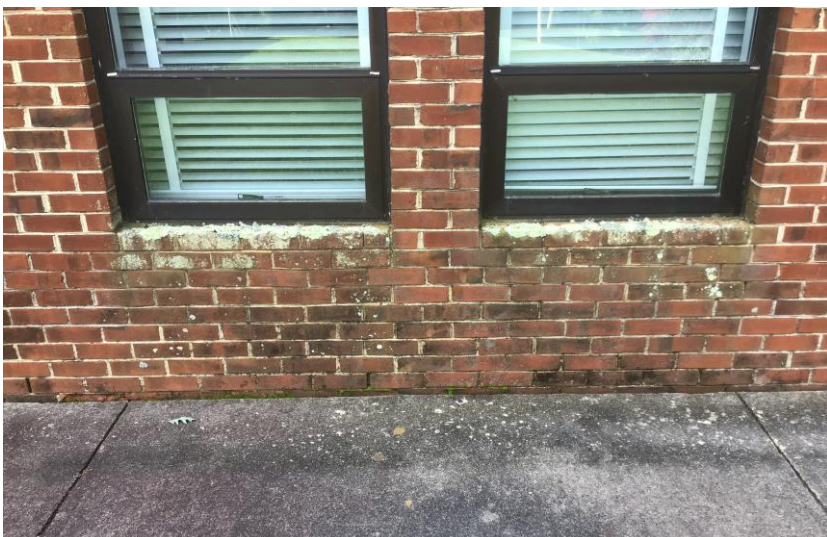
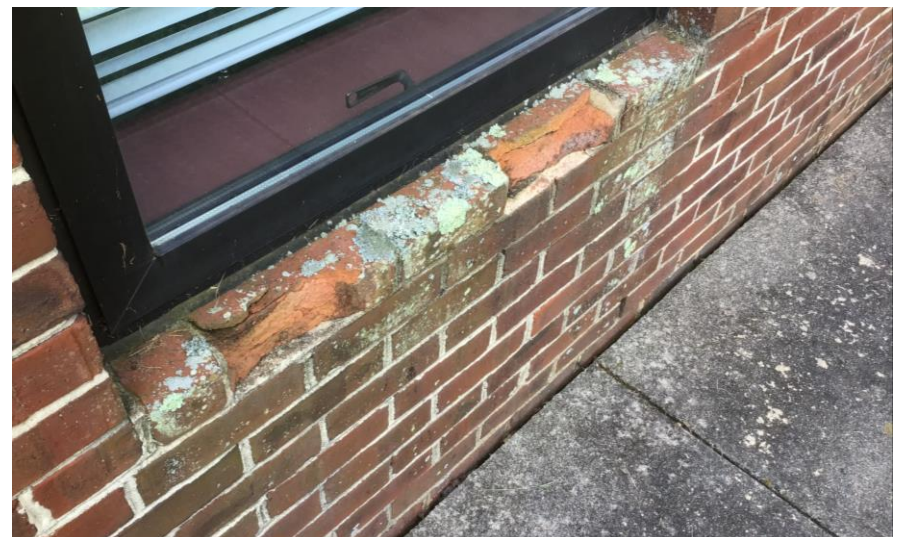
The exterior window stools along the north side of the building have moss growing on them. The window stools are constructed of brick but the tops are flat and not sloped to allow rainwater to run-off. It is recommended at a minimum to have the brick pressure washed and cleaned to remove the moss.

In at least one case, the damage from the water infiltration is so bad already that the brick itself has begun to spall and break apart.

A better long-term repair would be to remove the one course of brick at each of the windows and have a sloped brick stool installed to aide in runoff of rainwater. This may not completely eliminate the problem but not having the water sit for extended periods of time on the flat surface of the brick would help out a lot.

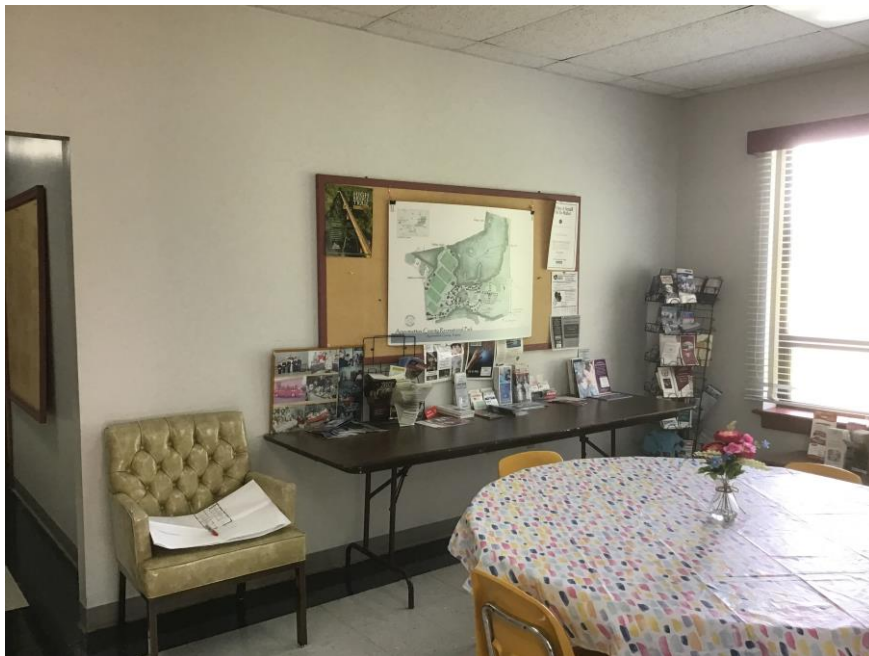
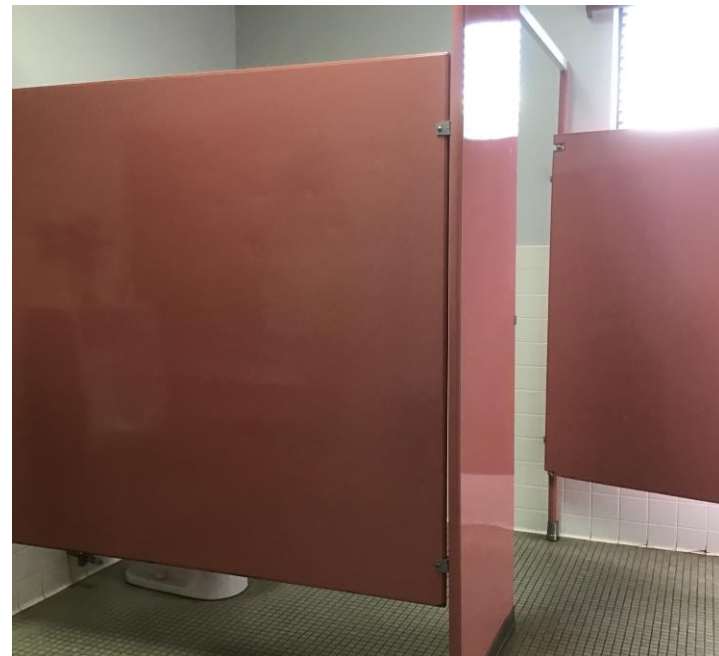
Some sagging of the acoustical ceiling tiles was evident; however, this is normal with ceiling tiles that are 30 years old or more. It is recommended to replace the ceilings during the next planned renovation.

The interior does not appear to have been updated recently. Most of the furniture and décor is not current and gives the facility a dated feel when entering.

A small renovation that updated colors, floor and ceilings and replaced the laminate countertops would go a long ways in giving this facility a fresh new look without spending a lot of money.

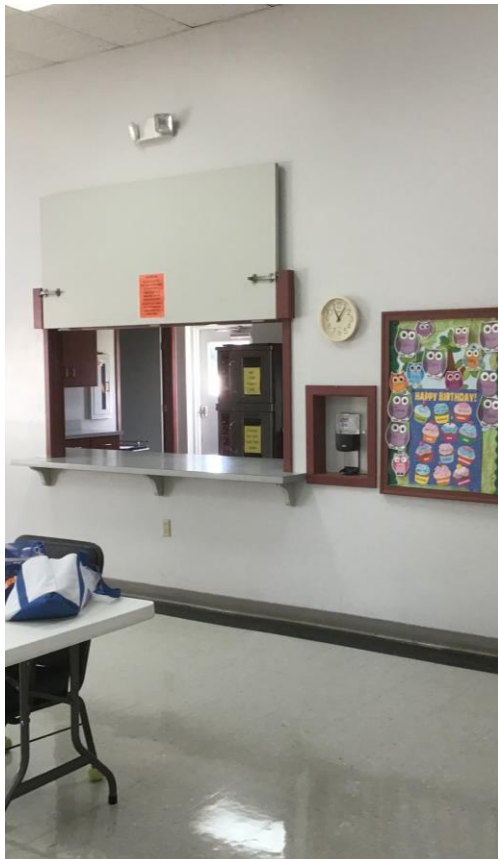
A nice sized warming kitchen is located adjacent to the multi-purpose area of this facility. The service counter is secured by a sliding door leaf. This method is not recommended as the sliding door leaf is quite heavy and could drop if not used properly. It is recommended to replace this door leaf with an overhead coiling counter door to prevent injury to persons that may use this facility.

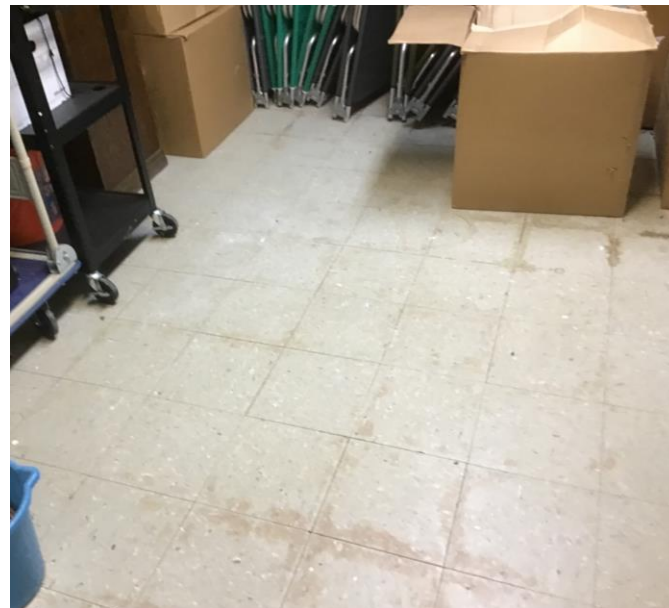
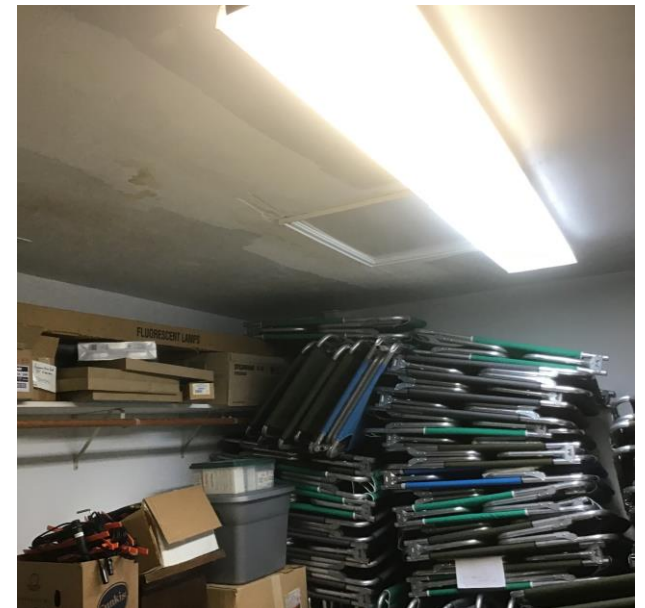
The VCT flooring in the storage areas along the north side of the building is beginning to release from the concrete slab. Also, there are several areas that are stained. It appears from the staining that water may be coming into the building perhaps through the concrete slab. It is recommended to have this monitored to determine how the water is getting into the building.

The ceiling is also stained and damaged within the storage areas.

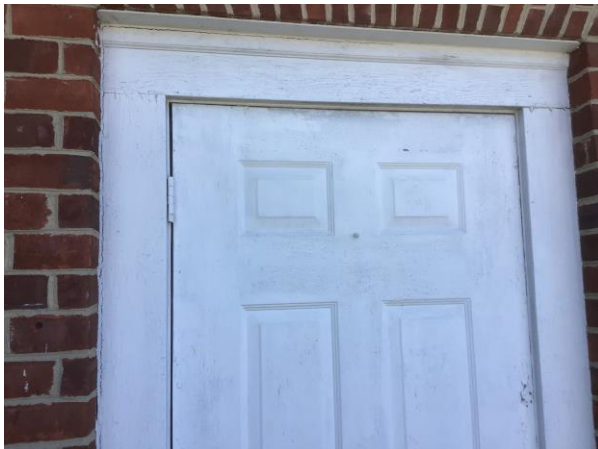
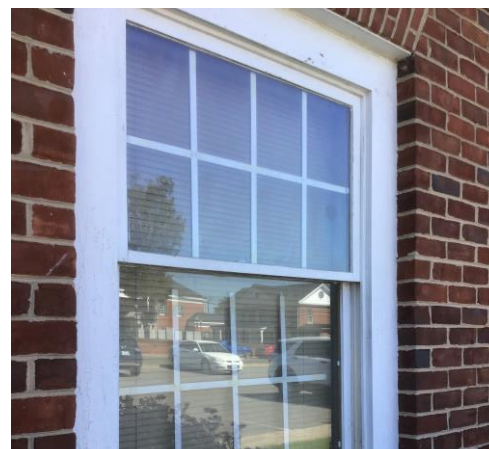
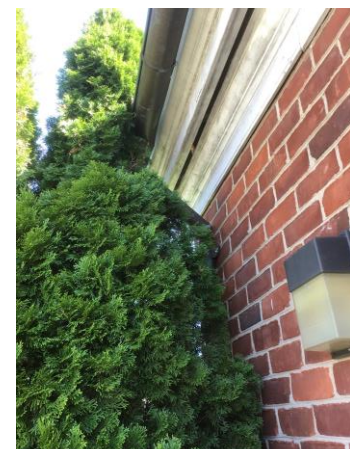
The exterior of this facility is in fair shape for a building of this age. The exterior windows and doors are all exhibiting peeling paint and beginning to fall into a state of disrepair. If the County intends to keep the School Board at this location, it is recommended to replace all windows and exterior doors. Newer products will have higher thermal properties and will provide better insulating qualities for the building. This will cut heating and cooling costs and save the County operating expenses. Another concern with the exterior is how close the landscaping is to the building and the fact that the landscaping has not been maintained and is now overgrown and touching the building in multiple places along the front façade.

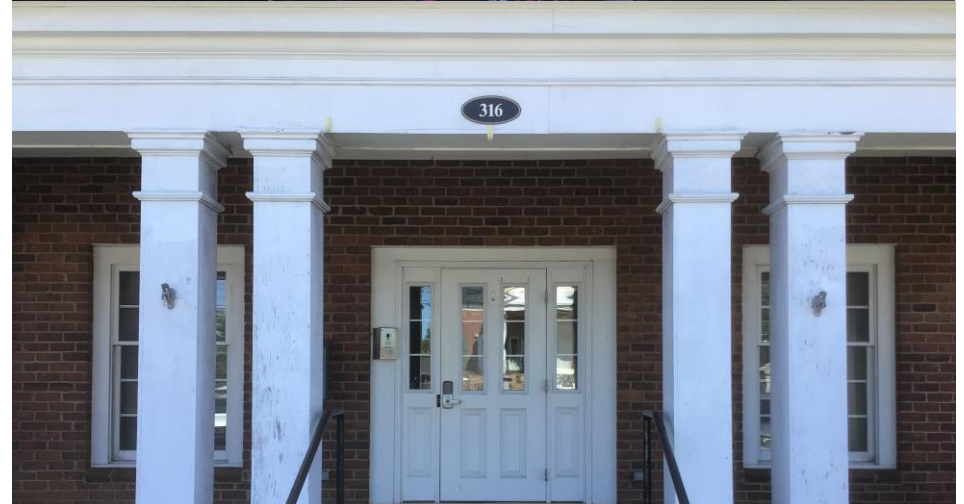
All of the wood trim, cornice and moldings on the exterior is at the beginning stages of having peeling paint. All of the white woodwork is dirty and has mildew present. The woodwork should be thoroughly cleaned, and a fresh coat of paint added at a minimum. We would also recommend having all the joints in the wood caulk so as to prevent any water infiltration.

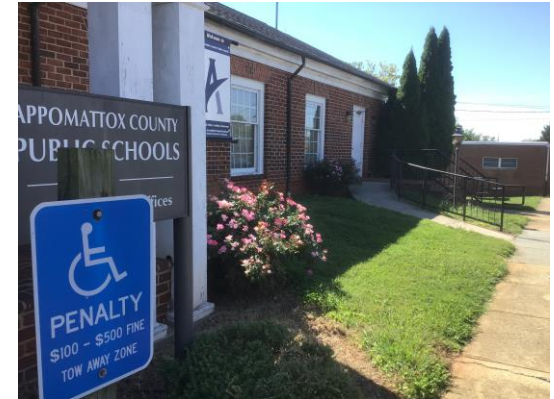
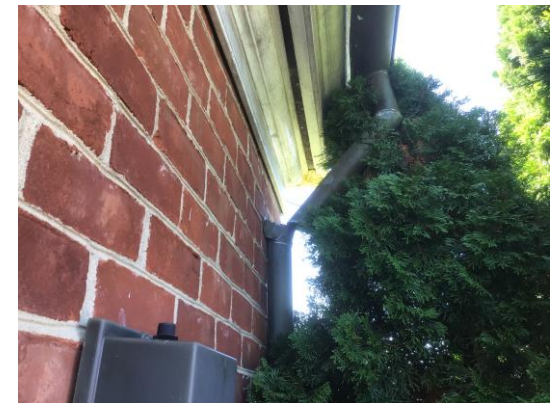
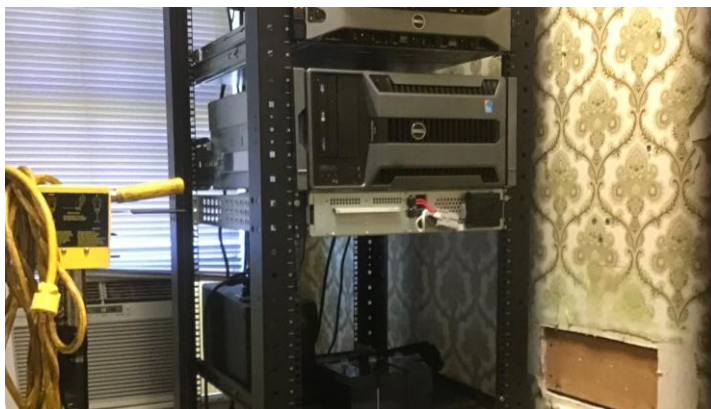
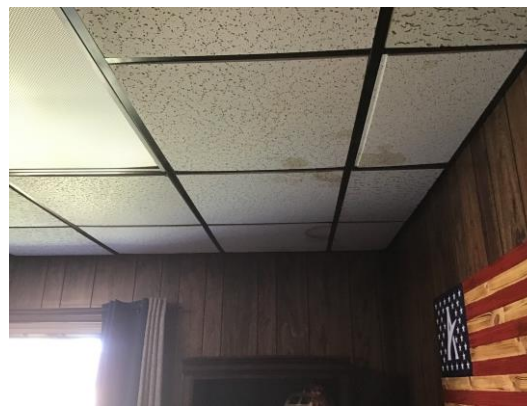
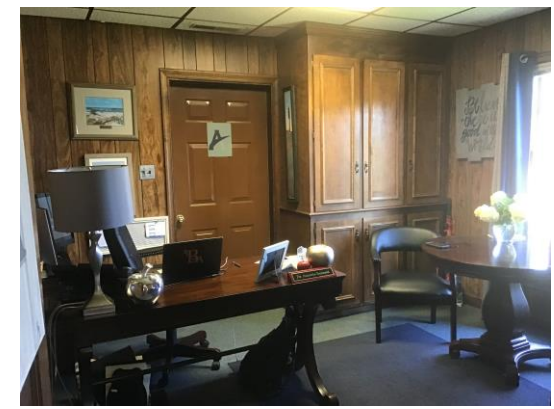
The placement of the signage at the front is not the best layout. The main sign is blocked by the required ADA parking sign.

At the downspout on the southwest corner, the elbow that connects the leader from the roof to the leader that runs vertically is completely missing. Anytime it rains, all this water that is flowing through the downspout from the roof just gets dumped onto the grade, right at the building. The roof is in fair condition and should be replaced in the next 10 years.

The interior of this building is very dark. This is due to the wood paneling used throughout the spaces. This is not an ideal material for use in offices, as it is prone to damage. Also, since it is so thin, it often allows sounds to be easily transmitted through the walls to the adjacent spaces. This is not desirable.

Some stains were visible on the ceiling tiles on the day of our visit. It is unclear as to the cause of the stains, however, these are presumed to be from roof leaks. The age of the roof is unknown, however, the asphalt shingles appear to be in decent shape.

In the I.T. Closet, adjacent to the Superintendent's office, a window air-conditioning unit was observed. Due to the heat load of the equipment within this space, more cooling is needed than other spaces within the building, however, the window unit is not the best solution as it offers minimal control of temperature and humidity within the space.

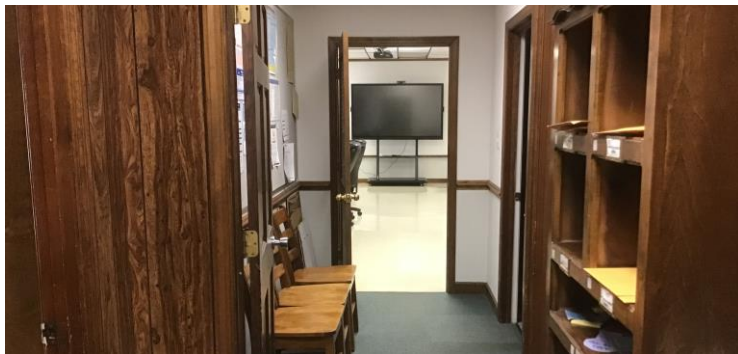
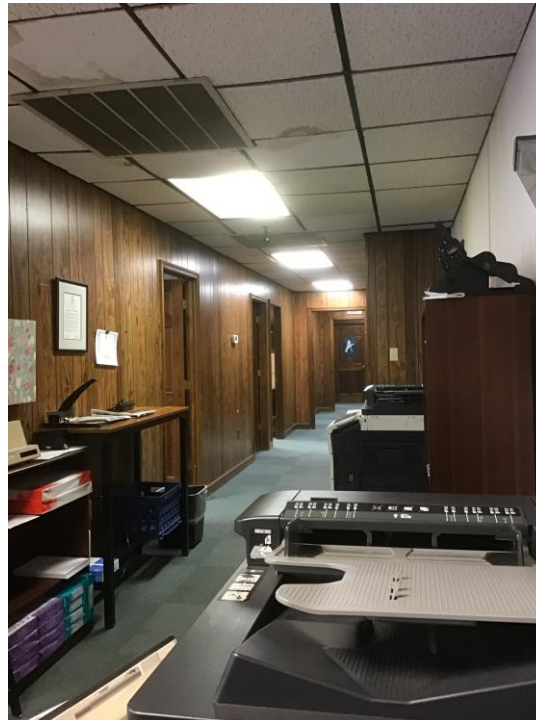
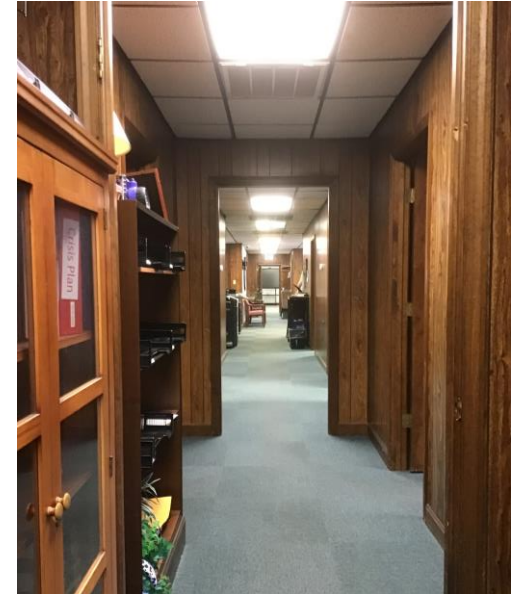
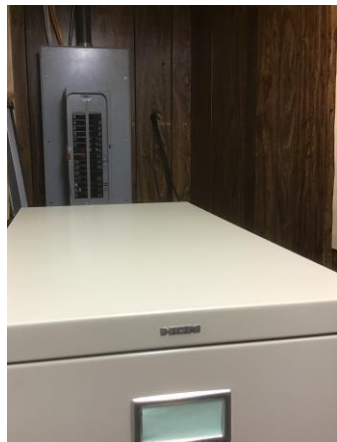
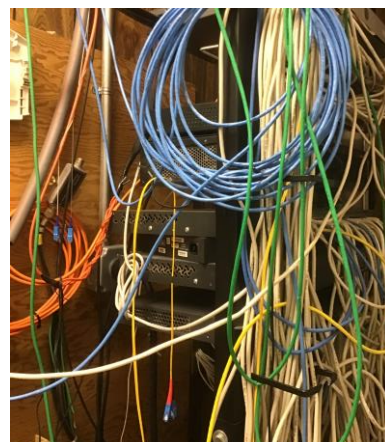
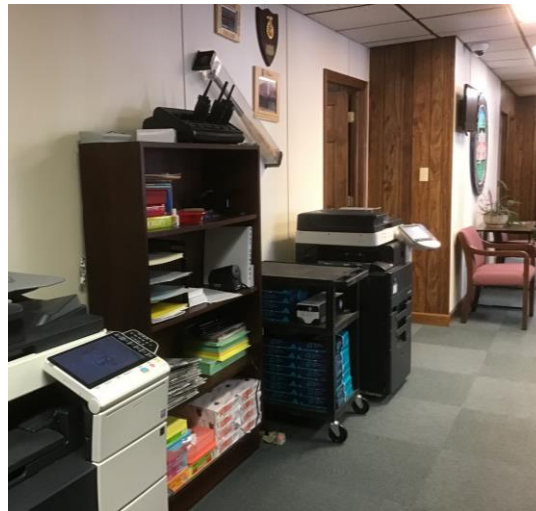
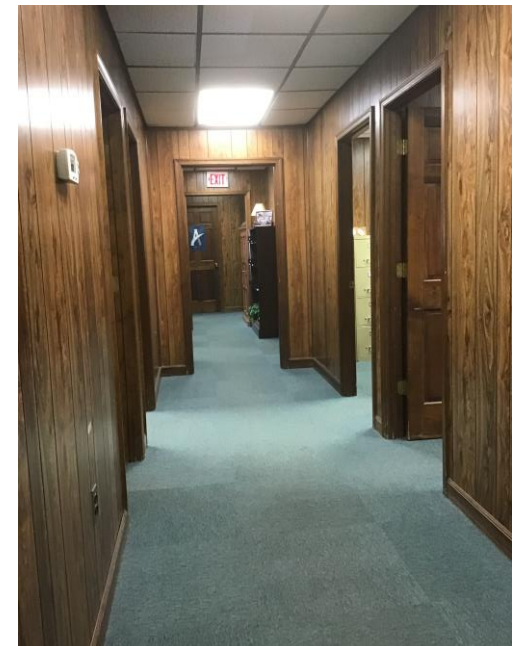
The hallways are narrow at this location, and to make matters worse, shelving, bookcases and copiers have been added, as there is no other space to have these items where all employees can access these items.

A portion of one of the offices has been separated to form an electrical/I.T. closet. This room contains a lot of wiring as well as an electrical panel. On the day of our visit, the electrical panel was not accessible, as a file cabinet was blocking the access to this electrical panel. This is a Code violation as electrical panels require clear space in front of them (minimum of 3 feet clear).

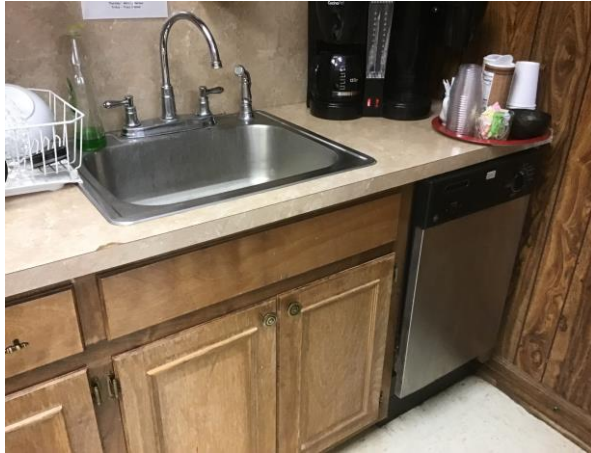
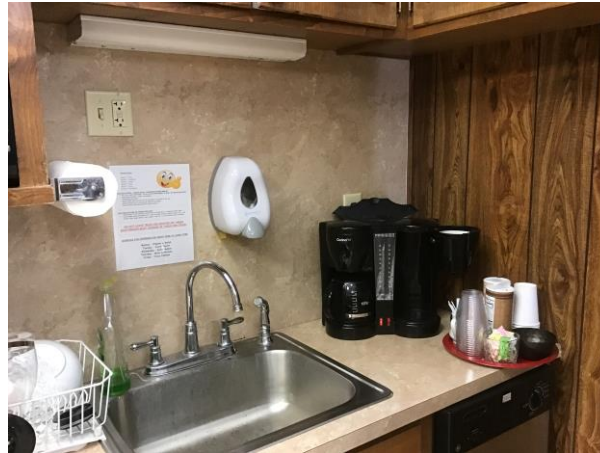
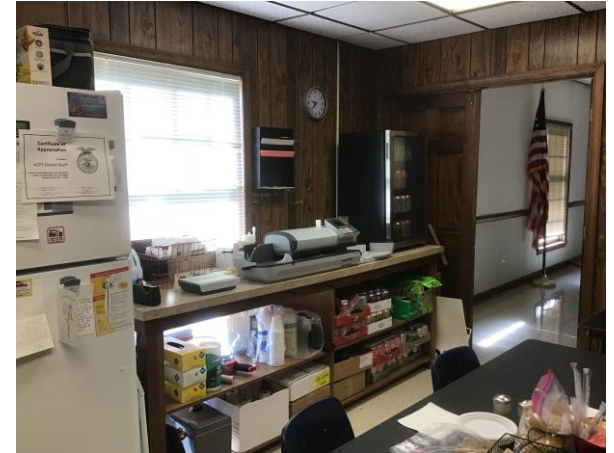
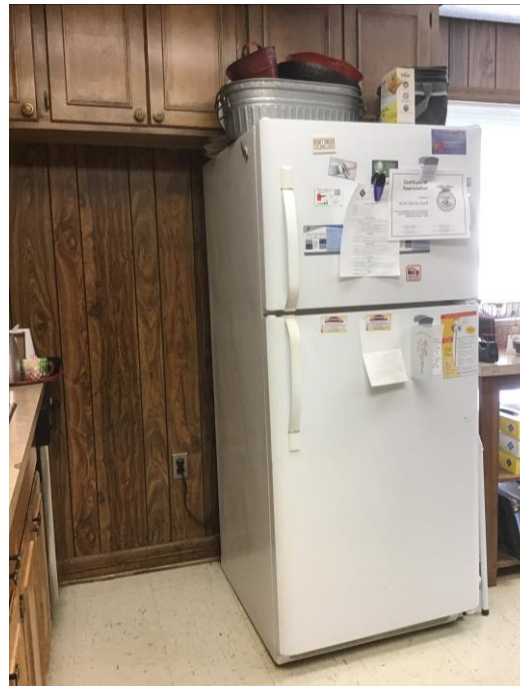
The breakroom really does not function well as a breakroom. There are many cabinets in this space, yet very little available counters. The cabinets, at least at the sink, are damaged from water and general usage. The space is very tight with the dishwasher and refrigerator.

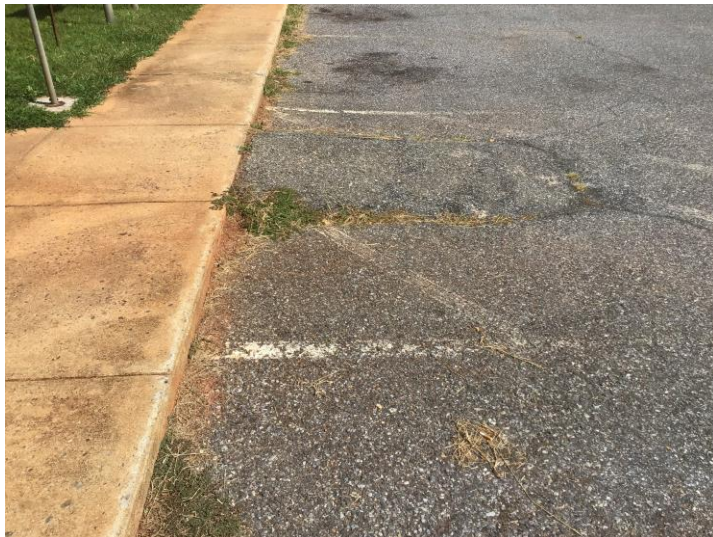
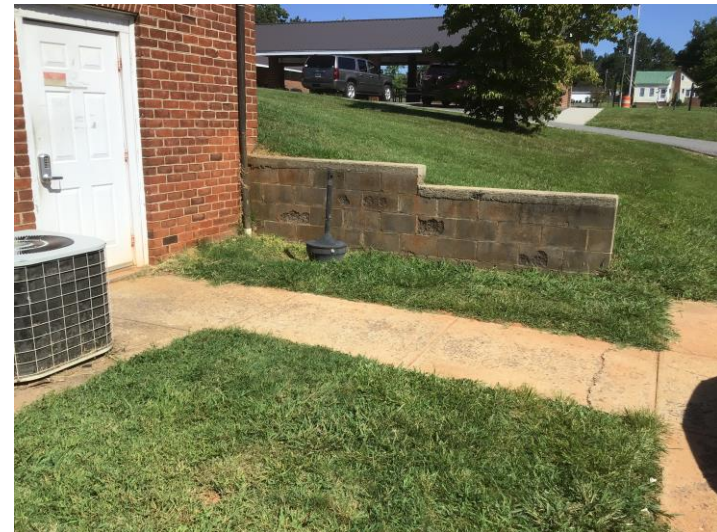
Much of the sidewalks at the far ends of the front façade of this building are beginning to crumble. It is recommended to have these sidewalks replaced so that further damage is not done. Also, there are no wheelstops provided in any of the parking spaces. We would recommend that these be installed so as to prevent vehicles from inadvertently running into the building. Also, the striping in the parking lot has faded to the point that the spaces are difficult for the average person to see.

There is a concrete block (CMU) retaining wall at the north end of the rear of the building. This wall is not painted and has begun to spall. This is not good as if this wall begins to fail, the grade that it is holding back could slide. We recommend having this retaining wall investigated by a licensed structural engineer.

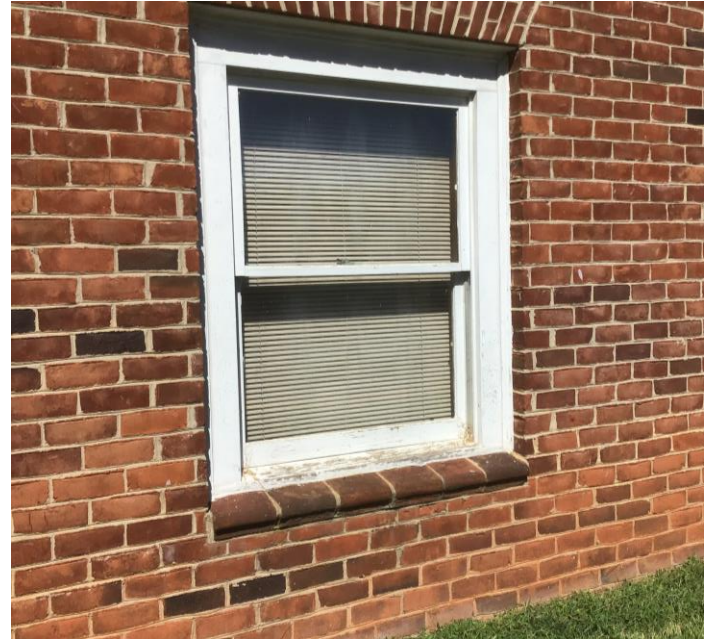
The exterior of this facility is in fair shape for a building of this age. The exterior windows and doors are all exhibiting peeling paint and beginning to fall into a state of disrepair. If the County intends to keep Social Services at this location, it is recommended to replace all windows and exterior doors. Newer products will have higher thermal properties and will provide better insulating qualities for the building. This will cut heating and cooling costs and save the County operating expenses.

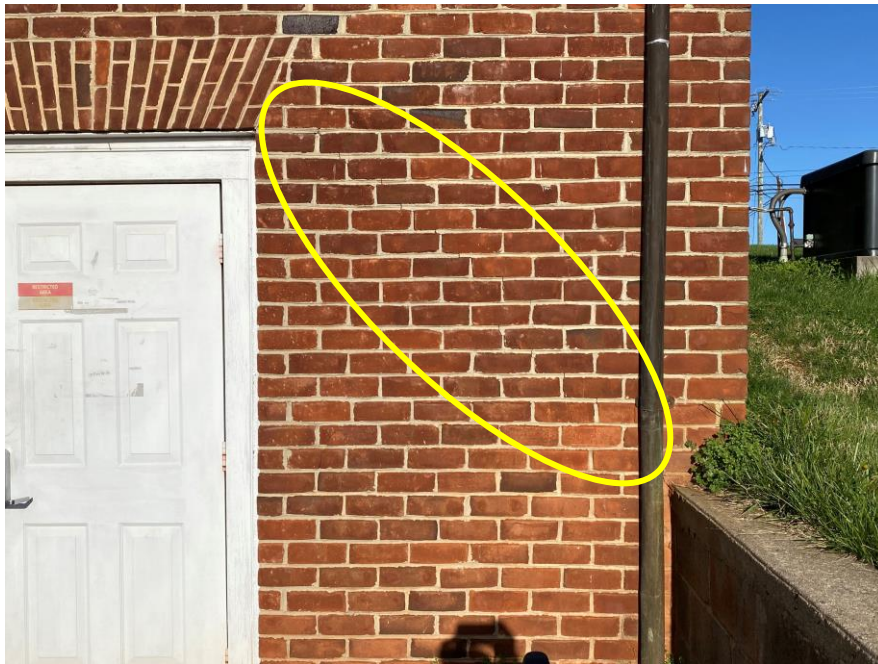
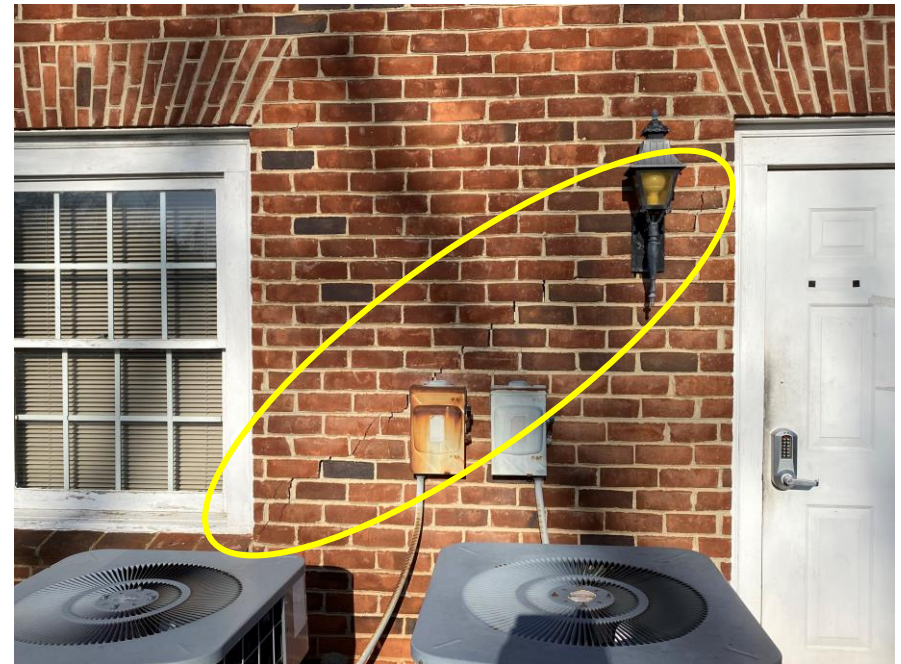
There are two major cracks in the brick veneer that need to be addressed. One is located on the Courtland Festival Park side of the building, extending diagonally from the concrete retaining wall to the top of the door. Note that this location is adjacent to the CMU retaining wall that has begun to fail. The failure of the brick veneer may be influenced by the failure of the retaining wall.

The second is located at left most entrance, running from the top of the door to the window. This location has more severe than the first location and is probably due to settlement of the foundation.

Also note that the building does not have any control joints
