# Appomattox County Assessment of County Buildings

July 17, 2023

## FACILITY ASSESSMENT CONDITION

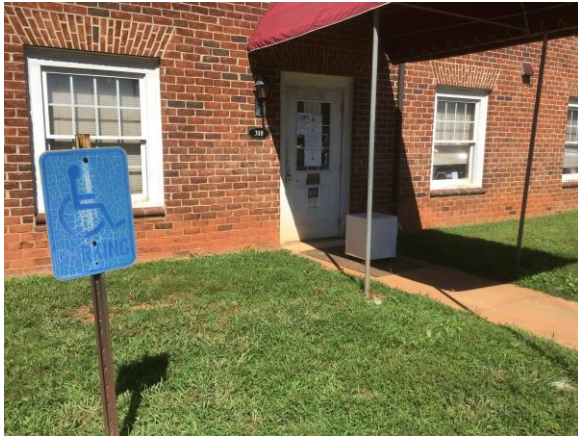
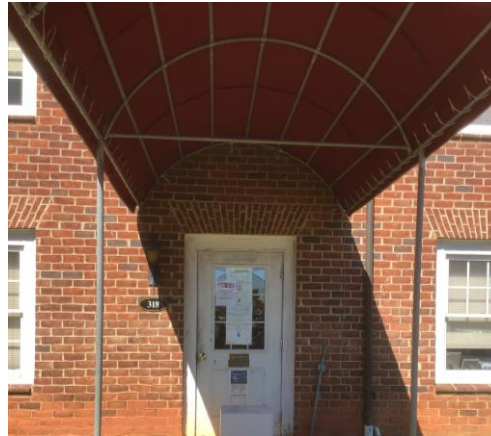
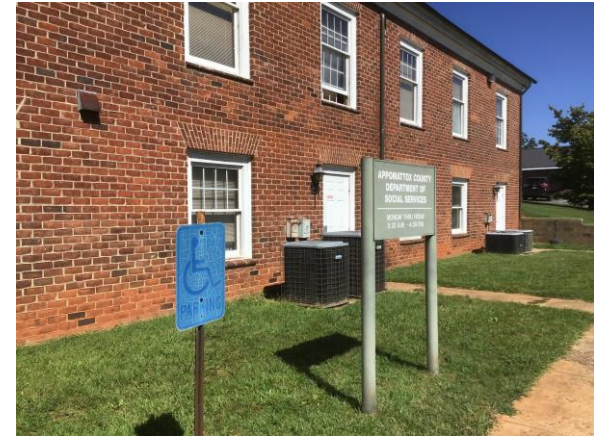
The rear of the building has (3) separate doors. This is not an ideal set up for the Social Services Department. Human beings are prone to go to the first door they see. The main entry door is the center door but is not very inviting for a public entry. Also, there could be better wayfinding so that the public knows which door is the intended entry for use by the public.

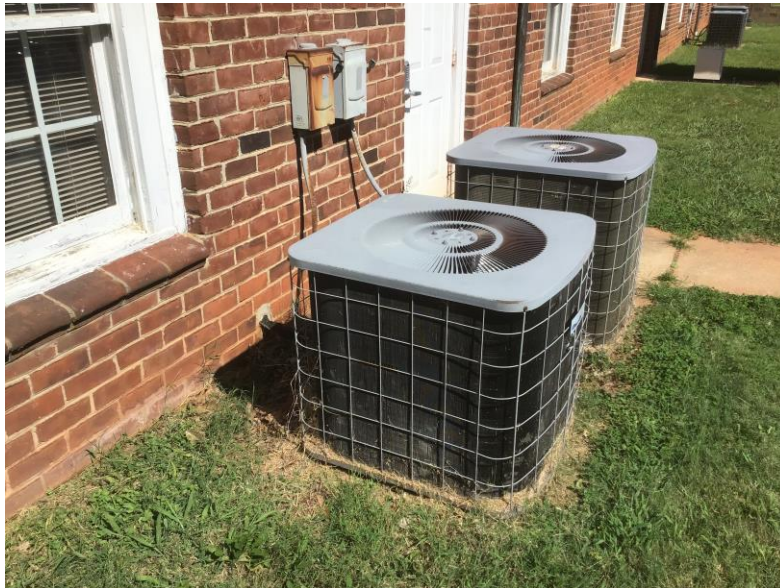
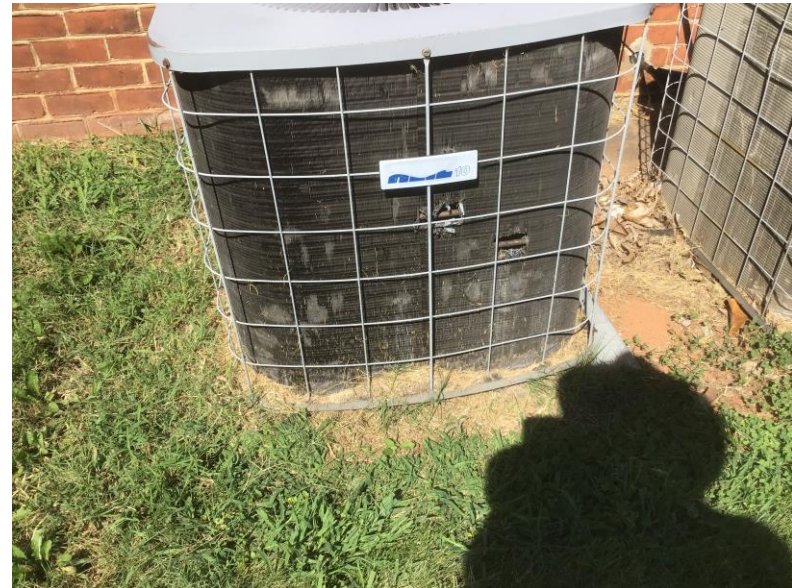
Another concern at the rear façade is the all of the ground mounted HVAC units are in full view. Many of these are dirty, rusty or in disrepair. This is not something that most businesses want the public to see as they approach the building. We would recommend having an aesthetically pleasing screen or fence installed to shield these HVAC units from view of the public.

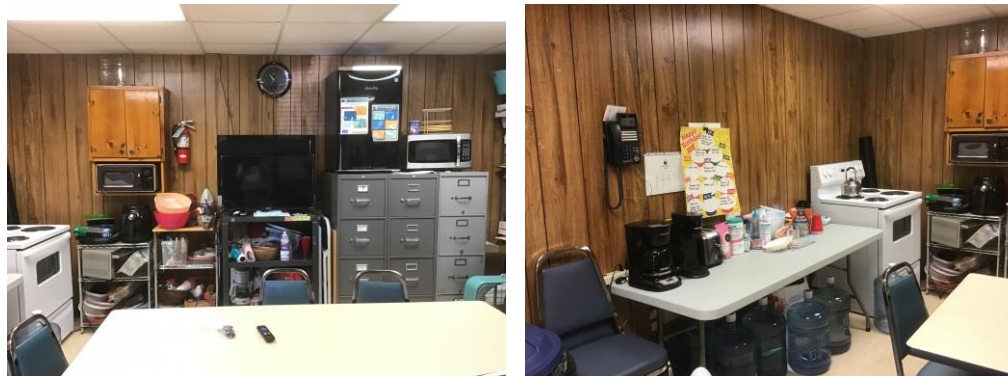
On the day of our visit, the faucet at the utility sink was continuously running. We recommend having this faucet replaced in order to save water.

The breakroom appears to double as a storage room, based on what we observed on the day of our visit. This is not ideal. For example, the door to the oven cannot be safely opened due to the close proximity of the shelving located in front of the range.

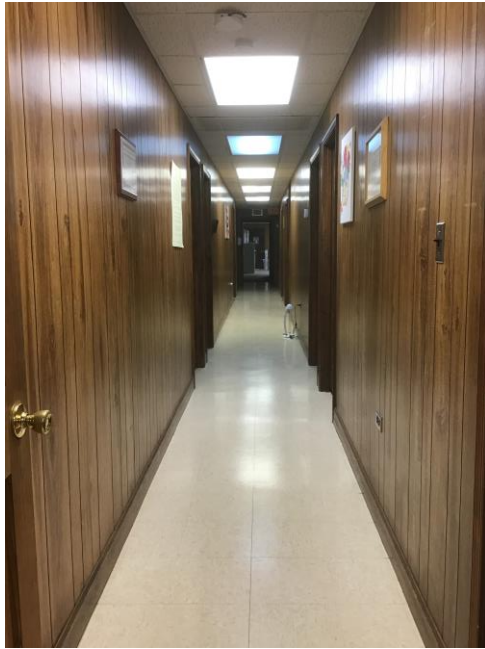
The existing halls are very narrow, do not meet ADA requirements and are very dark because of the wood paneling. The halls are narrow enough that two people cannot pass each other. This is not ideal and we recommend at a minimum, painting the wood paneling to provide a lighter space. It would be better if the wood paneling were replaced with drywall. This would allow the opportunity to add acoustical batt insulation to the wall. Furthermore, the drywall would be a better material than the wood paneling. It would hold up better to abuse, provide a brighter environment and offer better acoustical qualities than the wood paneling.

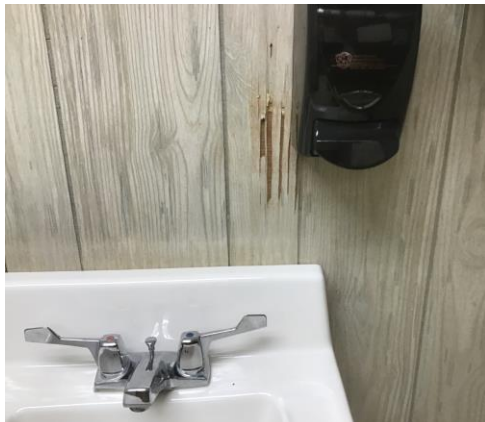
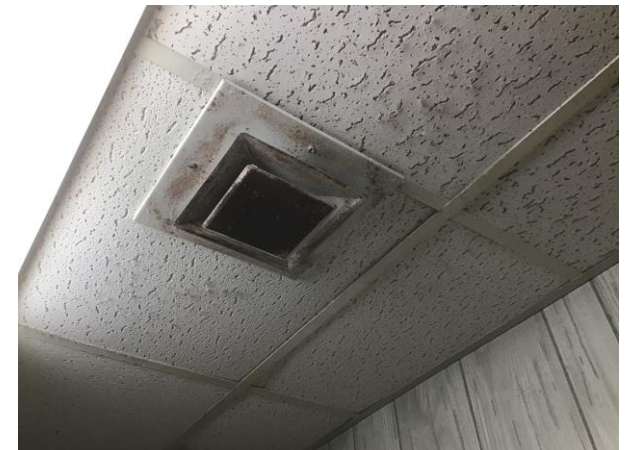
The existing toilets are small and do not meet current ADA regulations. The use of wood paneling within the restrooms is not an ideal choice and damage can already be seen adjacent to the soap dispensers. The wood paneling is easily damaged by moisture/water and is a porous surface that is not easily cleaned, particularly in a restroom environment.

At the rear restroom, which is the smallest of the two restrooms, items are being stored within the already small restroom. This is not ideal and is not a sanitary practice.

The grille for the bath exhaust fan is very dirty, rusty and beginning to fail. It is recommended to replace this fan with a new one.

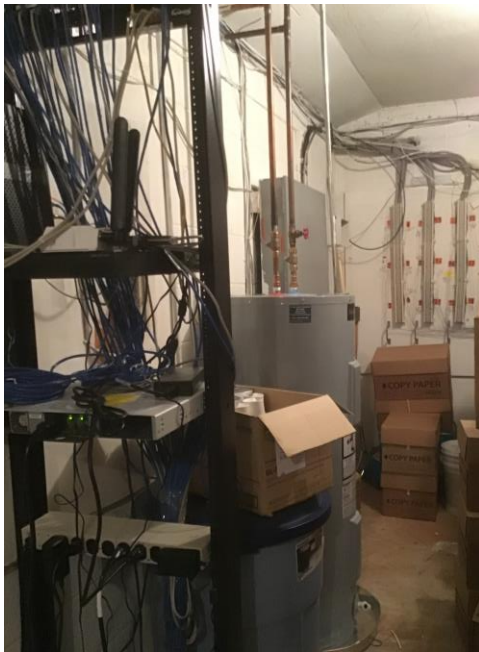
At the rear of the building, in the center, there is an electrical room underneath the front porch. This room is also being used as a storage room. There are concerns about items being stored within Electrical Closets as this is a Code Violation.

This room was very hot on the day of our visit and does not appear to have air-conditioning. This room contains several pieces of equipment that generate a substantial heat load: water heater and various pieces of I.T. equipment. Much of this equipment has a temperature range that is optimum for it to operate successfully. It is recommended to have the mechanical engineer review the heat load for this space and provide an assessment. We believe air-conditioning will need to be provided to this space, due to the heat load of all of the equipment.

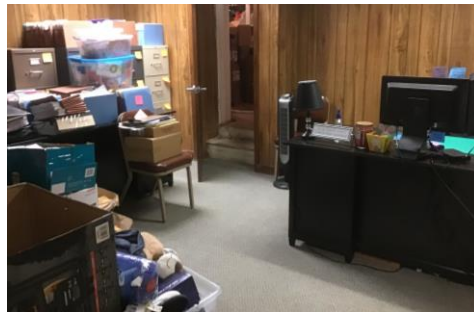
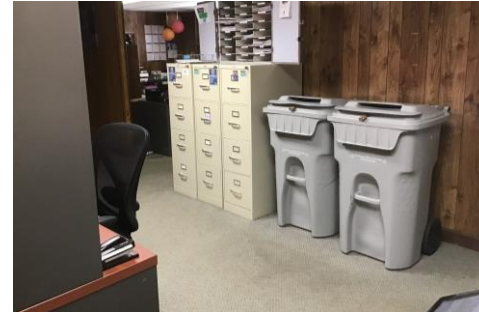
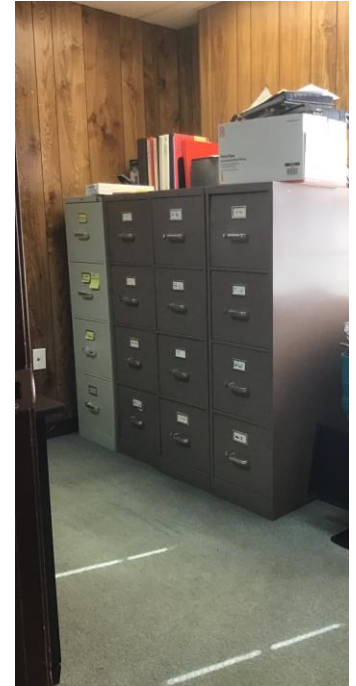
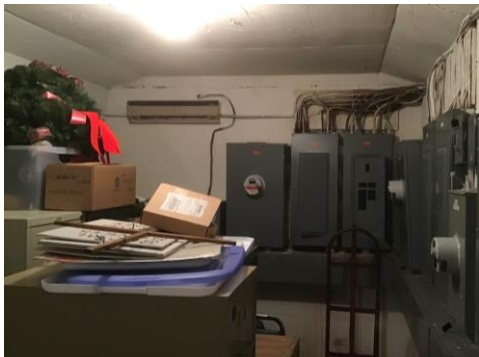
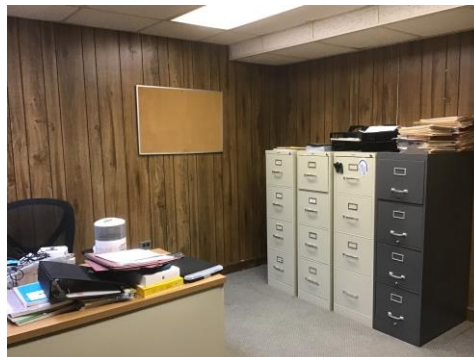
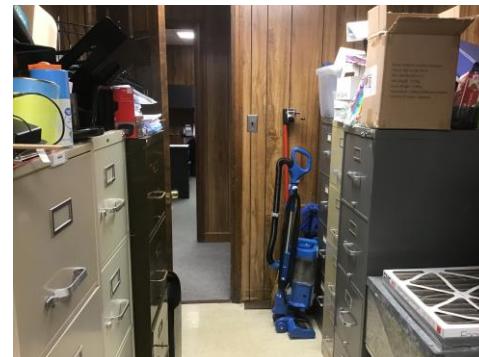
At the south end of the building, along the rear, there is a long narrow mechanical room that is also being used as a storage room. This is concerning in that if there is a leak or problem with the mechanical unit and a fire starts, there is a lot of paper and materials located directly beside the mechanical unit that would fuel the fire.

It appears that there is an overall lack of storage space at this facility, at least for files. On the day of our visit, we observed file cabinets located in the breakroom, electrical rooms, mechanical rooms, conference room, hallways and offices. In looking through the photos we took while visiting the building, we counted 52 file cabinets.

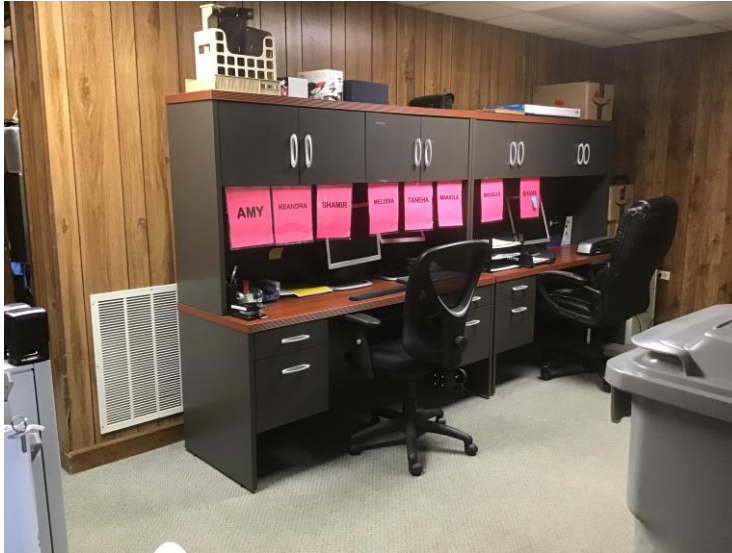
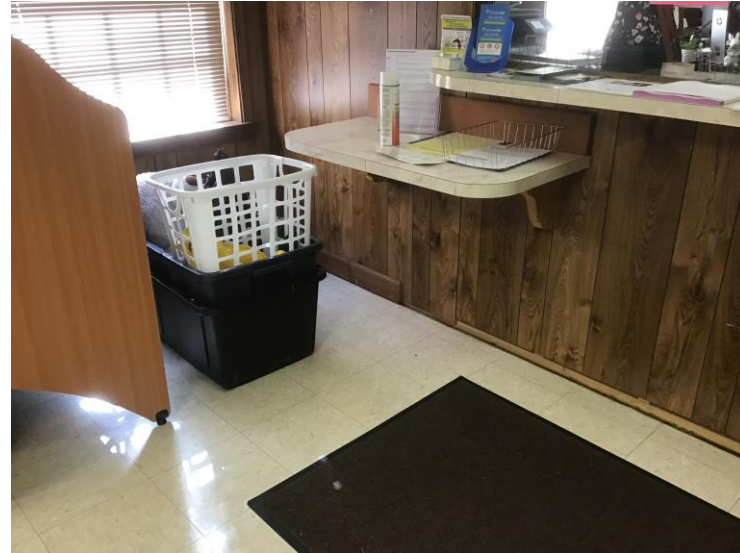
In the open area, just outside of the main staffing area for reception, we noticed a desk unit that is blocking a return air grille. This is not ideal in that this practice can starve the HVAC unit for return air and shorten the life of the equipment.

At the public service counter, while there is a lower portion, this counter still does not meet ADA regulations. The counter for ADA use should be unobstructed so that a person can roll under (if in a wheelchair), and sign, read or review documents. This lower counter is not only too low, but, in its current state is obstructed to the point that it is not usable by the public.

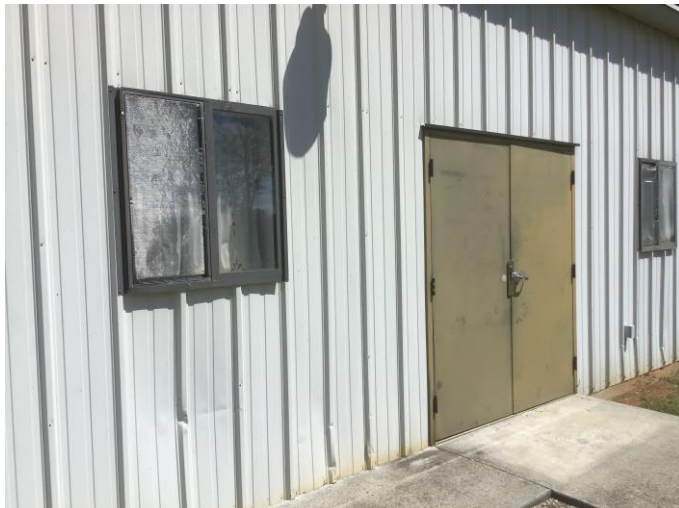
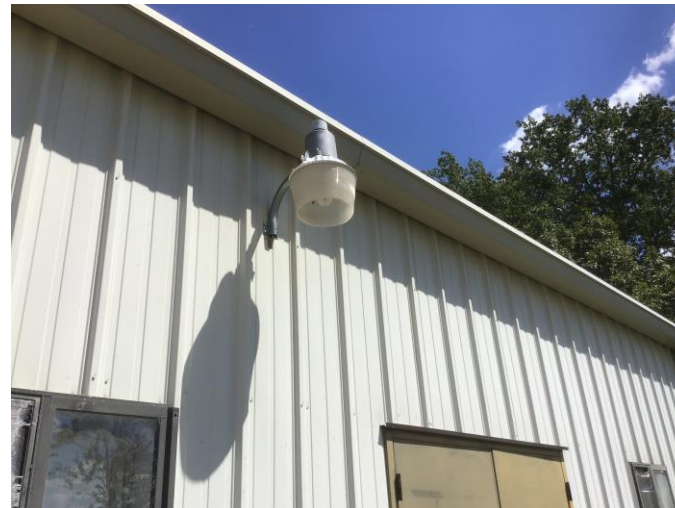
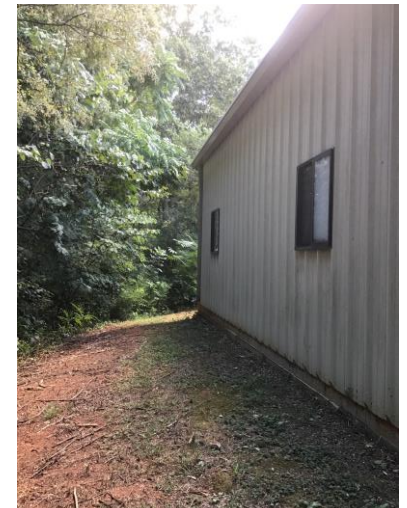
The exterior doors are in poor condition. These doors are not thermal doors and experience temperature swings related to the outside temperature. These doors were very hot on the day of our visit. The exterior paint has faded. These doors really should be replaced with insulated doors.

The windows are in fair shape; however, the existing screens have failed. It is recommended to replace the screens on the windows.

The security light at the main entry provides sufficient light. This particular type of light fixture is not the most attractive light fixture to have at the main entry to a building that acts as an event space.

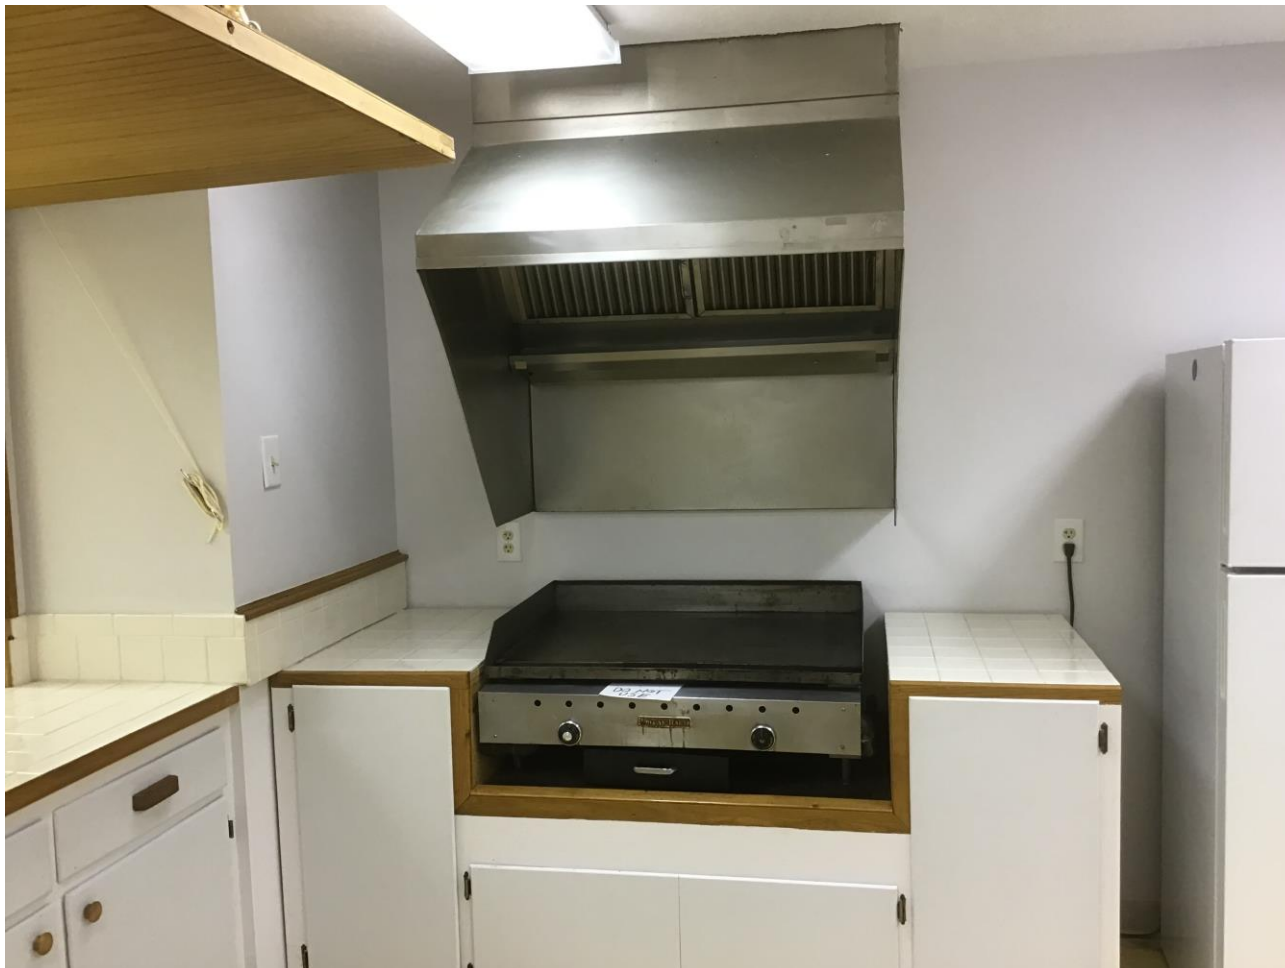
As for the grill, the sign states do not use. It is unclear if there are problems with the grill or not.

A larger concern, is that while the grill has a ventilation hood installed, the hood installed does not provide fire suppression as is required by Code for a commercial kitchen hood of this type.

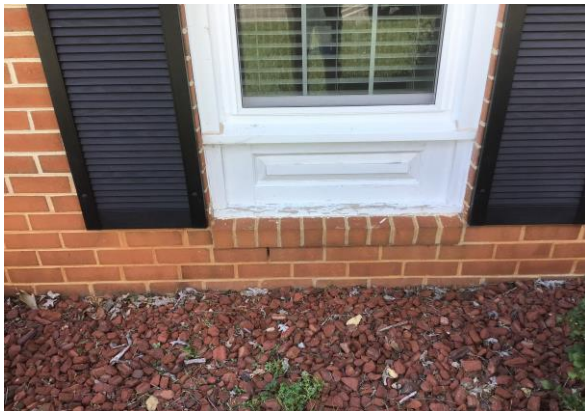
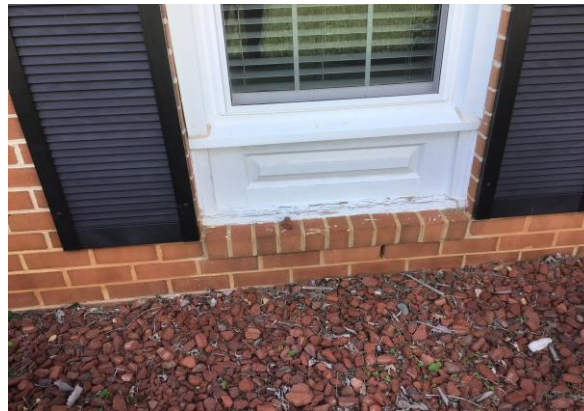
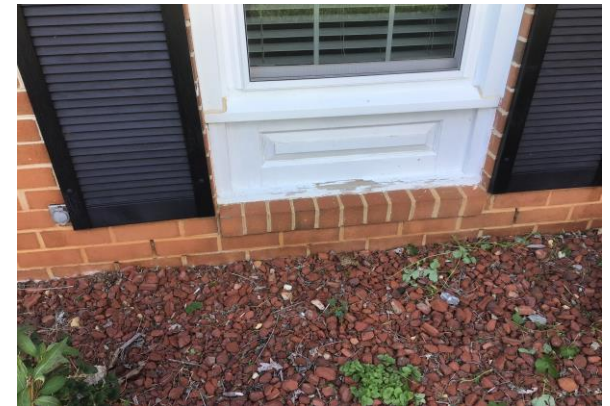
The exterior of the building is in fair shape for a building of this age. The larger size windows on the building have a wood panel below on the exterior. While this is very aesthetically pleasing, it is a maintenance nightmare. All of these panels have peeling paint and are beginning to deteriorate. It is recommended to have these panels replaced with a composite material (AZEK) in order to maintain the building style and aesthetics without having the maintenance and upkeep of the wood panels on the exterior.

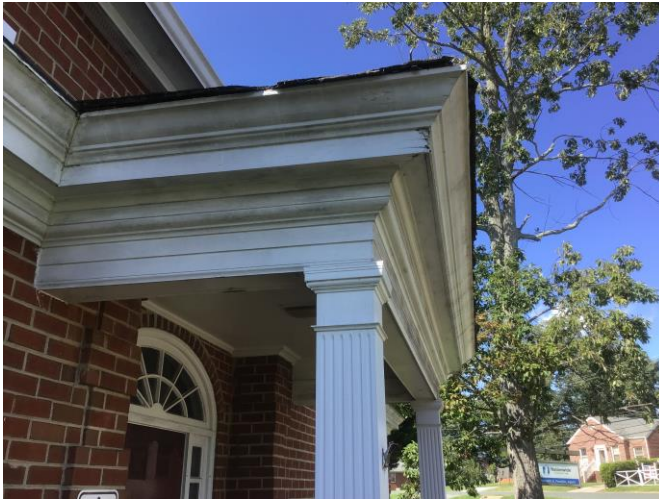
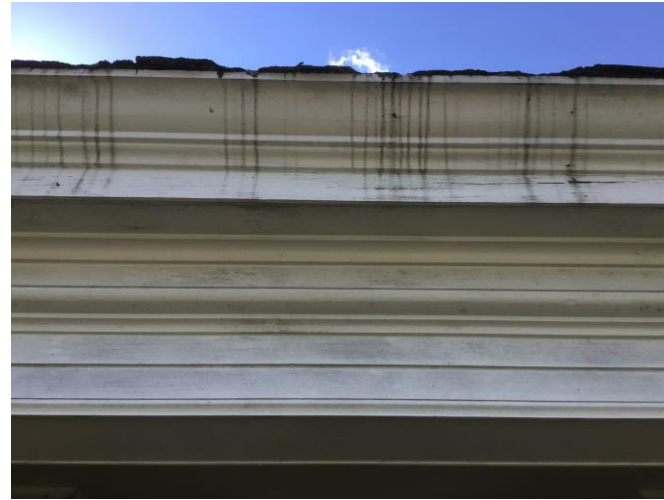
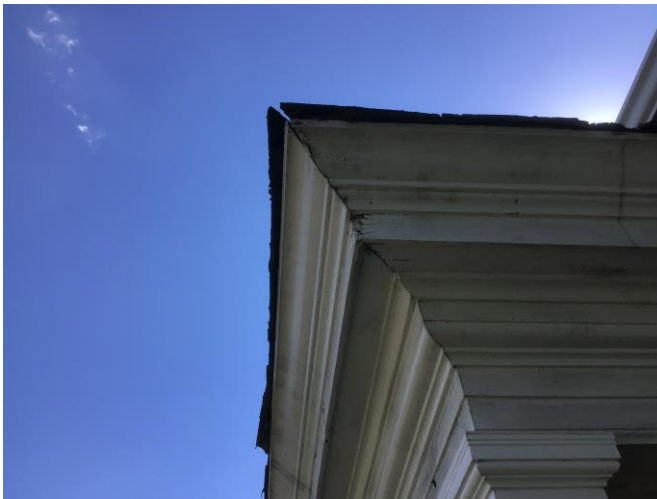
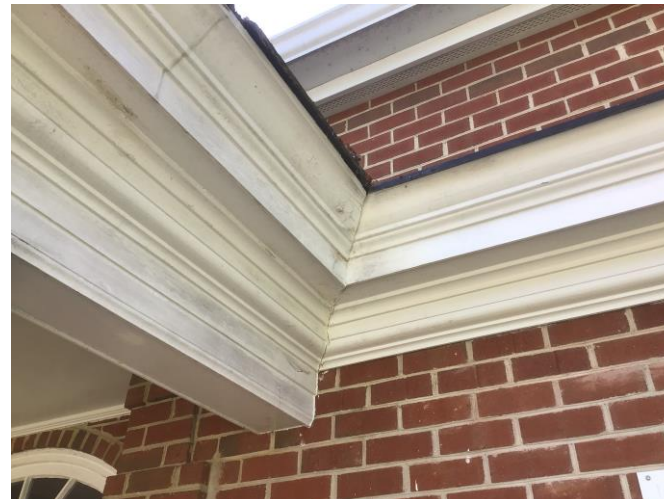
The wood cornice is in fair condition. The joints are beginning to open up. There is concern about water infiltration. Some of the wood has already begun to rot. If the County intends to keep this building long term, we recommend a full replacement of the wood cornice with a composite material to match the existing cornice in style. If the County would like a short-term solution, we recommend that joints in the wood be repaired and recaulked. The wood cornice could then be painted with two finish coats of paint, with any new wood being primed first.

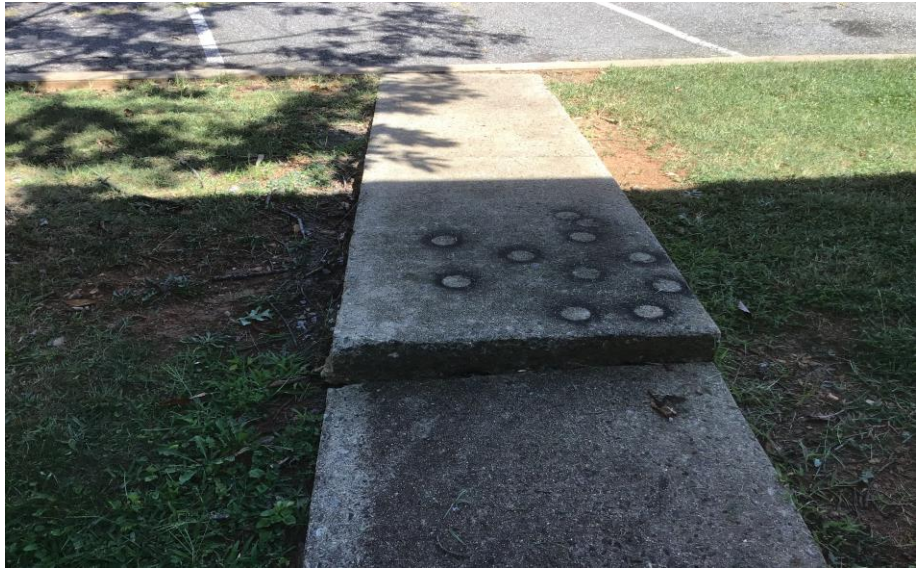
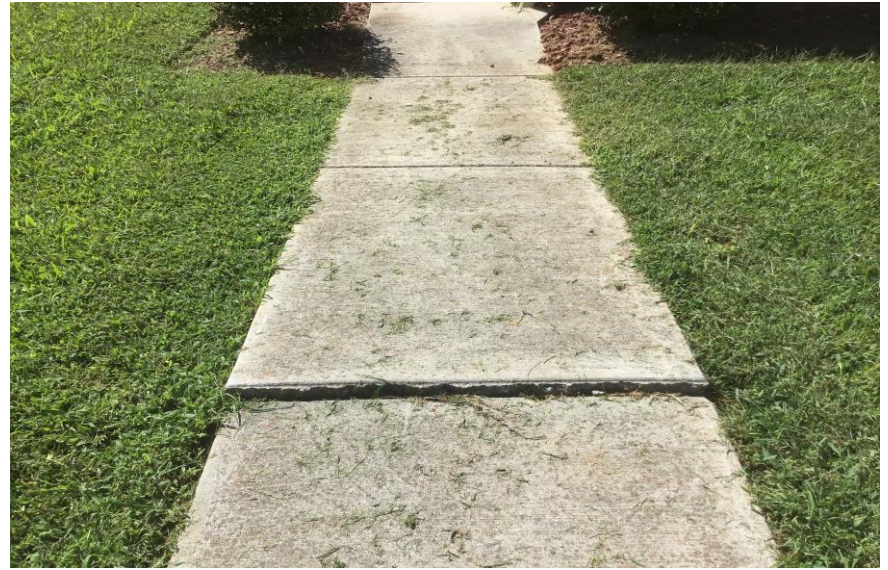
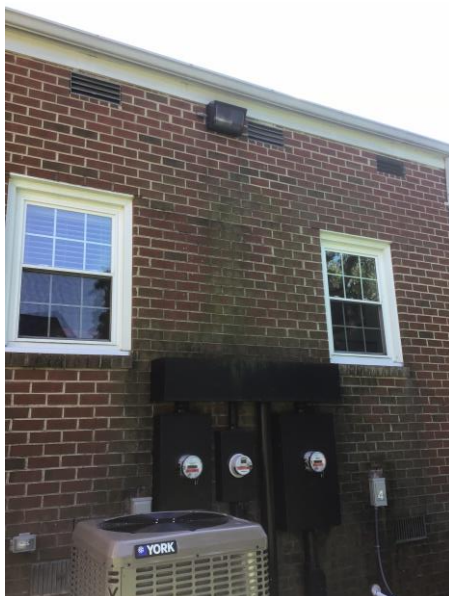
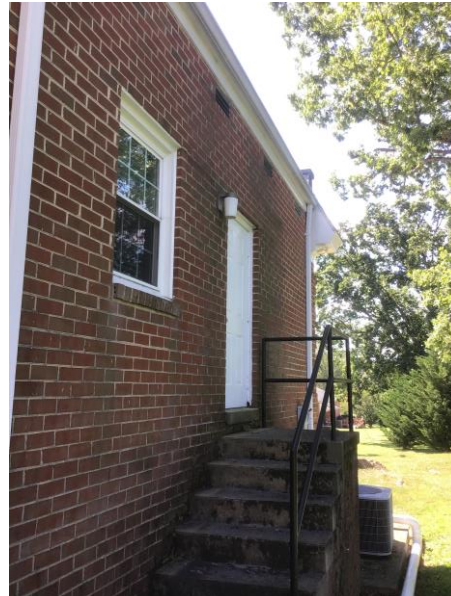
There are two different sections of sidewalk at different locations, that need to be replaced so that no one trips on them.

On the north side of the building, the brick is discolored above and around the electrical meters. It is unclear if this discoloration is from overflow of the gutter or because of splashing up onto the wall from the electrical meters. We would recommend having this wall cleaned to remove the discoloration and further investigate the cause of the discoloration. The same comments would apply to the area around the rear exit door, as the same discoloration can be seen here as previously mentioned. The discoloration at this rear door also extends onto the stair below. We recommend having the stair pressure washed to remove the algae and discoloration that has formed.

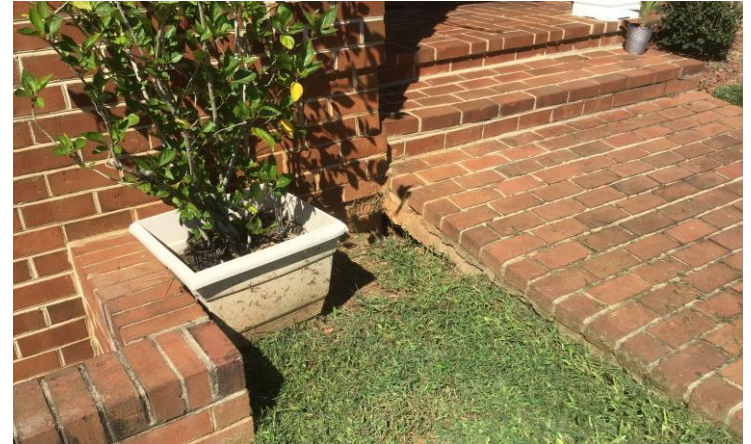
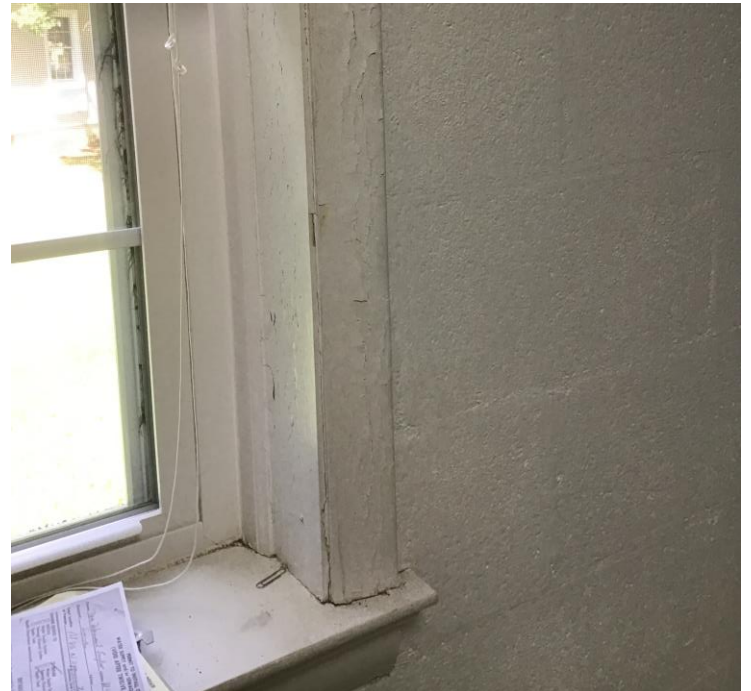
The exterior walls of constructed of brick and block (CMU) and it is doubtful that the walls are insulated. This is a costly concern as it increases heating and cooling costs for the building as a whole.

Vinyl replacement window sashes have been installed. When this work was done, the original wood trim on (exterior and interior) was left in place, and the wood trim covered with aluminum break metal. The wood trim on the interior is original and the paint is beginning to peel and blister. Given the age of the building, there is the possibility of the presence of lead-based paint. We would recommend to have the wood trim tested lead-based paint and if found, the lead-based paint should be abated, the wood trim primed and painted with (2) finish coats of paint.

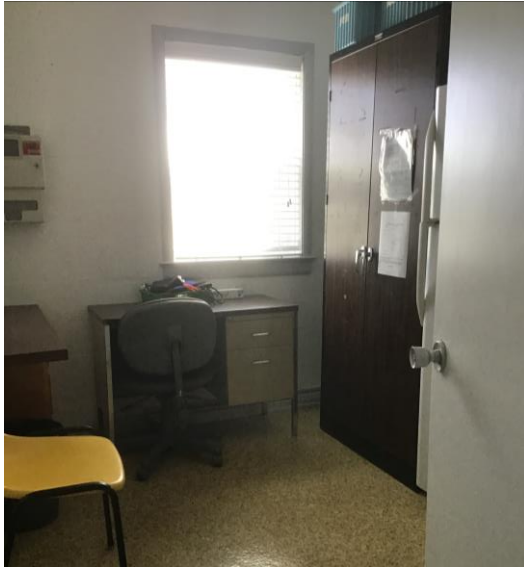
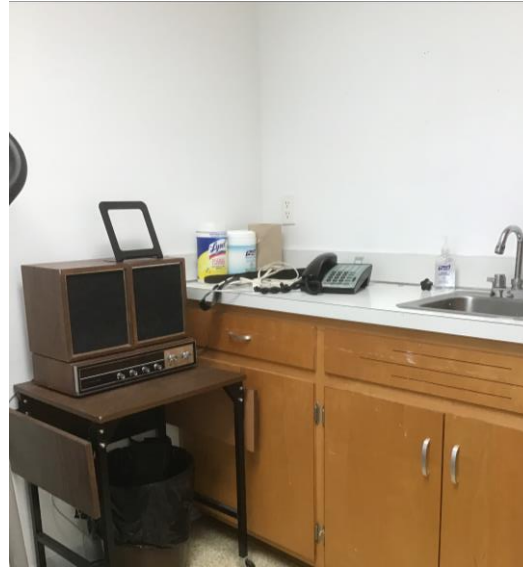
The interior finishes (floor, wall and ceilings) have begun to show signs of wear and should be replaced if this facility is to remain in operation as the County Health Department. The County's Health Department should have finishes that are well maintained, easily cleaned and that are not exhibiting signs of peeling paint and deterioration due to the types of services that are generally performed by the health department.

Many of the Exam Rooms are no longer used for that purpose and have been converted to other uses; mainly storage. Looking at the items that are stored, it is questionable if these stored items are still in use or just leftover from a previous point in time.

Most of the storage rooms at this location are so full of items that one cannot fully enter the room, at least not in a safe manner.

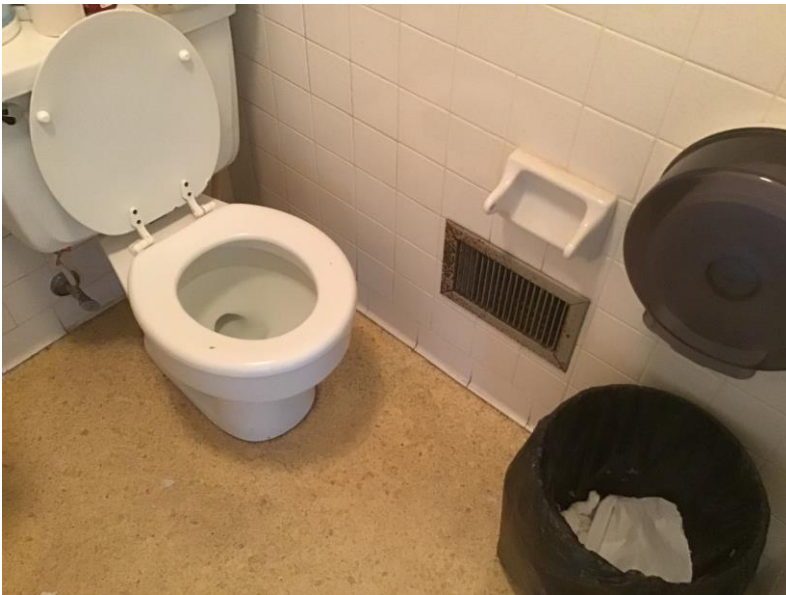
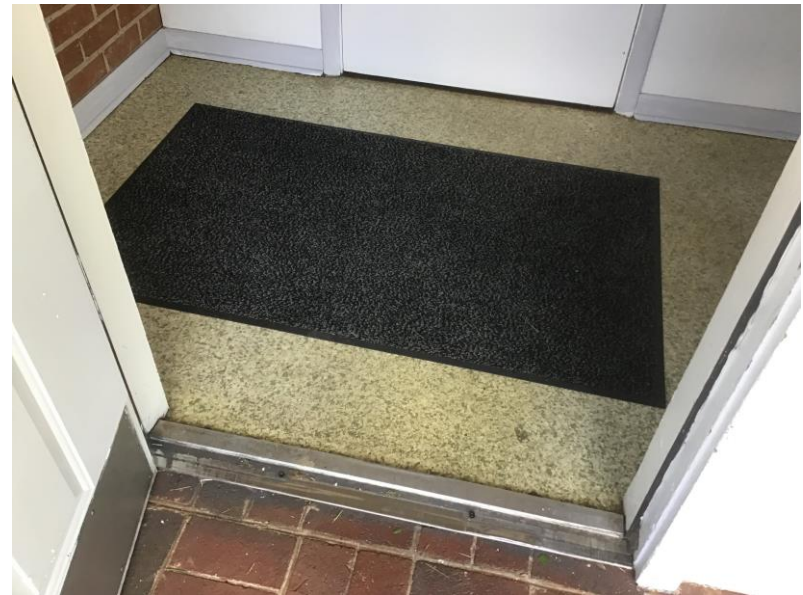
At the public entry, an interior door has been added to create a vestibule and to knock off the chill when persons enter on cold days. The only problem is that the interior door has been installed too close to the exterior door and this is a Code violation. Doors in series such as these must be no closer than 7'-0" between the doors. The installation shown above in the picture on the right has approximately 4'-6" of space between the doors versus the Code required 7'-0."

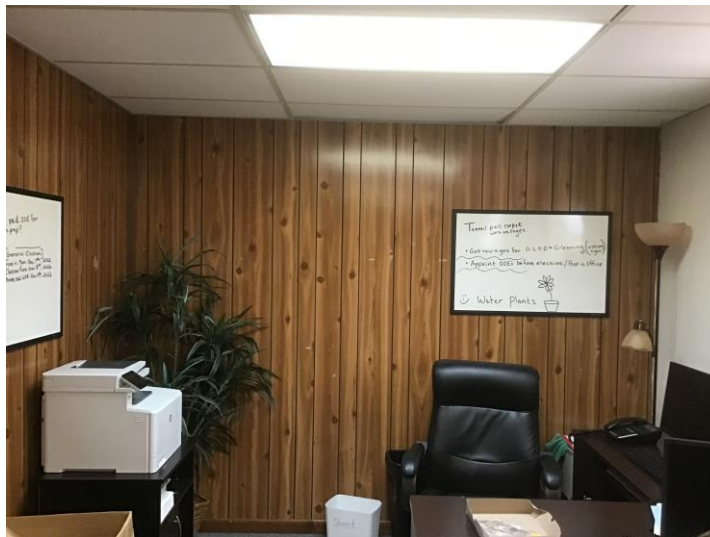
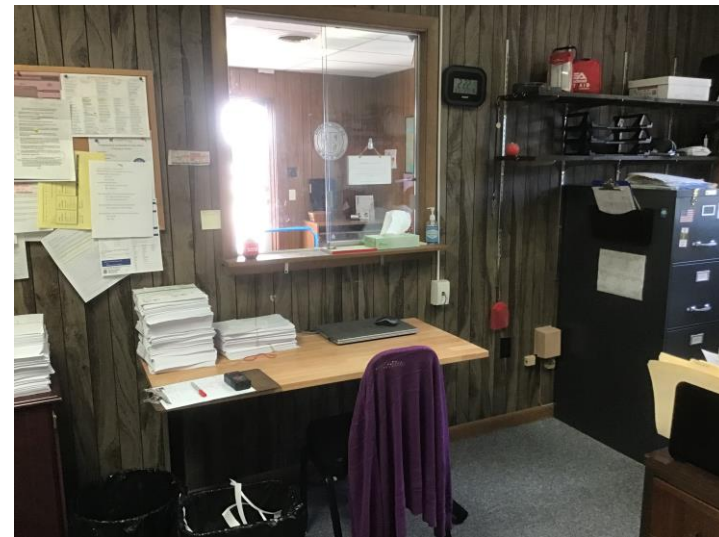
The interior spaces in this department do not appear to have been updated. Many spaces contain wood paneling from the 1970s. This choice of material is not ideal in this type of work environment as this material is very thin, is easily damaged and provides almost no privacy when installed as a finish wall material as is the case here. Additionally, this material is far easier for someone to break thru than drywall and again is not the best choice of material to be used in an office where secure files are being stored.

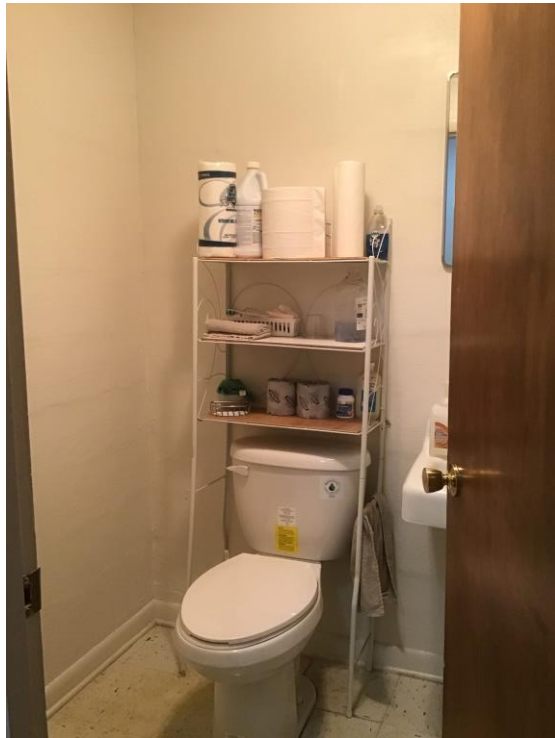
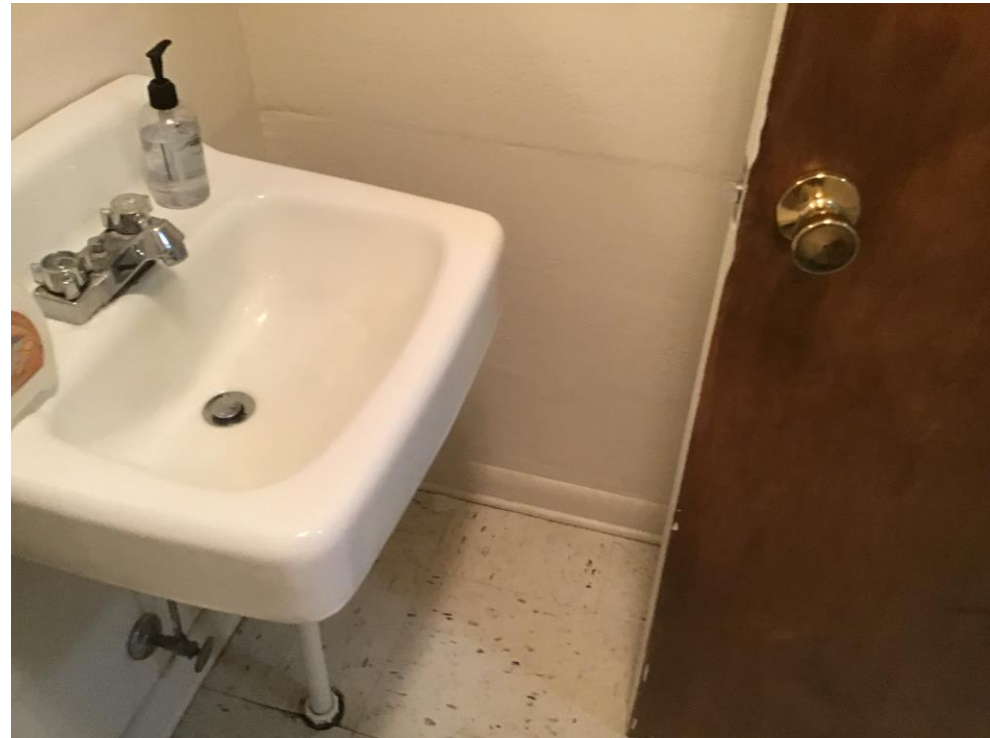
Many of the spaces in this department, do not have an exterior window or natural light. This is unfortunate and as a result many of the spaces are very dark and uninviting. This is not an ideal scenario for office space.

The existing toilets do not meet ADA requirements currently in place. The toilets are very small, and the finishes have not been updated. The existing door hardware is also not ADA compliant.

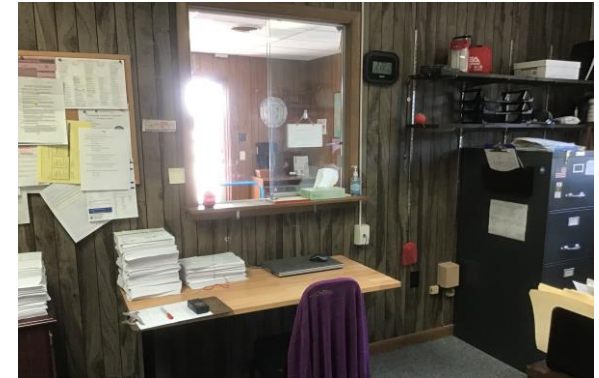
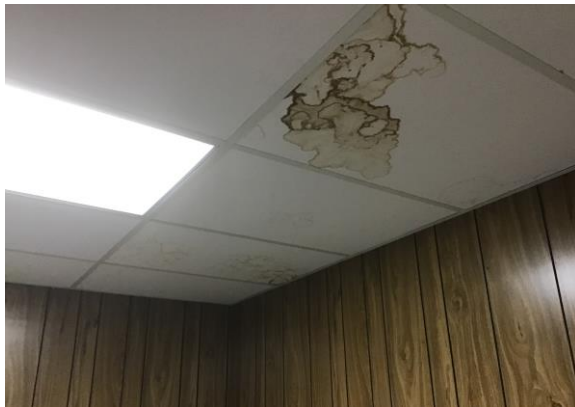
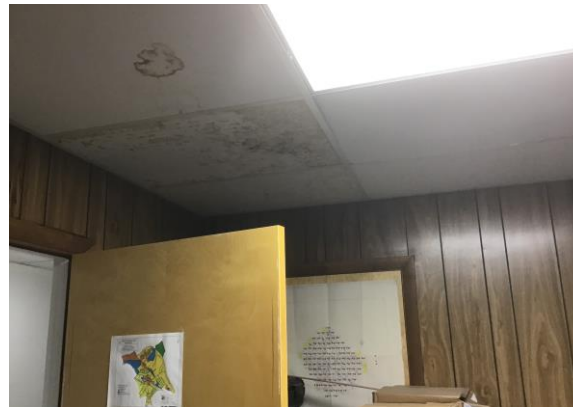
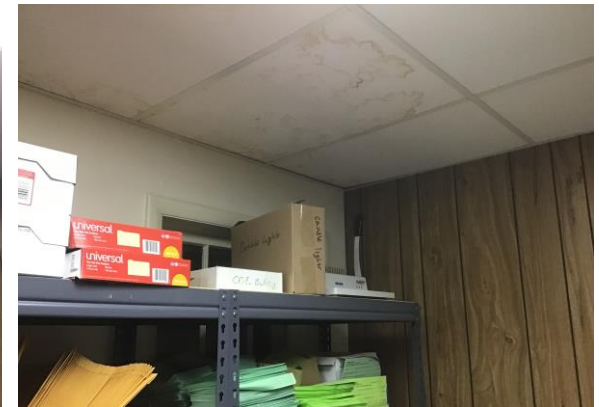
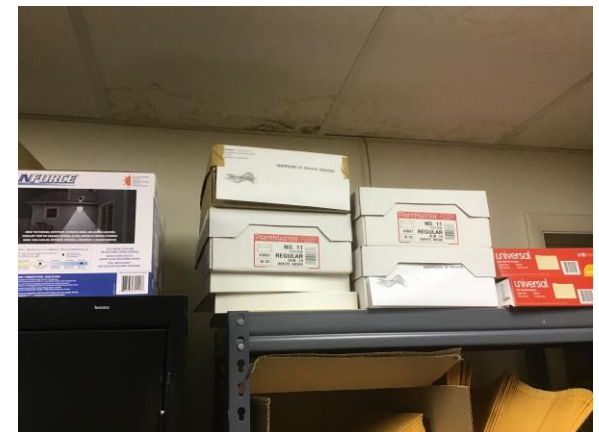
Though there is a public service counter, the existing service counter is not ADA compliant.

Many of the ceiling tiles are badly stained. The cause of the staining is unknown, however, it is presumed that due to the location of most of the ceiling tiles with stains, the stains are from plumbing leaks in the restrooms and water/waste piping above in the Health Department.

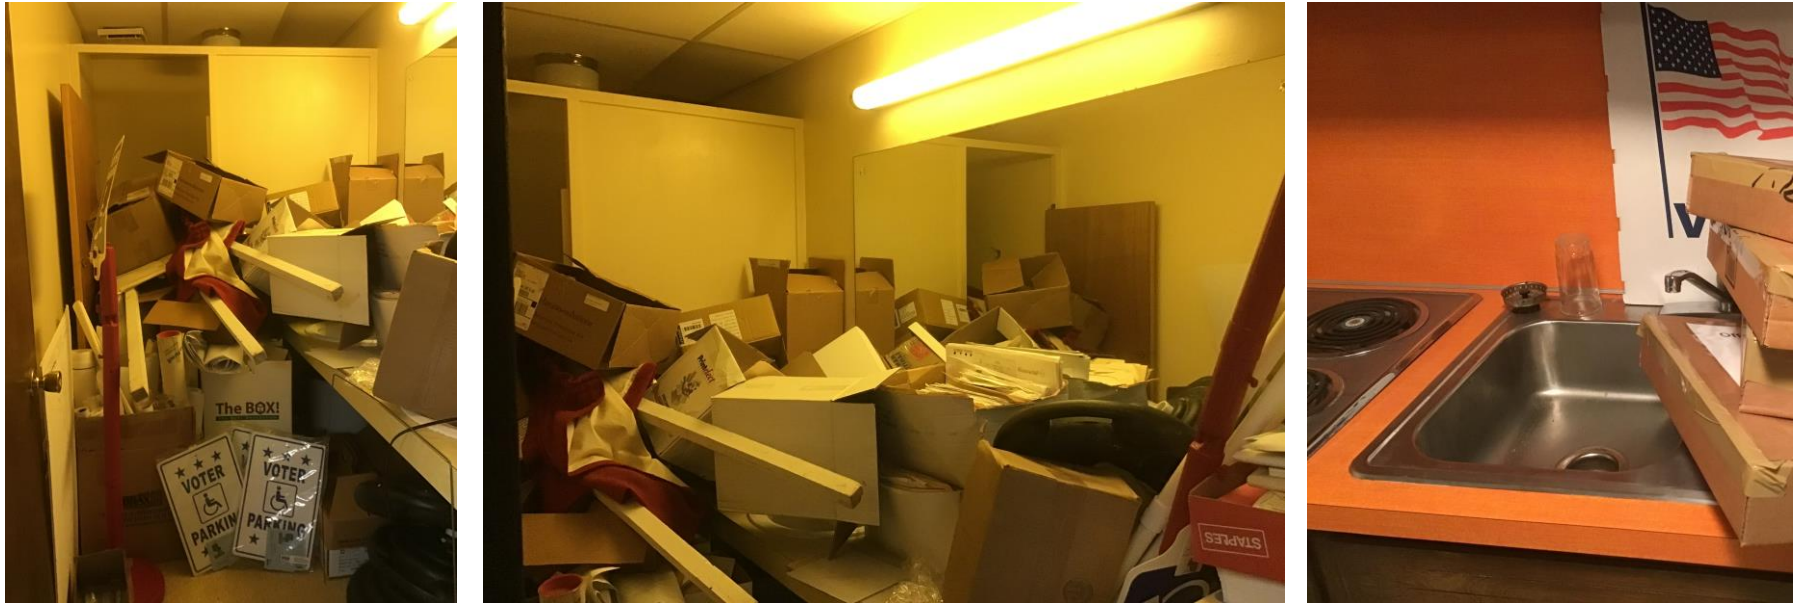
Similar to the Health Department above, some of the spaces in this department are no longer being used for their initial intended purpose. One is this toilet room that is now being used as a storage room. There were so many items stored in this space that we could not access the rear area to verify whether or not a toilet was still there.

It would be beneficial for this department to have ample storage space with large enough doors that the large equipment associated with voting could easily be moved in and out of the spaces. Right now, maneuvering this equipment is challenging at best. Hallways are narrow. Doors are narrow. This is not an ideal setup for the large equipment that must be stored in these small spaces.

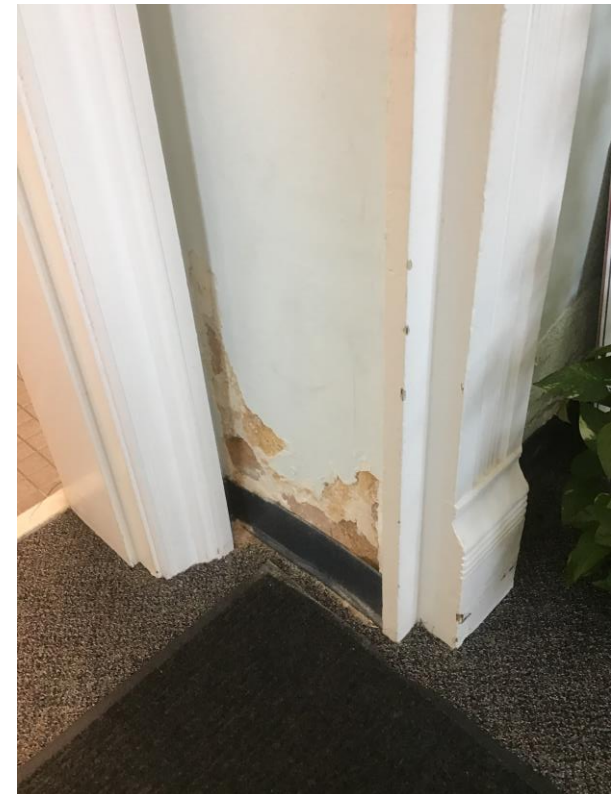
The brick used on the original building is soft and absorbs moisture which in turn has migrated to the interior and damaged the plaster. To help resolve this issue, the joints have been repointed (the quality of the work is poor). We cannot tell what type of mortar was used, but the façade should be evaluated for potential damage if the mortar is harder than the brick. If it is, then the face of the brick will pop off due to freezing and thawing. Historic structures were designed to allow moisture absorbed through the brick to wick to the exterior via the mortar joints. Additionally, the exterior envelope has been sealed with silicone last year. This is a short-term solution for the masonry moisture absorption and will require reapplication in 5 years.

An additional masonry problem is rising damp which is a capillary movement of moisture from the ground up through the walls. As moisture is wicked up the walls damaged to the masonry occurs as well as any interior finish (plaster or paint). This is noticeable in several locations in the original section of the building.

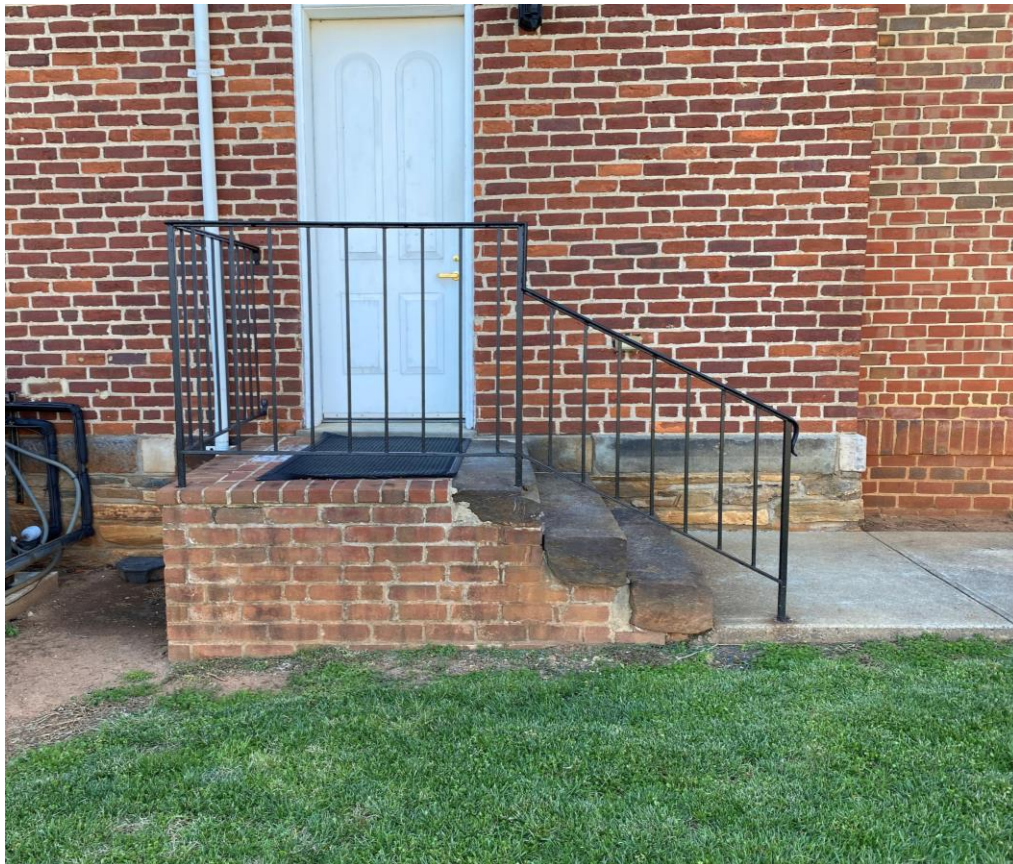
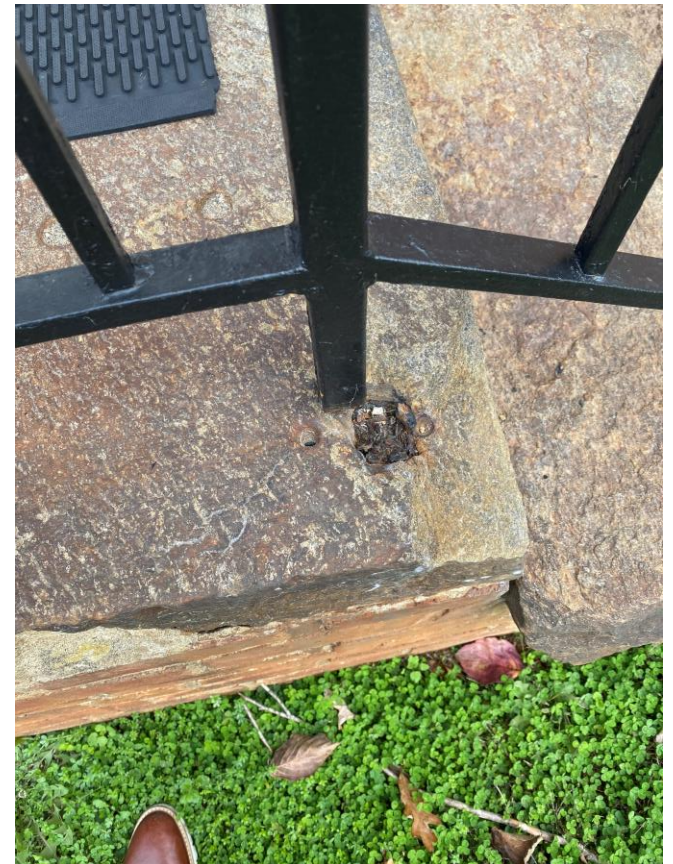
The rear steps and railing are in need of repair. The bricks are cracking in various locations and the railing post has rusted through and separated from the section concealed by the masonry and from the concrete sidewalk.

The stone steps are old and have been reused from another building which unknown.
