# Appomattox County Assessment of County Buildings

July 17, 2023

## FACILITY ASSESSMENT CONDITION

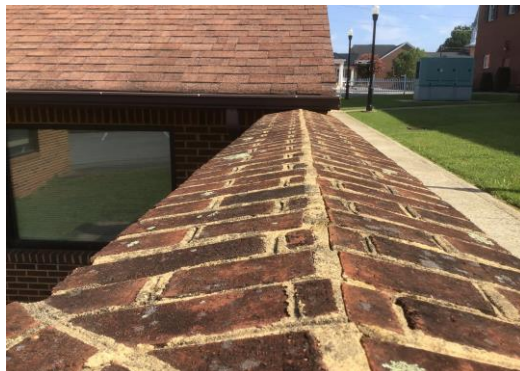
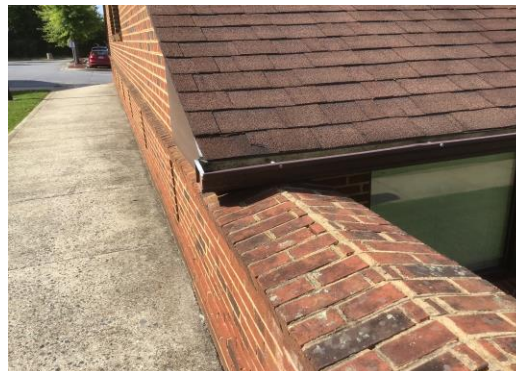
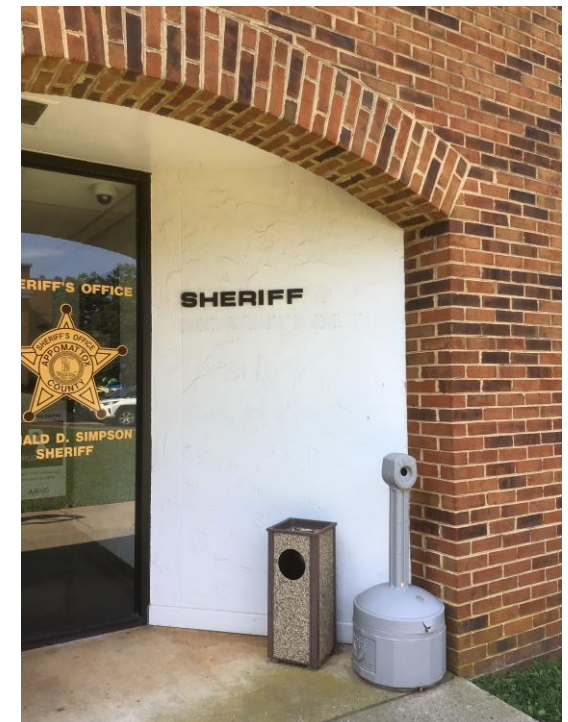
There is a small section of stucco/EIFS at the main entry to the building. This is not the best choice of material for the exterior. This material is in fair condition now, however, it will need repair or replacing soon.

On the Courthouse side of the building, there is a brick masonry wall. The mortar joint along the top of this wall is beginning to crack. This should be reworked so as to prevent water infiltration into this wall. Preventative maintenance of this kind will save a lot of repair costs years from now as once the water infiltrates the wall, it can freeze during winter months and cause internal damage that is not clearly visible from the outside.

While there is signage for the building, if one is not familiar with the layout of the County buildings, it is not immediately clear as to how to arrive at the main entry to the building. We would recommend larger, clearer and better positioned exterior signage in order to help visitors with wayfinding.

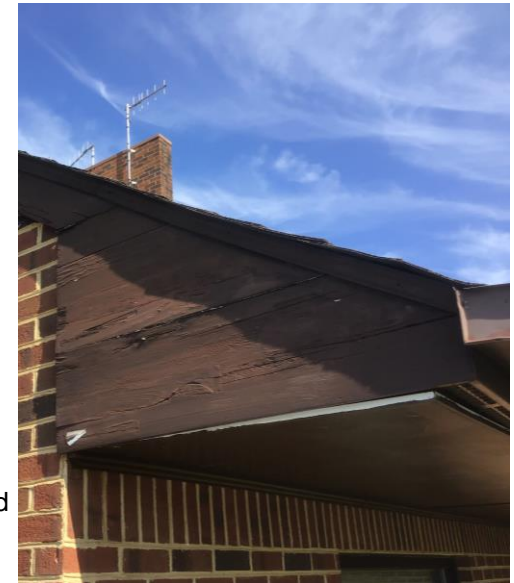
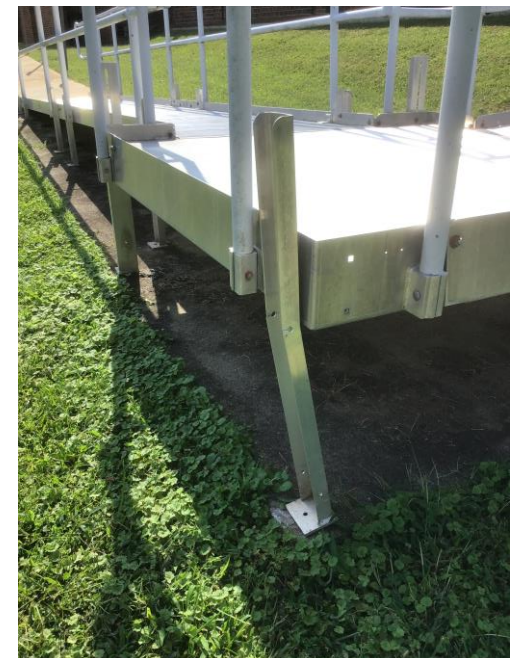
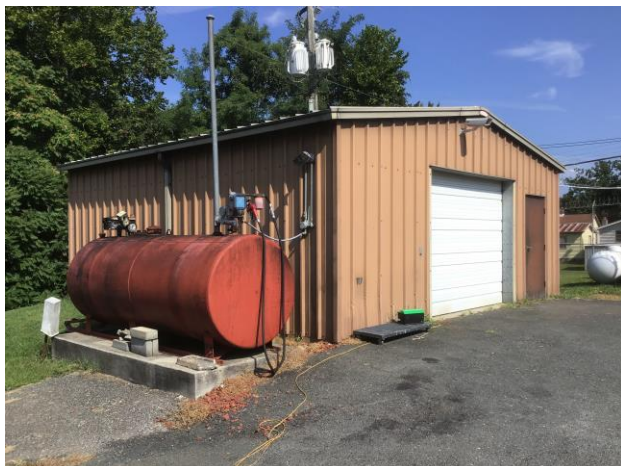
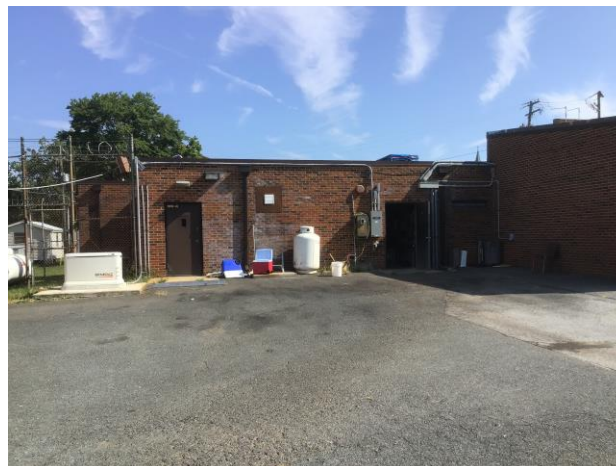
There is a fair amount of wood rake and fascia on this building. This is not a good choice of material as wood is prone to rotting, even if it is painted. We would recommend having all wood trim, rake and fascia removed and replaced with fiber cement (non-organic) when the asphalt shingle roof is replaced. The asphalt shingle roof is 22 years old this year and should be replaced along with all of the associated flashing. Strands of fiberglass are already starting to show through in the field of the shingle roof.

There is a ramp installed for access to the Magistrate, however, this ramp is not fully ADA compliant. This ramp is too narrow, does not have the proper height ramp edge at the ramp surface and has one leg that has been damaged, presumably because of being hit with a lawn mower. We recommend replacing this ramp with a permanent, fully ADA compliant concrete ramp.

There is a storage building at the rear of the property. This building is a pre-engineered metal building. We recommend having this building painted and conditioned so that the files inside can be protected from mold and mildew.

Since the fenced in yard at the rear of the jail wing is no longer used by inmates, we would recommend removal of the fencing and razor wire.

At the rear of the Sheriff's office, we have several recommendations:

- Bollards should be added in front of the emergency generator
- Remove the unused propane tank and piping
- Install bollards in front of the fuel tank beside the storage building
- Clean the effervescence from the brick façade, adjacent to the garage door

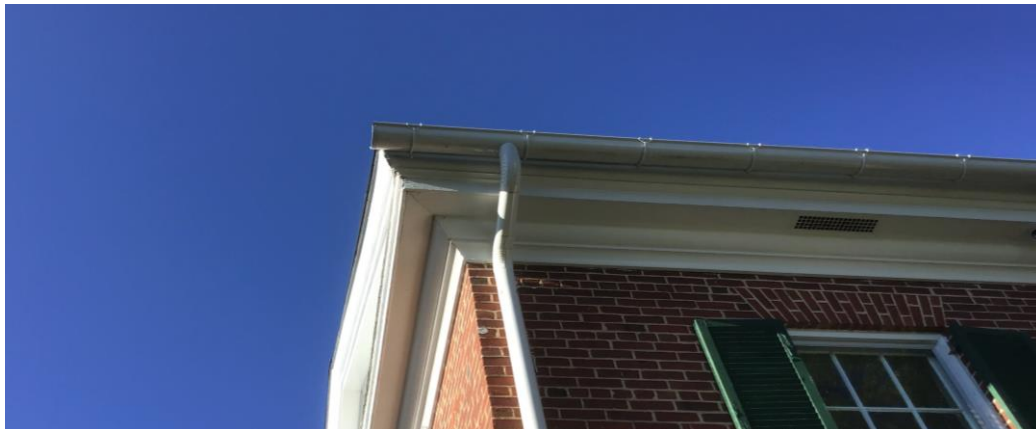
The historic shutters are beginning to fail and are in desperate need of repair. Since this structure is historic, the Secretary of the Interior's Standards for Rehabilitation will need to be followed for any and all repairs made to this structure.

The joints in the wood cornice and other areas are beginning to separate and open up. These repairs should be made in the near future to prevent further damage and also to prevent water infiltration into the building.

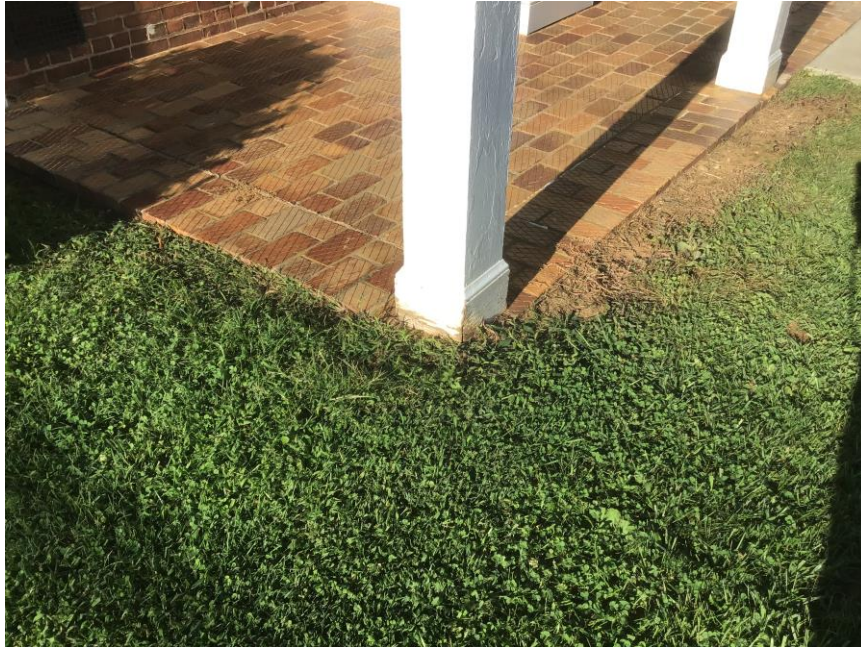
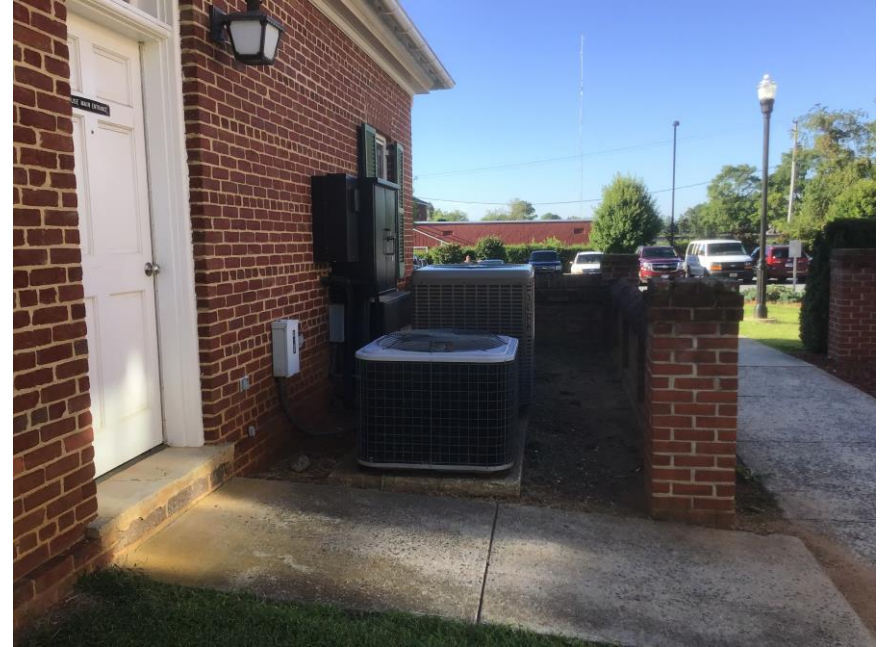
The wood bases of the columns at the front of the building are being severely damaged by the grounds crew when mowing and weed eating. Care should be taken so as not to damage these columns. Once the paint has been beaten off, water infiltration and wood rot can begin. Perhaps a gravel strip should be installed to prevent this on-going problem from occurring.

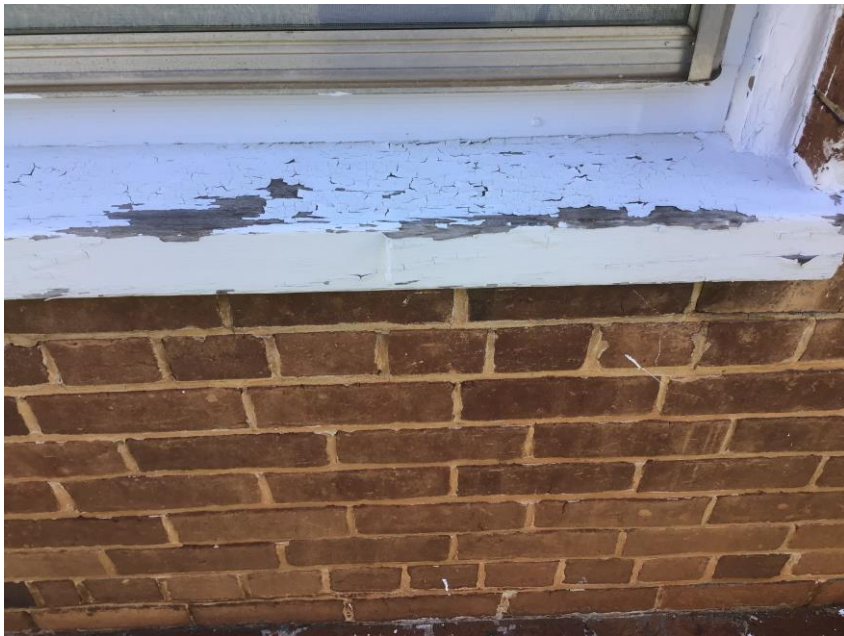
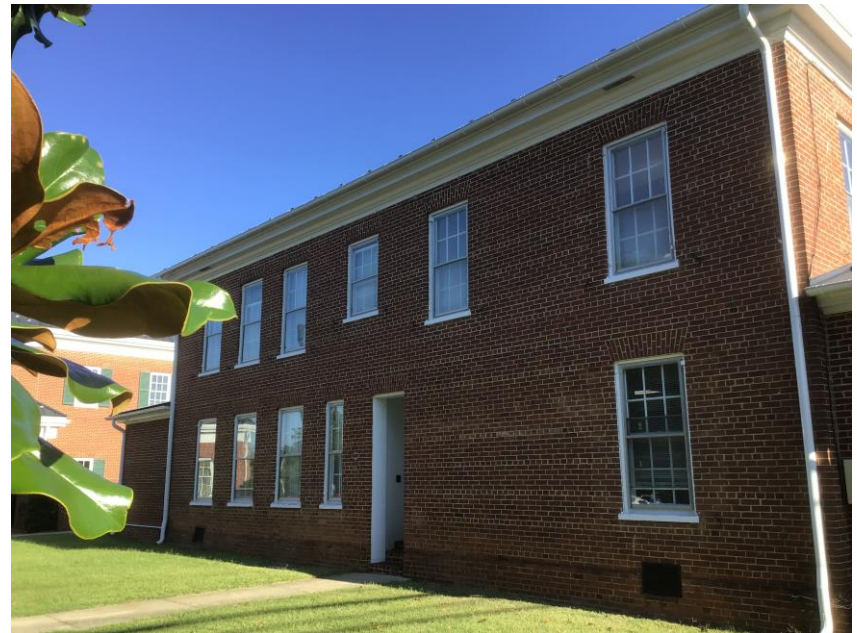
At the rear of the building, there is a large stump that is visible. This stump is visible to the public as they pass by on their way to this building or the adjacent courthouse. It is recommended to have this stump ground up and landscaping installed in its place.

The windows on this historic structure are all wood and all are beginning to deteriorate. It is recommended to have all the wood scraped, repaired or replaced as needed, and two finish coats of paint applied. Though these windows have screens, it is recommended (if the windows are not replaced) to have removable storm panels installed. This will help with offsetting heating and cooling costs and alleviate temperature extremes for staff that have desks near the windows.

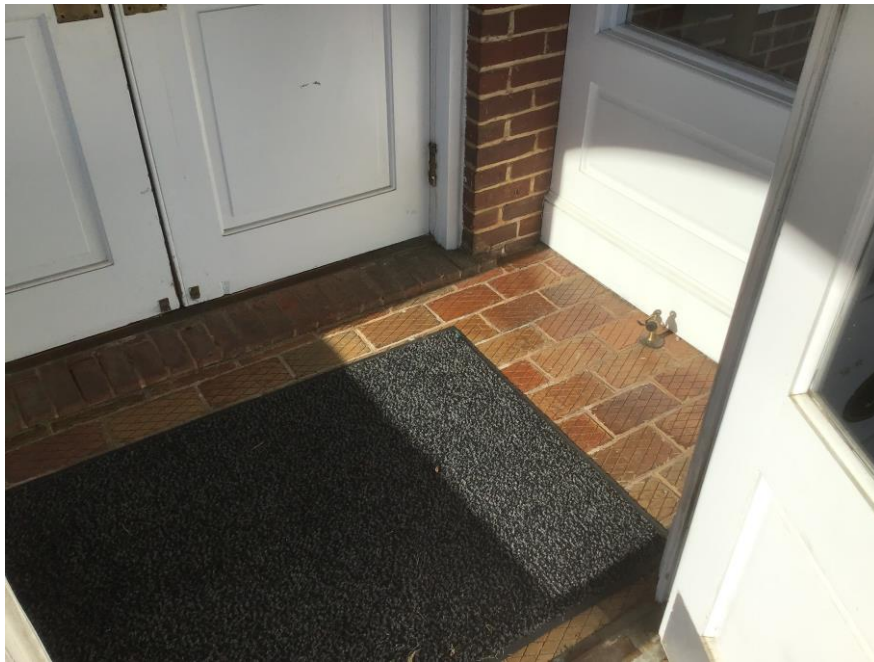
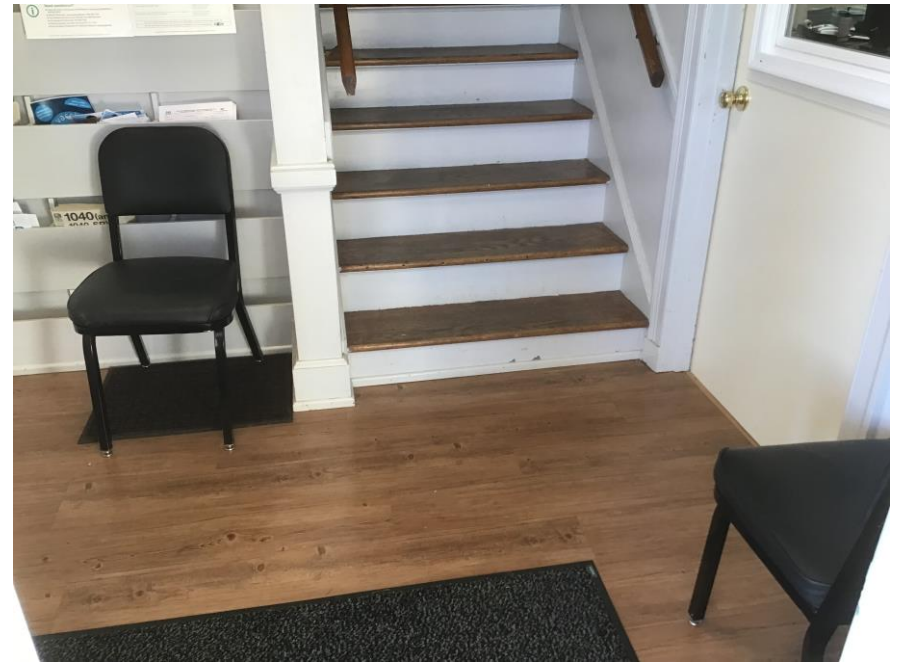
The main entry to the building is too small and the pairs of entry doors are located too close together to meet current Code. This arrangement makes it very awkward for visitors to this building and it is even more difficult if two people are entering/exiting the building at the same time.

If both of these departments are to remain in this building, the entry should be reworked to make it more usable by the public and to bring it up to current Code.

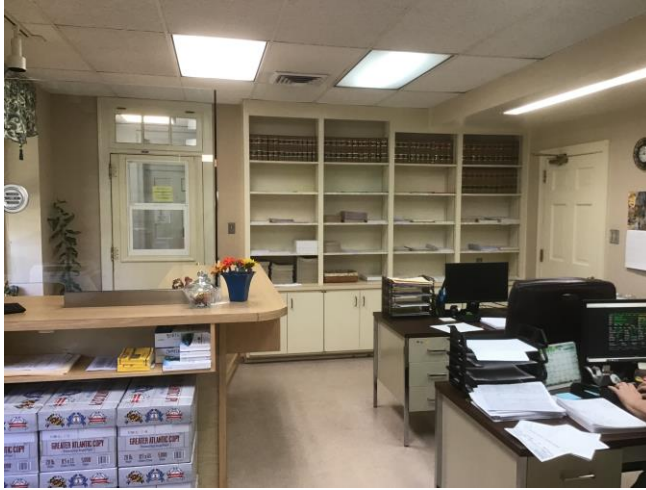
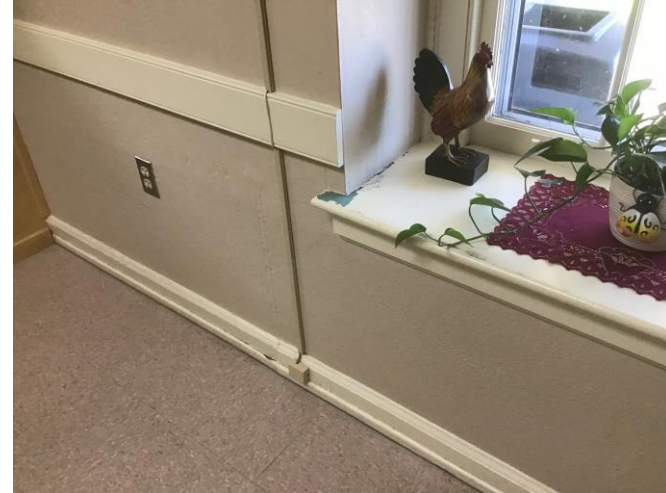
On the day of our visit, some peeling paint was noted at one of the front windows. The cause of the peeling paint is unknown.

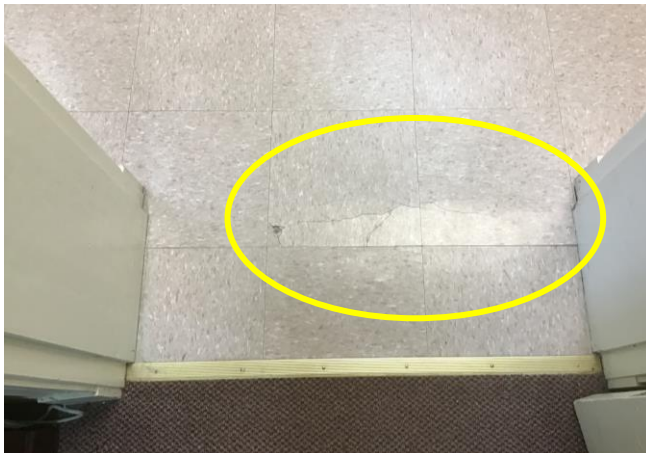
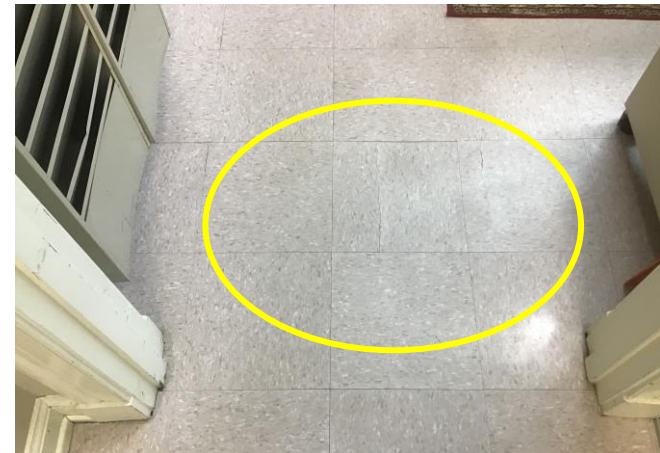
At the doors to the Commissioner's office, it was noted that the VCT flooring is beginning to split. This may be due to some minor settling of the structure at this points.

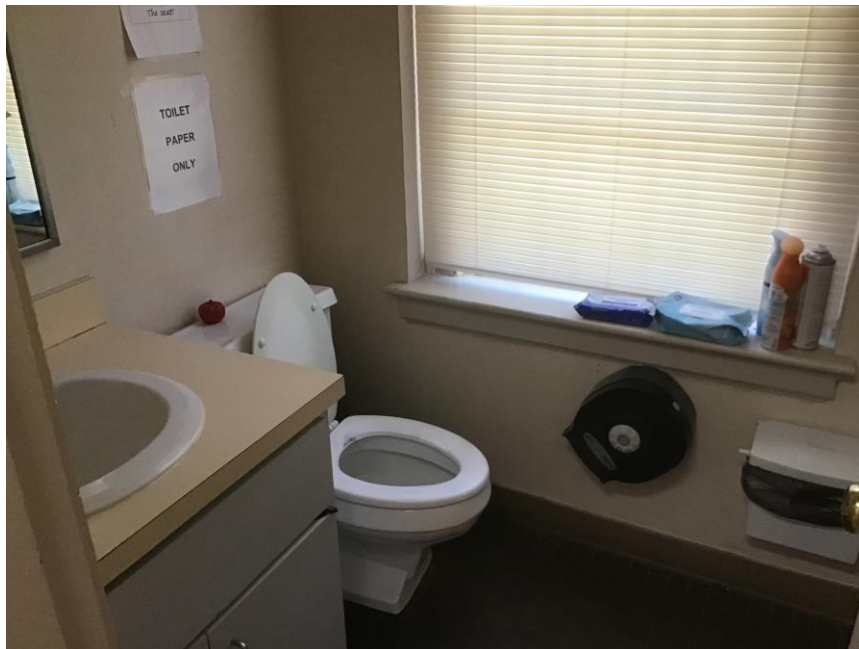
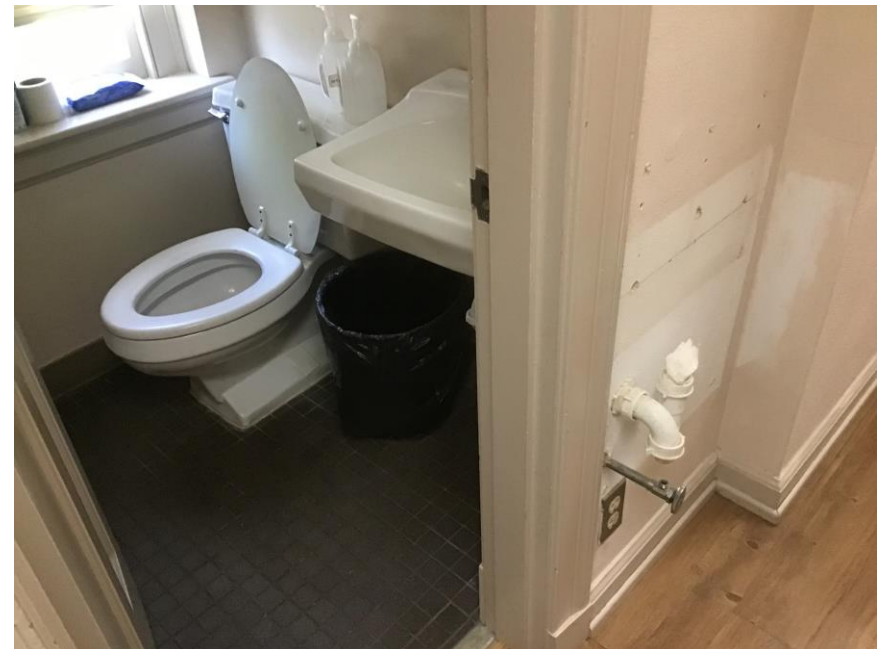
There is a tiny hall at the rear of the building that connects both the Treasurer and the Commissioner of Revenue suites with toilets and a staff entry; all of which are tiny.

None of these spaces meet current Code with regard to ADA regulations. All of these spaces are too small and anyone in a wheelchair or having any issues walking (walker, crutches, cane, etc.) will not be able to use these spaces due to their small size. This is a major Code violation, and we recommend investigating if this building is the right location for these departments due to its's age, size and lack of ADA accessibility.

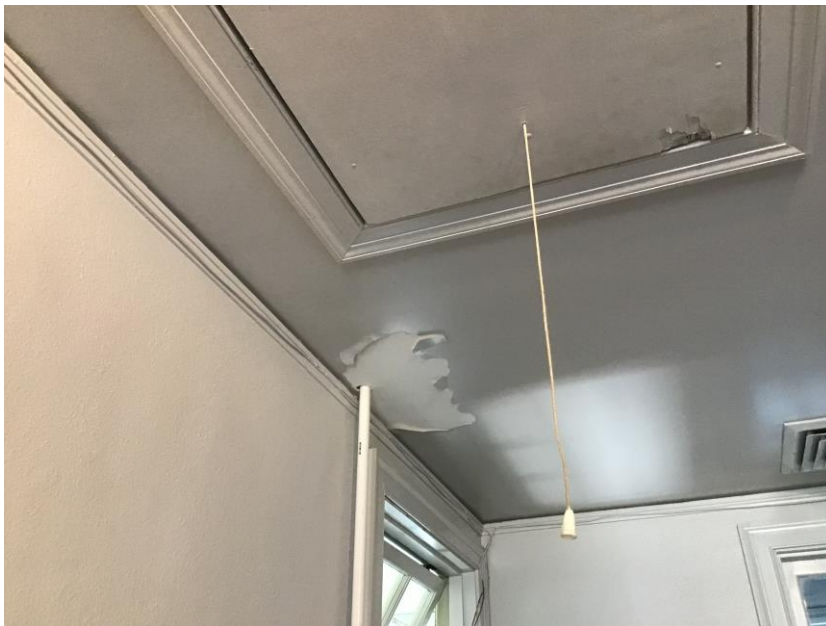
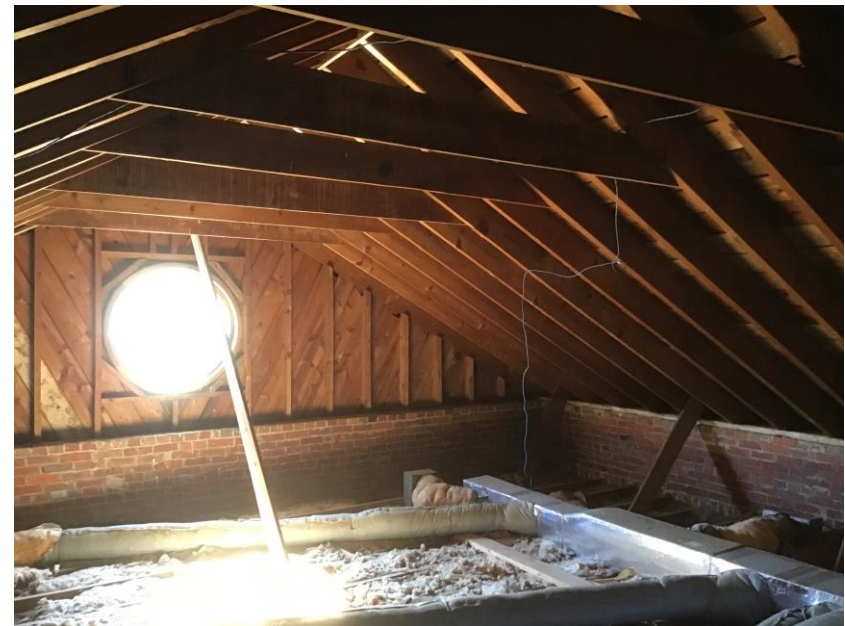
Within the upstairs toilet, a wall-hung style sink has been installed within a countertop. Also, the countertop has a seam in the laminate. This is not an ideal set up and should be removed. If a countertop is desired, a seam should not be located near the sink as this will ultimately lead to failure of the countertop through water infiltration at the seam.

The Break Room sink is original to the building. The wood floor is stained and damaged from water.

Peeling paint was noted on the ceiling in the hall. The cause of the peeling paint is unknown.

The attic appears in good condition and there were no visible evidence of leaks on the day of our visit. We do recommend adding an additional layer of R-38 batt insulation to the existing attic insulation as an extra layer. This will also offset heating and cooling costs and prolong the life of the roof covering. There are pieces of antiquated equipment (phones, typewriter, etc.) in the attic that should be removed.
