Historic Structures Report

**APPOMATTOX DEPOT**

APPOMATTOX, VIRGINIA

JANUARY 8, 2019

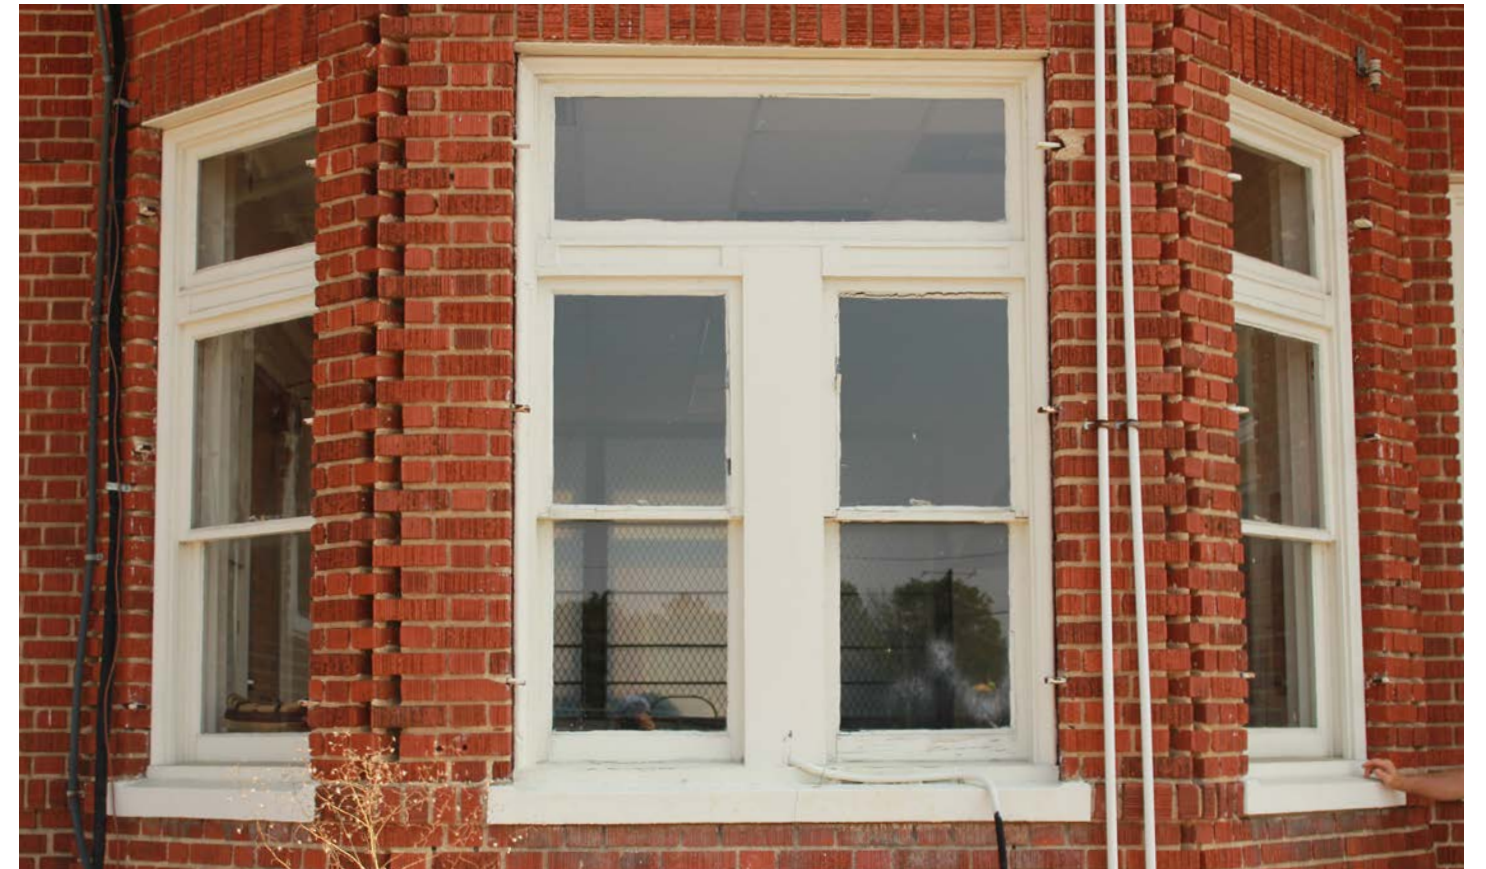
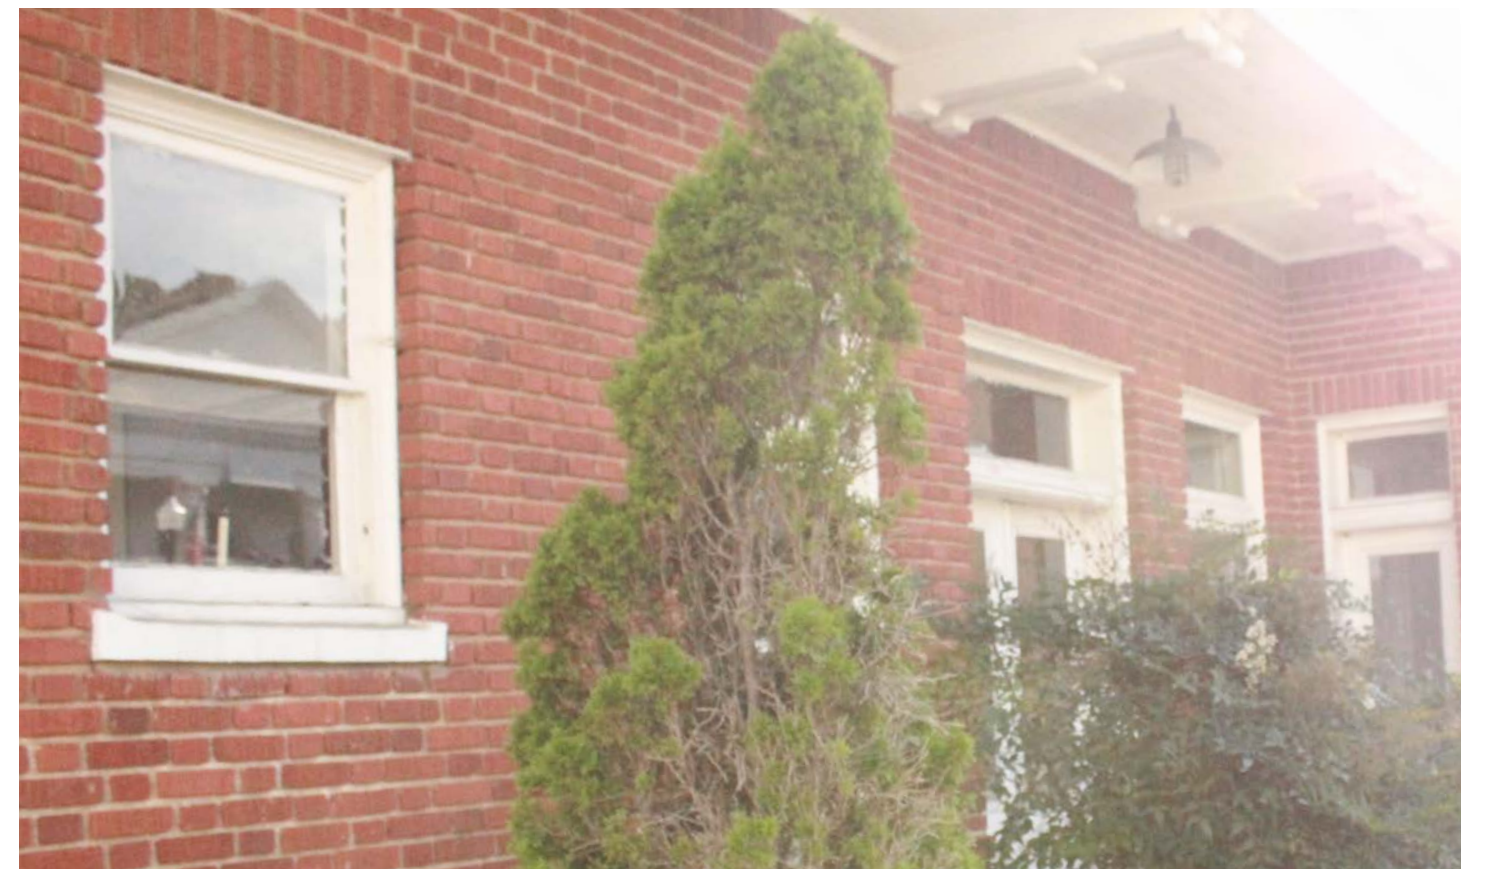
Window glazing and paint finish on most windows and transoms on all elevations exhibits widespread deterioration and loss of integrity. Numerous sashes exhibit deterioration and failing joinery. Previous repair attempts are visible which include the inappropriate application of wood filler, flexible sealant, etc. Many lower window sashes have been painted/sealed shut and no longer appear to function. The north window of the Women's Retiring Room (White) no longer possesses obscured glass, as indicated on the original 1923 architectural drawings. Broken and inappropriate glass is present in numerous transoms.

Cut paint and/or sealant from perimeter of lower sashes and deteriorated upper sashes to ensure they can be opened and/or removed for proper repair. Document, label, and remove all lower window sashes and any deteriorated upper window sashes. Install temporary protection to prevent weather intrusion into building during restoration of sashes. Remove failed glazing where required. Clean frames and glass to remove all dirt deposits, residue, etc. Prepare wood window members to remove loose paint, scaling, etc. Hand sand to feather paint remnants and to ensure sound, paint-ready surface. Repair deteriorated sash, frame, and sill members where required in an in-kind manner. Repair should include consolidation and infill with wood epoxy where areas are smaller than one cubic inch in size, or in areas of thin material loss over a sound existing substrate. Areas larger in size should be repaired with a Dutchman fabricated using Sapele (or equivalent). Significantly deteriorated members should be replaced using Sapele (or equivalent). All repairs, Dutchmen, and replacement members should match existing historic members in dimension and profile as accurately as possible. All bare wood should be treated with a wood consolidant. All wood surfaces should be primed with an alkyd-based primer. Replace any broken panes of glass using double-strength glass. Re-glaze where required using DAP 33 Glazing Compound. Once glazing compound has "skinned over" (approximately three weeks), window glazing can be primed and painted as described herein. The interior and exterior surfaces should then be painted according to the results of the historic finish analysis (see "Historic Paint Analysis" section for further details). Install spring-bronze weather stripping into window openings in a manner that will not be visible when the sashes are in their closed positions. All sashes should then be re-installed into their respective, original openings. Lower sash windows should be weighted with existing weights and bronze sash chain. Existing, historic pulleys should be stripped of paint and returned to serviceable condition. Ensure that all sash locks are stripped of paint and properly functioning. All hardware should be installed with slotted screws. In no event should Phillips-head screws be implemented. Any required replacement screws should match their respective historic hardware in material. In no event should lacquered brass be implemented.

**Glass in the north window of Women's Retiring Room (White) should be replaced with obscured glass as indicated in 1923 architectural drawings.**

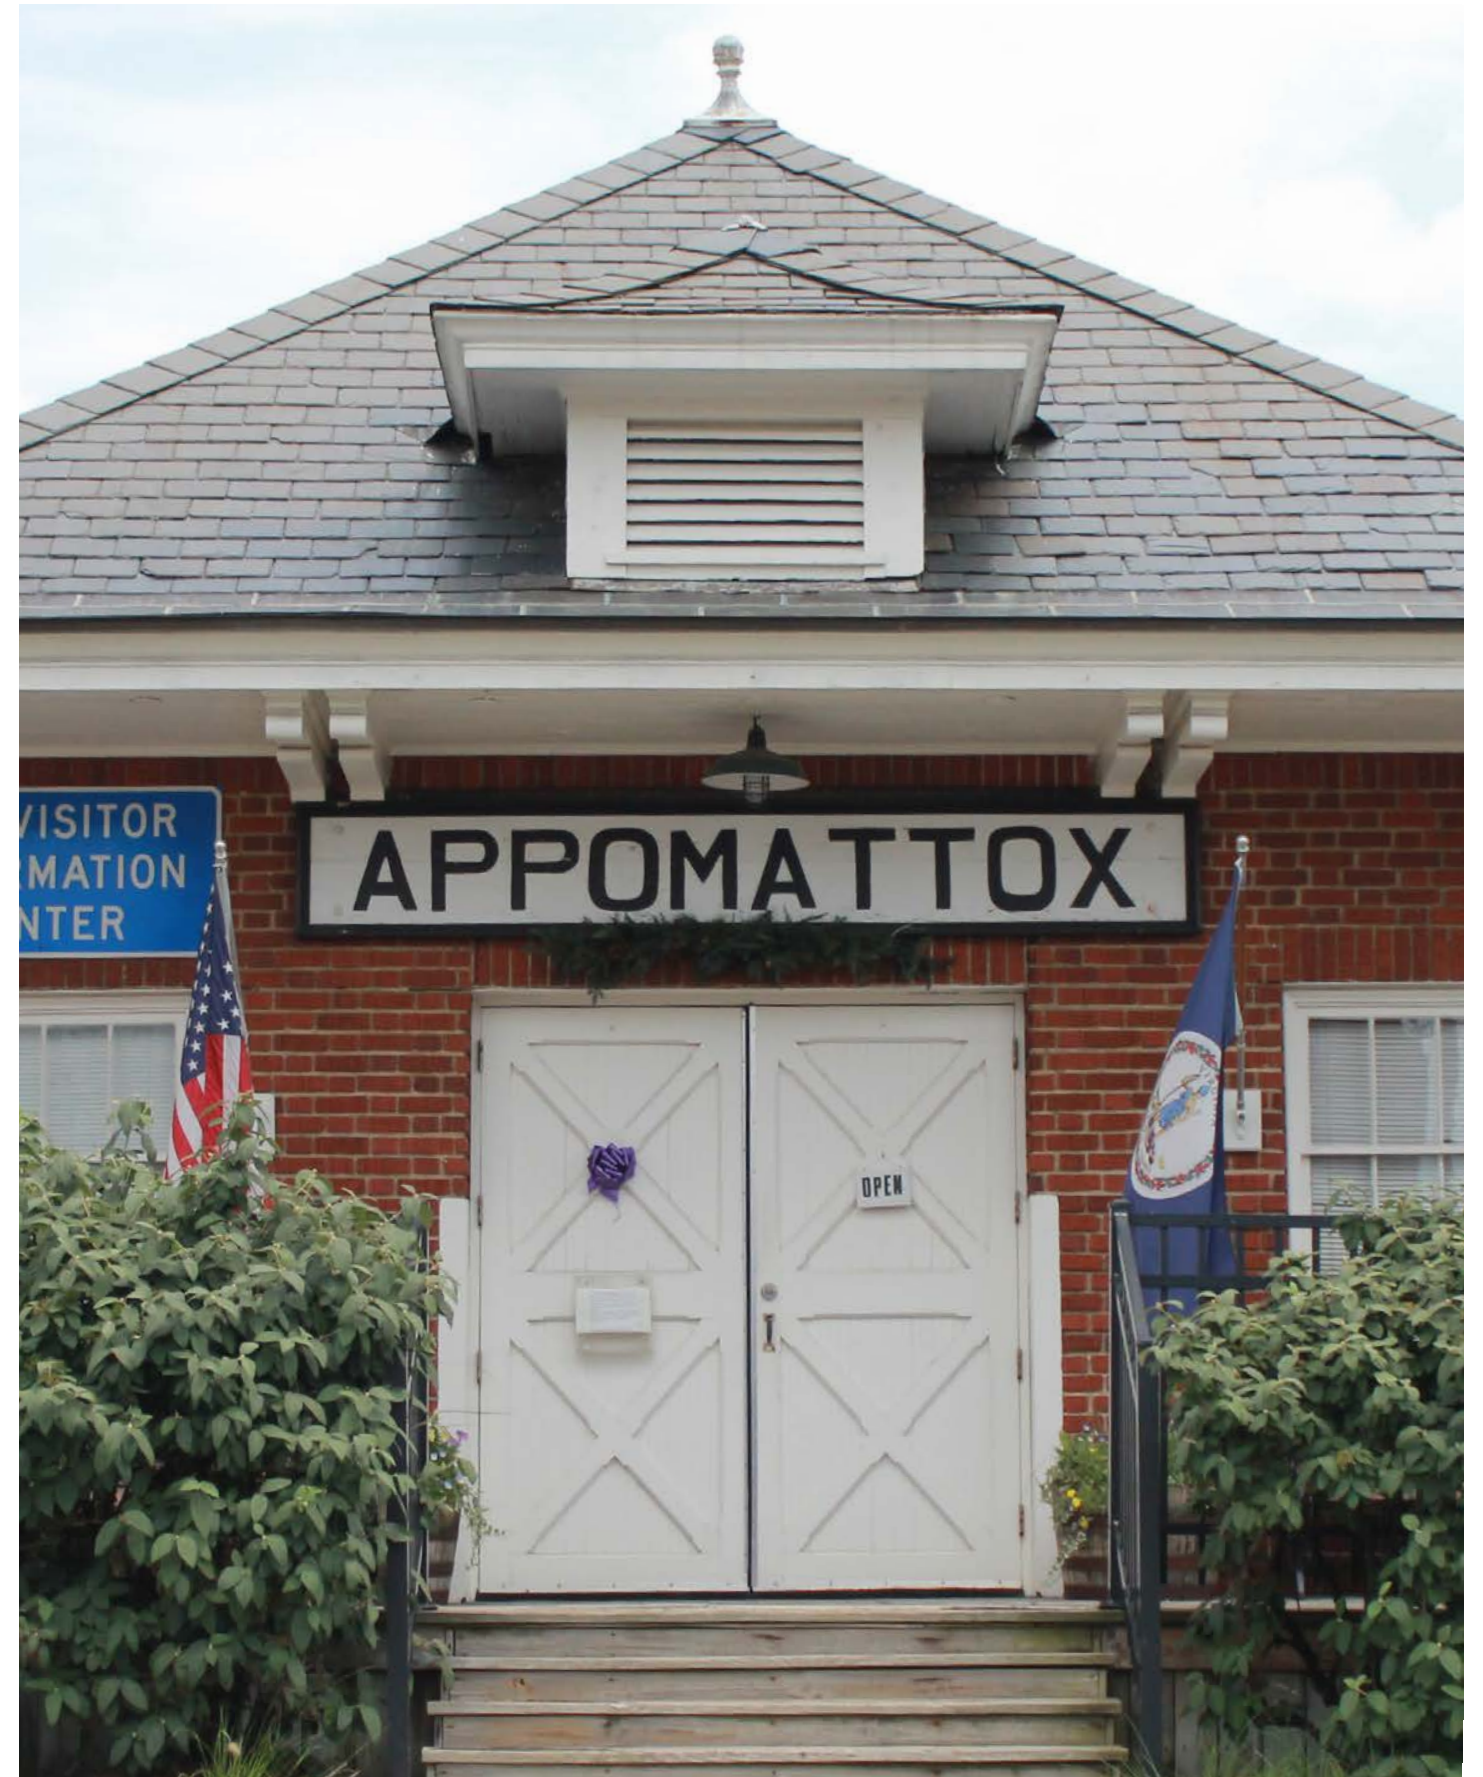
The existing, historic freight doors and door jambs vary in condition overall, exhibiting joinery failure, general deterioration, broken raised panels, and general degradation of operation. Paint finish on the doors and door jambs is failing. The steel lintels above the jambs exhibit progressive oxidation. Where interior sliding door hardware is still intact, doors no longer function properly. Numerous doors are missing most or all interior hardware. In many instances, door hardware is coated with paint. The flexible sealant at the union of the wood jamb and masonry opening has failed or is non-existent.

Doors should be documented, labeled, and removed. Temporary infill should be installed to protect building from weather intrusion. Existing hardware should be removed, stripped of paint (where applicable), and repaired to original function for reinstallation. Doors should be stripped to remove existing, failed paint finishes using Back to Nature Double-Duty VII (or equivalent). **Prior to paint removal, historic paint analysis should be performed as described in “Historic Paint Analysis” section above. Furthermore, as paint is removed, careful attention should be given to identifying original finish. Small samples of original finish should remain in place, without subsequent refinishing.** All stripped surfaces should be cleaned with denatured alcohol to remove residue. Re-attach loose door moldings where required using stainless steel fasteners and wood glue. Repair failed and deteriorated members and joinery to re-establish soundness. Repair should include consolidation and infill with wood epoxy where areas of deterioration are smaller than one cubic inch in size, or in areas of thin material loss over a sound existing substrate. Significant voids should be repaired with a Dutchman of durable species (sapele, cypress, red grandis, red cedar, or equivalent). All Dutchmen should match existing adjacent element in profile and texture as accurately as possible. Elements that are too deteriorated to repair will be replaced in-kind using a durable species (sapele, cypress, red grandis, red cedar, or equivalent). All replacement elements will match existing adjacent element in profile and texture as accurately as possible. All bare wood should be consolidated with alkyd resin prior to priming. All epoxy repairs and Dutchmen should be primed on all sides with an alkyd-based primer where possible. Apply three, hand-brushed finish coats of acrylic semi-gloss paint to doors. Exact color and sheen are to be determined. Clean and polish the original hardware and reinstall. Where hardware is missing, new historically sympathetic hardware should be installed that matches existing in design, function, and character as accurately as possible. Carefully reinstall doors into original door jambs at original locations.

Door jambs should be repaired as required. All surfaces should be scraped and sanded to removed failed paint. Hand sand to feather paint remnants and to ensure sound, paint-ready surface. Repair failed and deteriorated members and joinery to re-establish soundness. Repair should include consolidation and infill with wood epoxy where areas of deterioration are smaller than one cubic inch in size, or in areas of thin material loss over a sound existing substrate. Significant voids should be repaired with a Dutchman of durable species (sapele, cypress, red grandis, red cedar, or equivalent). All Dutchmen should match existing adjacent

element in profile and texture as accurately as possible. Elements that are too deteriorated to repair will be replaced in-kind using a durable species (sapele, cypress, red grandis, red cedar, or equivalent). All replacement elements will match existing adjacent element in profile and texture as accurately as possible. All bare wood should be consolidated with alkyd resin prior to priming. All epoxy repairs and Dutchmen should be primed on all sides with an alkyd-based primer where possible. Apply three, hand-brushed finish coats of acrylic semi-gloss paint to doors. Exact color and sheen are to be determined based on historic paint analysis results (see "Historic Paint Analysis" section above).

Remove failed paint from metal lintels at exterior of each window with hand tools to achieve sound, paint-ready surface. Treat lintel with rust converter (Ospho or equivalent). Prime lintel surfaces with a two-part epoxy or marine-grade primer. Paint lintel with two coats of Sherwin-Williams DTM semi-gloss finish. Remove all failed sealant from union of metal window frames and masonry jambs. Re-seal with a flexible, urethane-based sealant.

As the building is to undergo rehabilitation for a new use/uses, it should be expected that in order to meet code compliancy, it may be deemed necessary to install ADA or panic hardware. It is strongly suggested that all existing hardware be retained in place, and that any required new hardware be the most sympathetic and compatible in design. Every effort should be made to ensure that the historic integrity of the doors is not compromised.

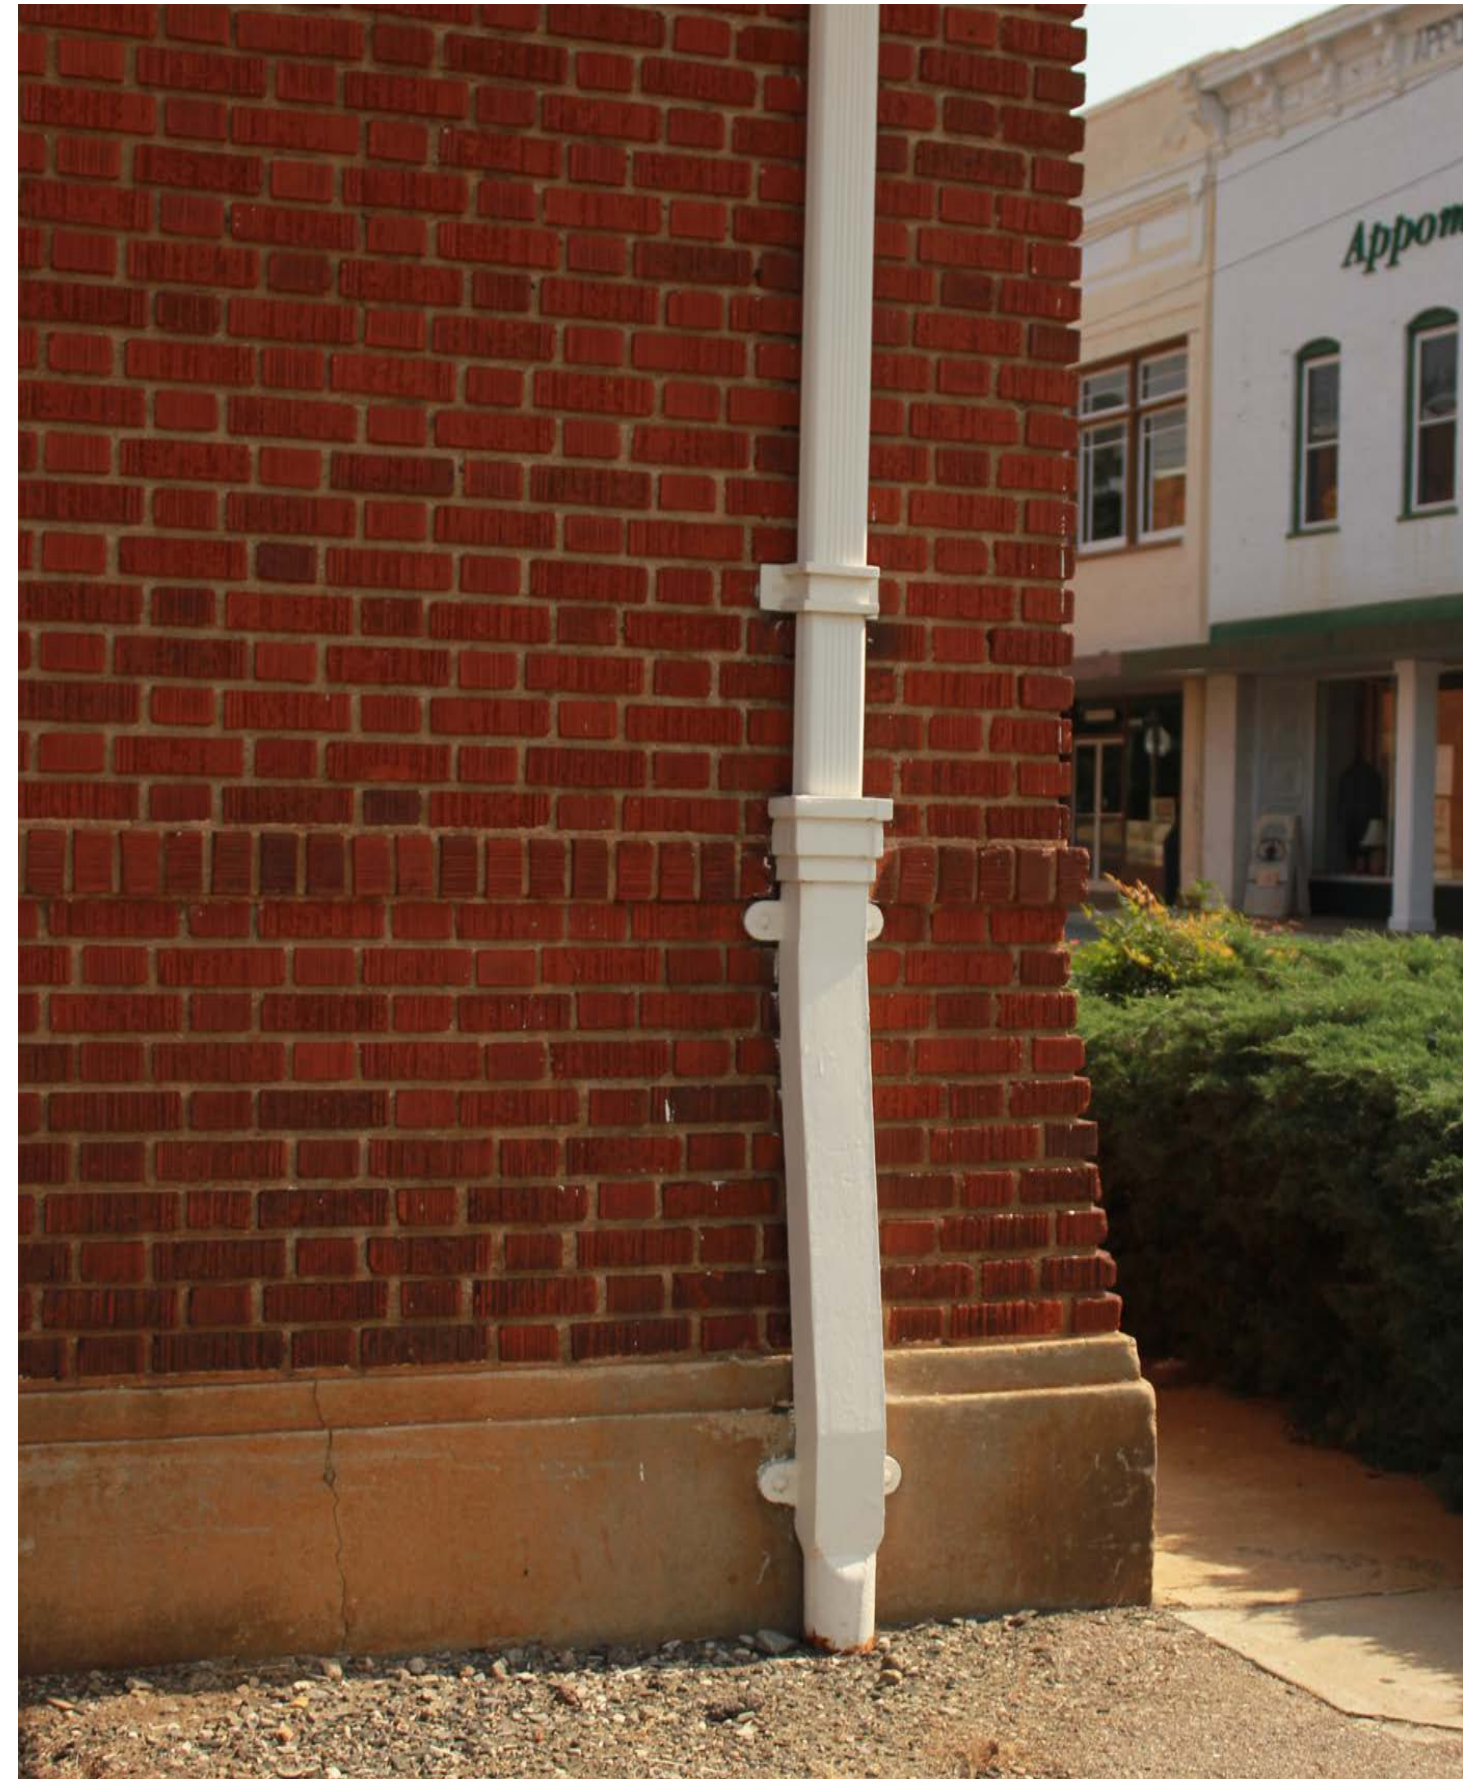
Numerous non-historic system components are in place on the exterior of the building. These components include air-conditioning condensers, line-sets, LP gas tanks, electrical meters, conduit, piping, communication consoles, communication wiring, etc. While aforementioned components are installed neatly, little effort was made to conceal them in a manner that preserves the historic appearance of the building.

Once new, rehabilitated uses for the building are determined, all planning and design efforts should strive to conceal these service components as much as possible. This effort serves to meet the *Secretary of the Interior's Standards for Rehabilitation*. The treatments for these service systems are more specifically described in the various, individual sections within this document. In general, piping, conduit, line-sets, etc. should be routed into basement, through interior wall systems, across attic spaces, etc. so that they are concealed as much as possible. Air-conditioning condensers, LP gas tanks, electrical meters, etc. should be installed in an unobtrusive location(s) or screened in a manner that is historically sympathetic. All original electrical components should be retained, where applicable.

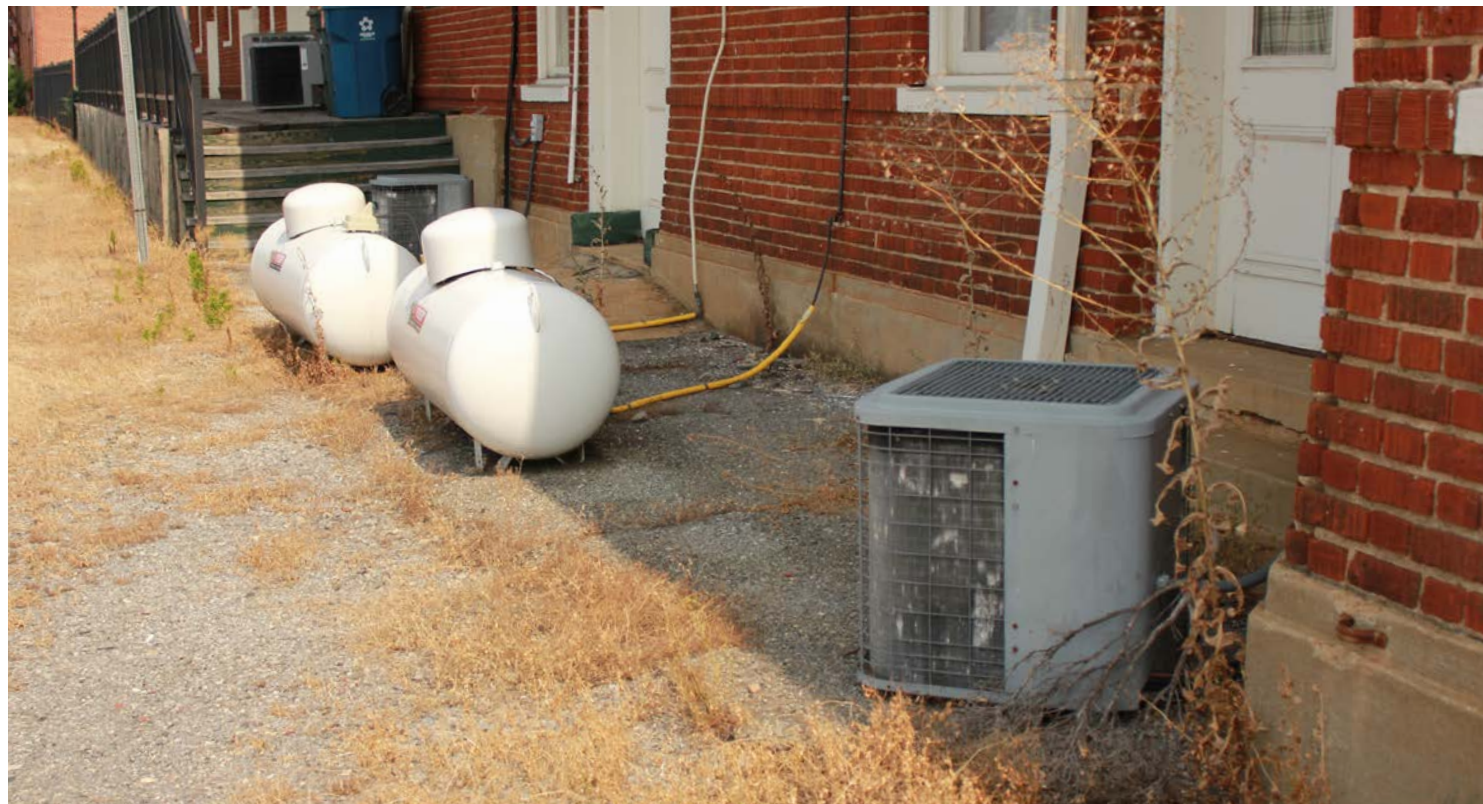
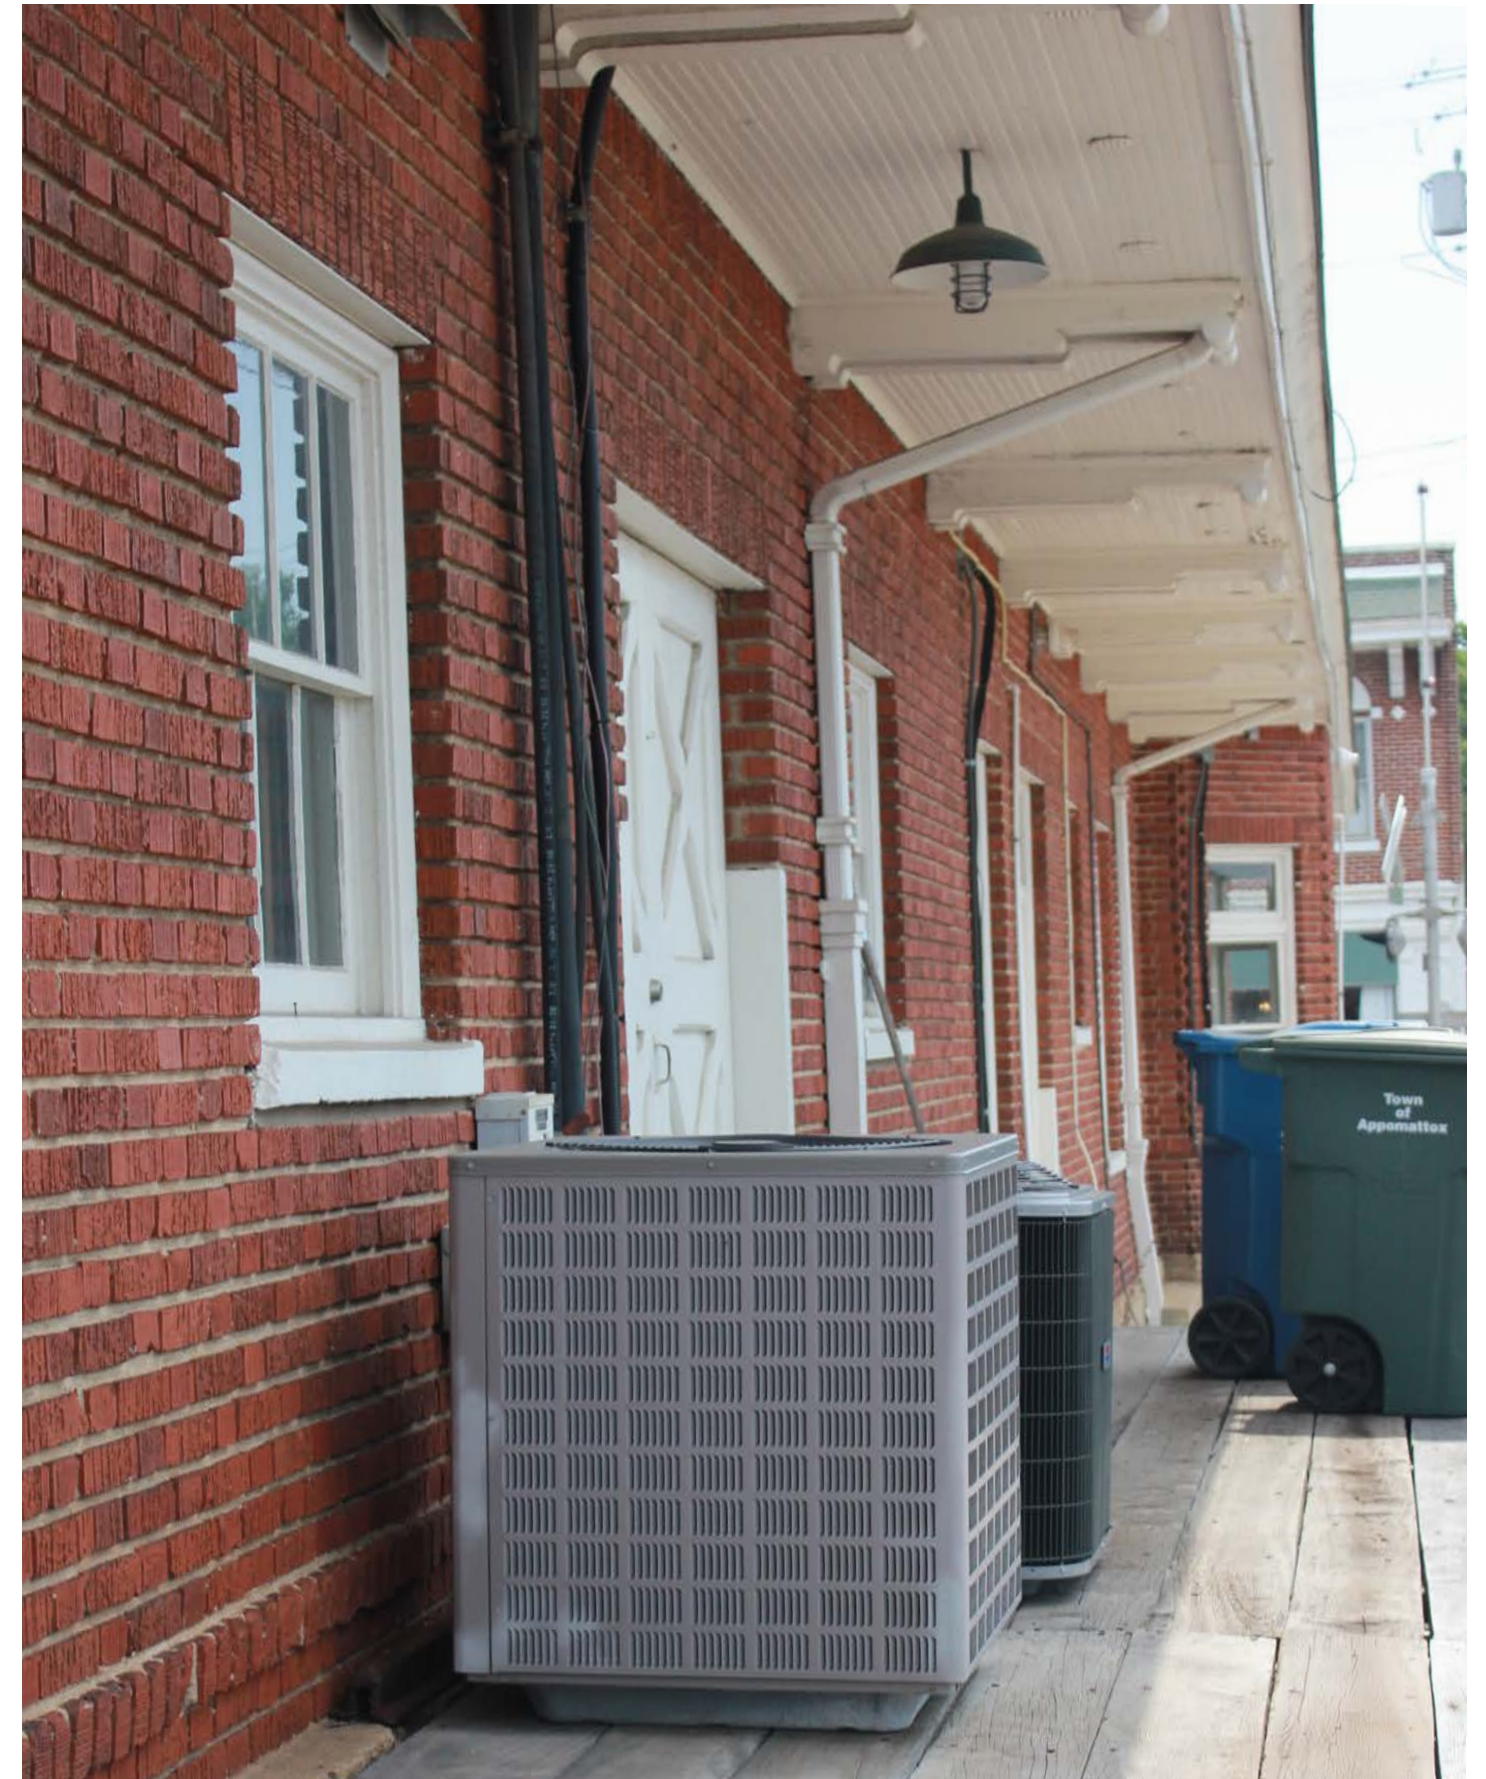
Existing landscaping is not historic and obstructs the historic appearance of the building, particularly on the north elevation. Invasive vegetation, vines, ivy, weeds etc. are present which adhere to the masonry causing advanced mortar deterioration. Shrubbery and hedges in place immediately adjacent to the building contribute to the deterioration of the building due to invasive roots and promotion of biological growth. Furthermore, they trap rainwater and general moisture by preventing proper drying following weather events. Existing irrigation system further saturates the conditions adjacent to the building. Original grade on the north elevation has been raised to accommodate the re-paving of the adjacent street over time.

All existing landscaping should be removed to include vines, shrubbery, hedges, weeds, ivy, mulch, etc. Remove existing irrigation system. Regrade north elevation to re-establish a more historic grade, if possible. Install gravel at base of building on all elevations, where possible, to assist with drainage following rain events. In general, the absence of landscaping is in keeping with the historic appearance of the building and alleviates elements that exacerbate saturation and pre-mature deterioration of mortar and masonry.

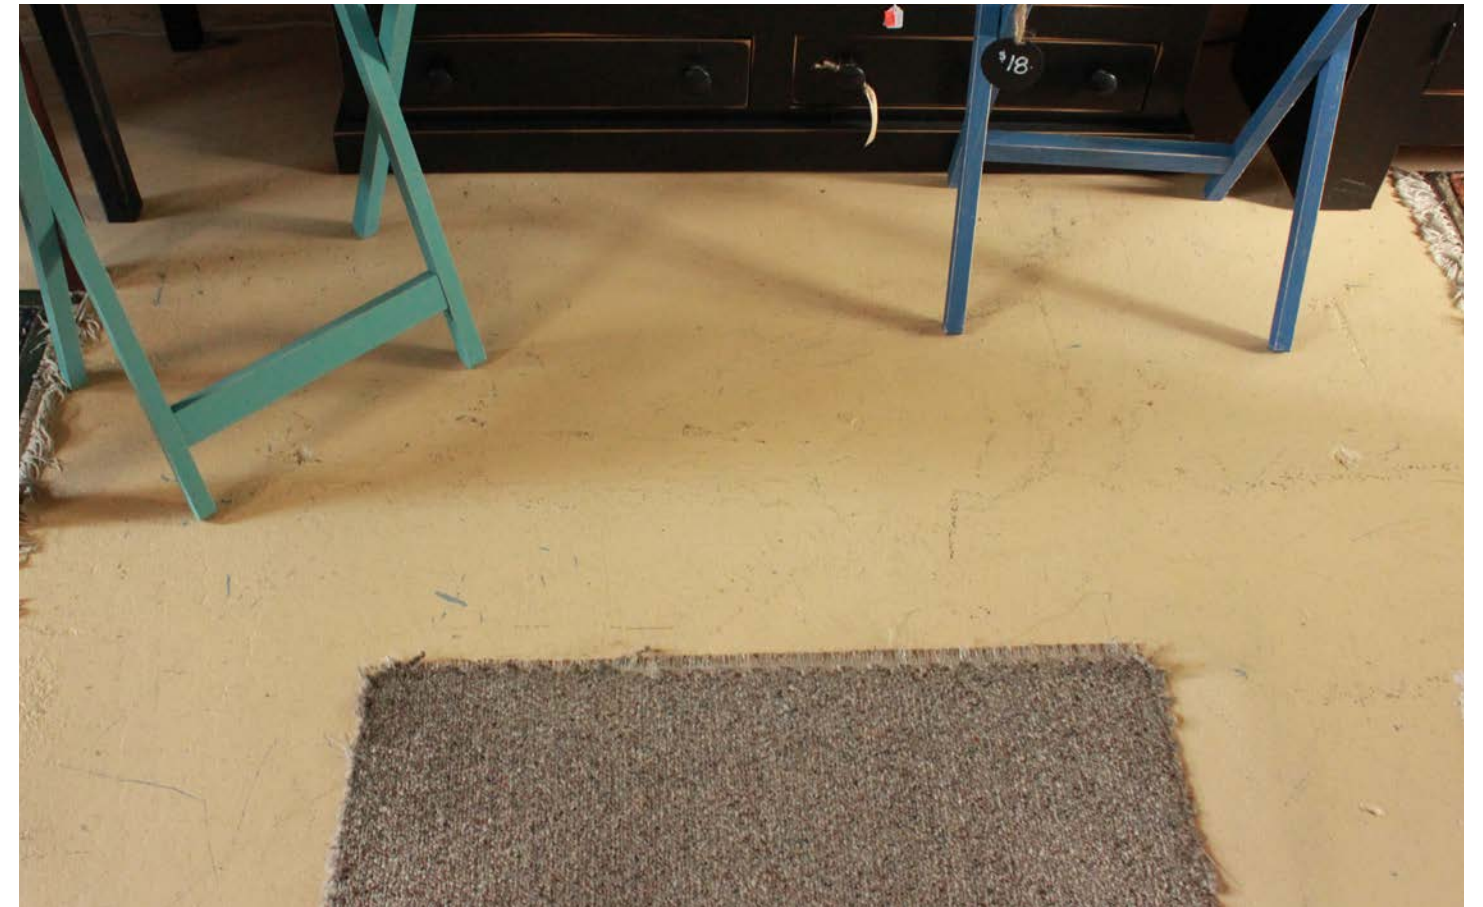
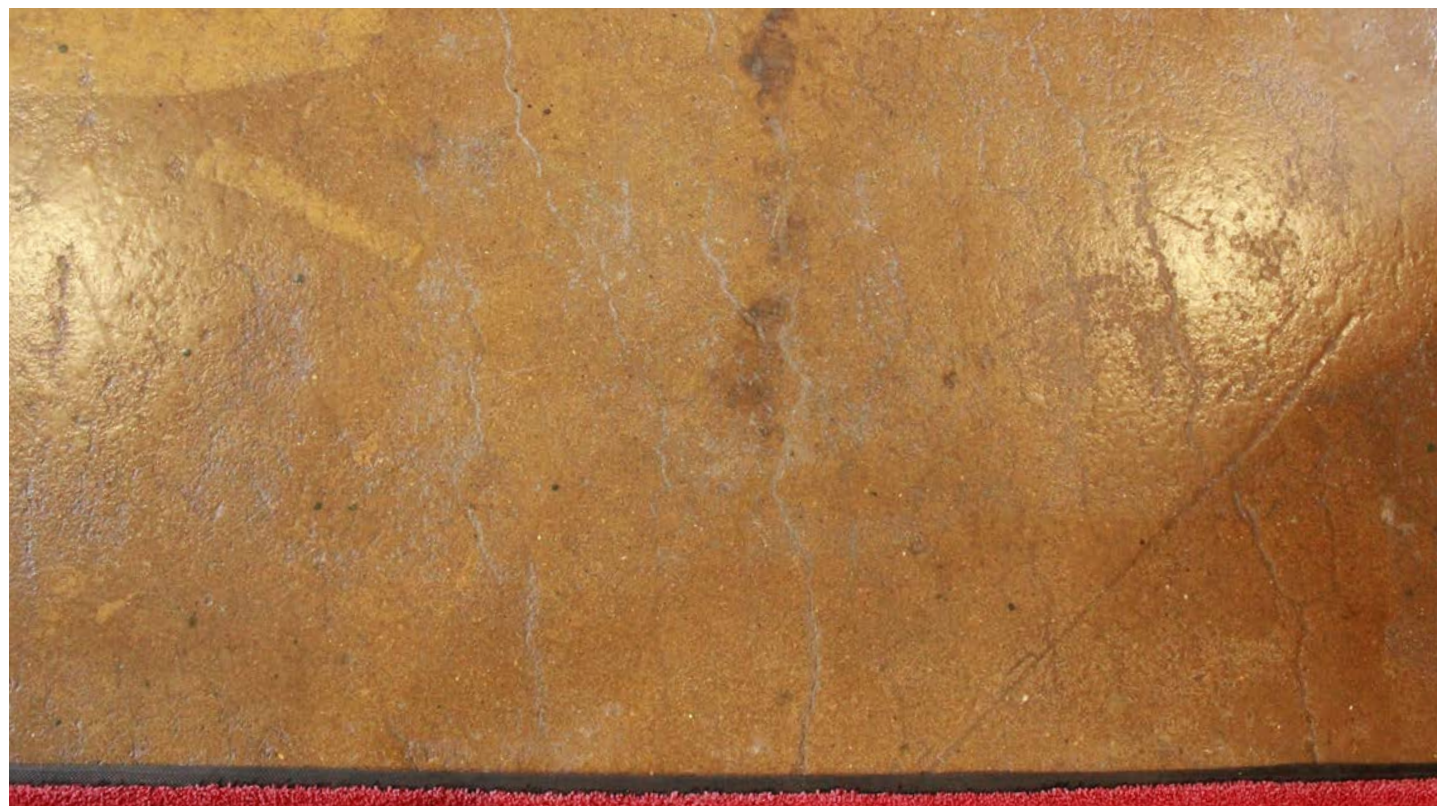
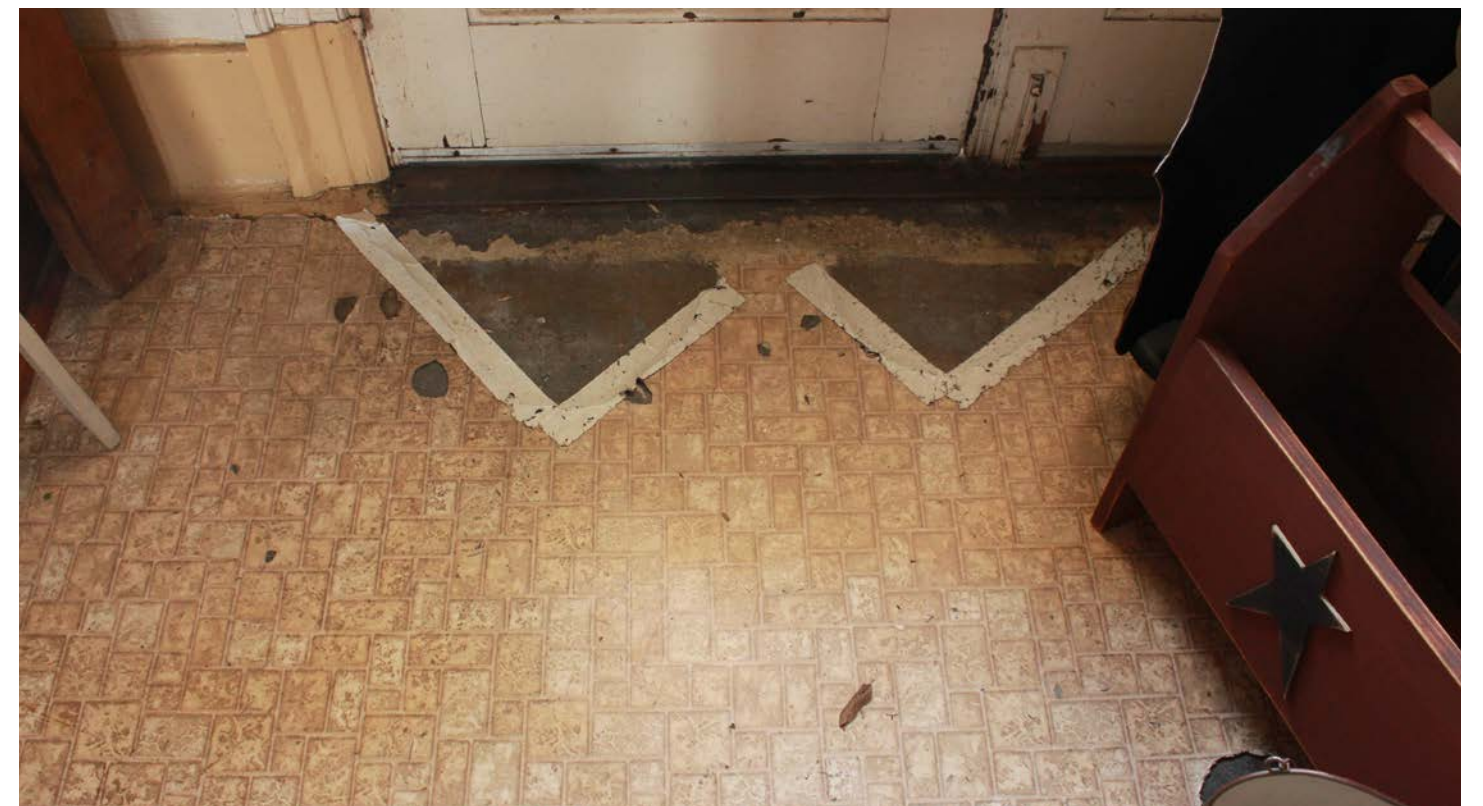
Concrete floors in all spaces have been stained, painted, or covered in linoleum. Following the removal of inappropriate linoleum as recommended in the 'Selective Removals' section above, it should be anticipated that residual adhesive will be present (Waiting Room (Colored) and Baggage and Express Room). Minor cracking has been observed in various locations throughout the building.

All concrete floors should be cleaned to remove surface grime. Residual adhesive beneath linoleum floors should be removed using a chemical stripper (Back-To-Nature Double-Duty VII, or equivalent). Cracks should be prepared and filled with Portland-based concrete patch material, matching adjacent surfaces in plane and texture as accurately as possible. All concrete floors should be prepared and primed to manufacturer's recommendations to achieve a paint-ready surface. All concrete floors should be painted with a two-part, catalyst-based floor paint. Colors for each space should be determined based on the results of historic paint analysis.

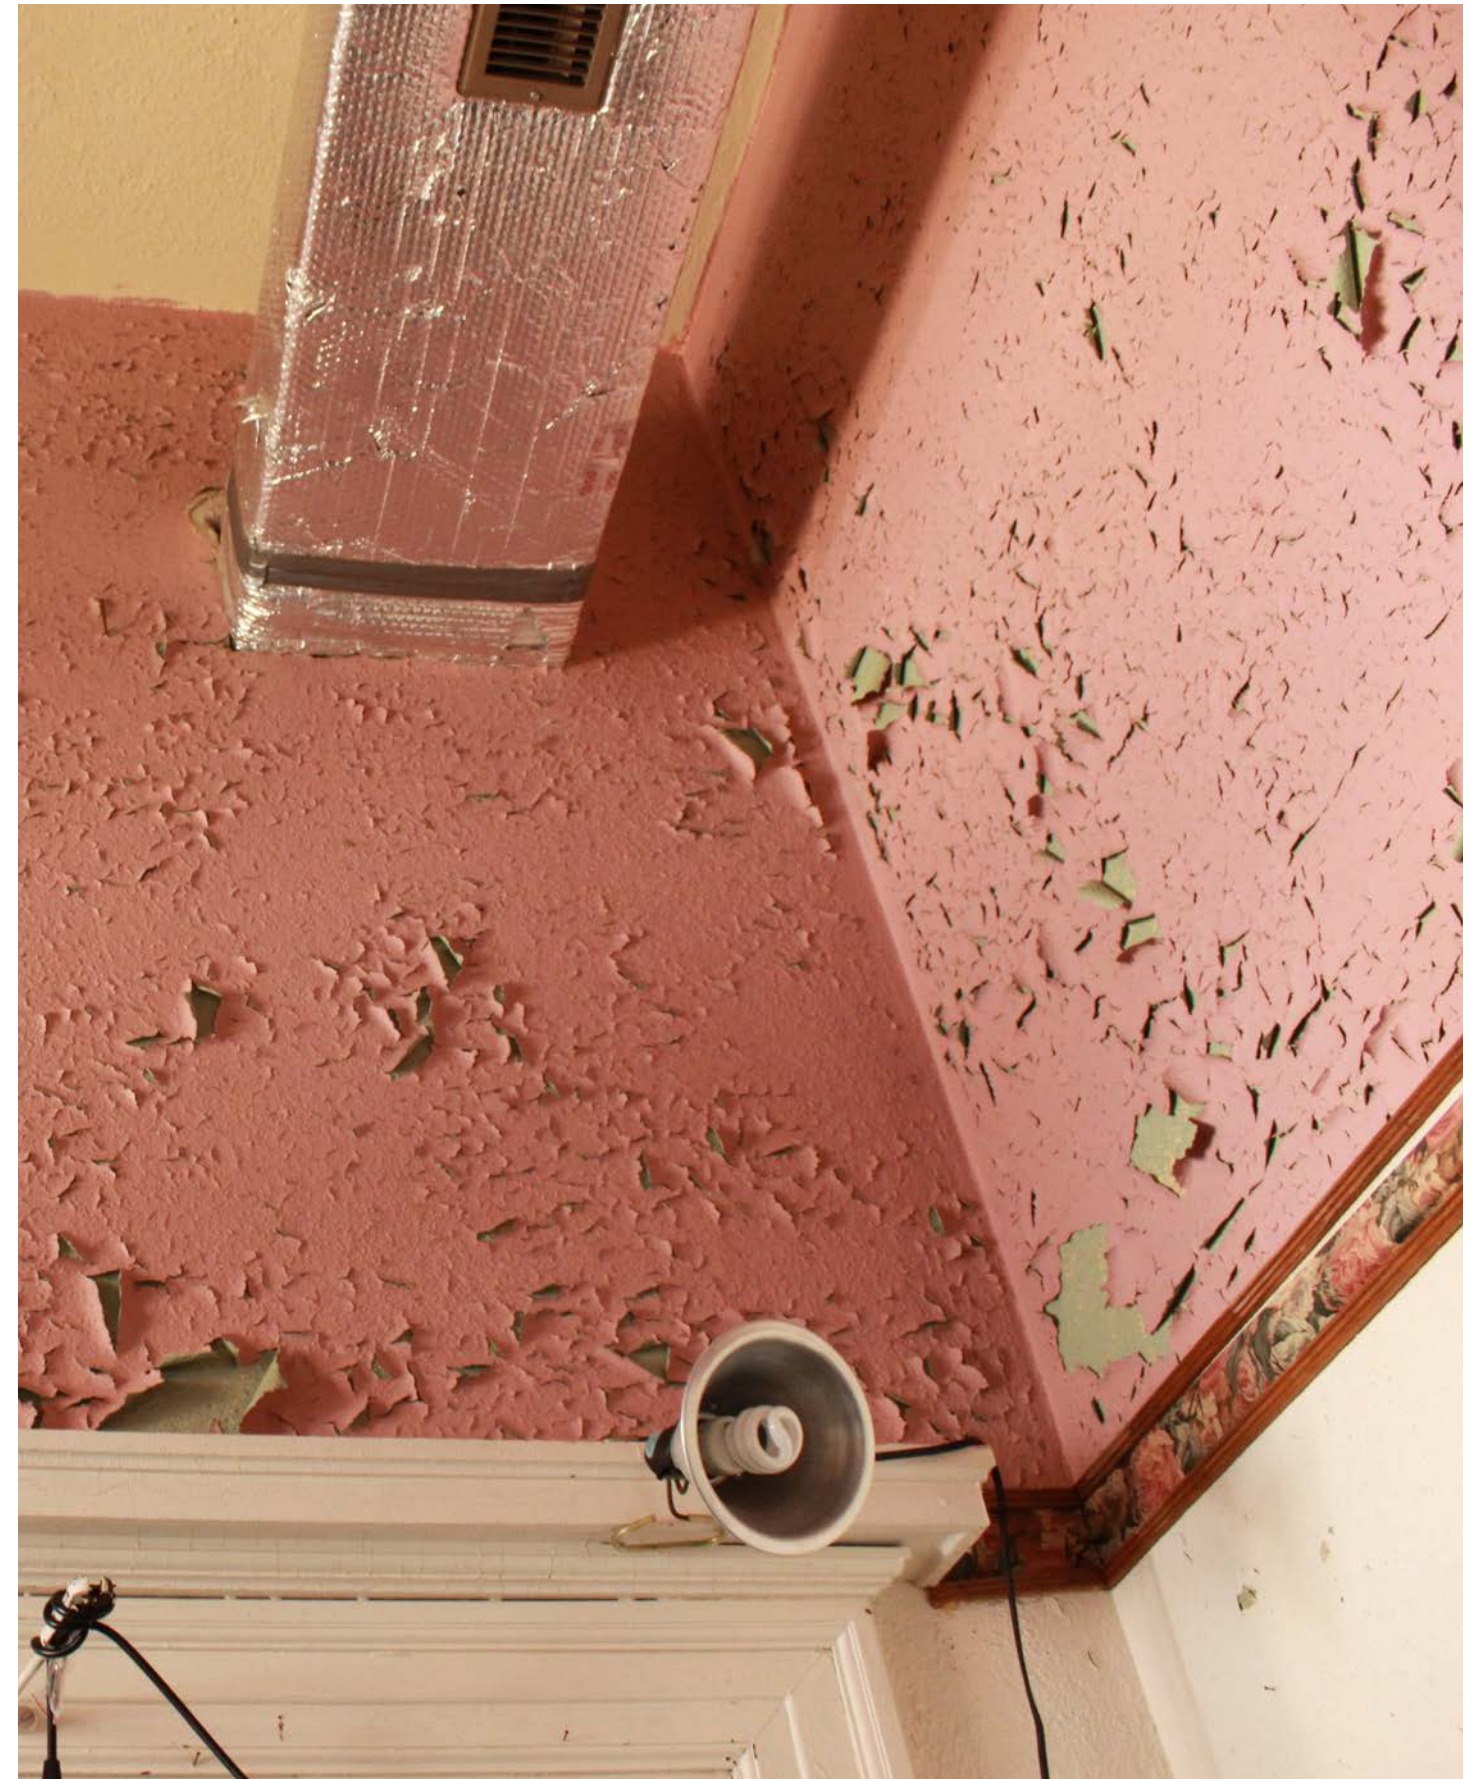
Original plaster walls are in place in all rooms within the passenger portion of the building. Plaster exhibits cracking and failed paint. Inappropriate prior repairs are evident which do not match adjacent historic plaster in plane or texture. Isolated areas of water damage are present.

All deteriorated/damaged plaster should be repaired in-kind. Loose and deteriorated material should be gently removed using hand tools only. Removal should be done only to the extent that a sound substrate is achieved. Patching should occur using in-kind materials, taking great care to match existing adjacent surfaces in plane, texture, and profile as accurately as possible. All water-damaged plaster should be repaired in-kind. Loose and deteriorated material should be gently removed using hand tools only. Removal should be done only to the extent that a sound substrate is achieved. Patching should occur using in-kind materials, taking great care to match existing adjacent surfaces in plane, texture, and profile as accurately as possible.

General cracking should be repaired to restore stability. Areas of cracking should be sounded to determine if plaster keys are broken (loss of adhesion to substrate). In such instances a case-by-case determination should be made as to the extent of plaster removal. Only the minimum amount of plaster should be removed in an effort to preserve as much original material as possible. Where plaster is removed, new in-kind plaster should be installed. New plaster should occur using in-kind materials, taking great care to match existing adjacent surfaces in plane, texture, and profile as accurately as possible.

Where plaster is still well adhered to the substrate, cracks should be repaired. Cracks should be excavated to achieve sound substrate. Cracks should then be injected with an acrylic adhesive to ensure soundness. Plaster should then be installed to infill the excavated areas using a bonding agent. Surface of repaired cracks should match existing adjacent surfaces in plane, texture, and profile as accurately as possible.

Once all plaster repairs have been made, surfaces should be prepared to a paint-ready surface by hand scraping loose paint and feathering paint remnant edges. All walls should then be primed with a stain blocking, alkyd-based primer. Two coats of acrylic-latex finish should then be applied. Color and sheen should be determined based on historic paint/finish analysis (see "Historic Paint Analysis" section).
