Historic Structures Report

**APPOMATTOX DEPOT**

APPOMATTOX, VIRGINIA

JANUARY 8, 2019

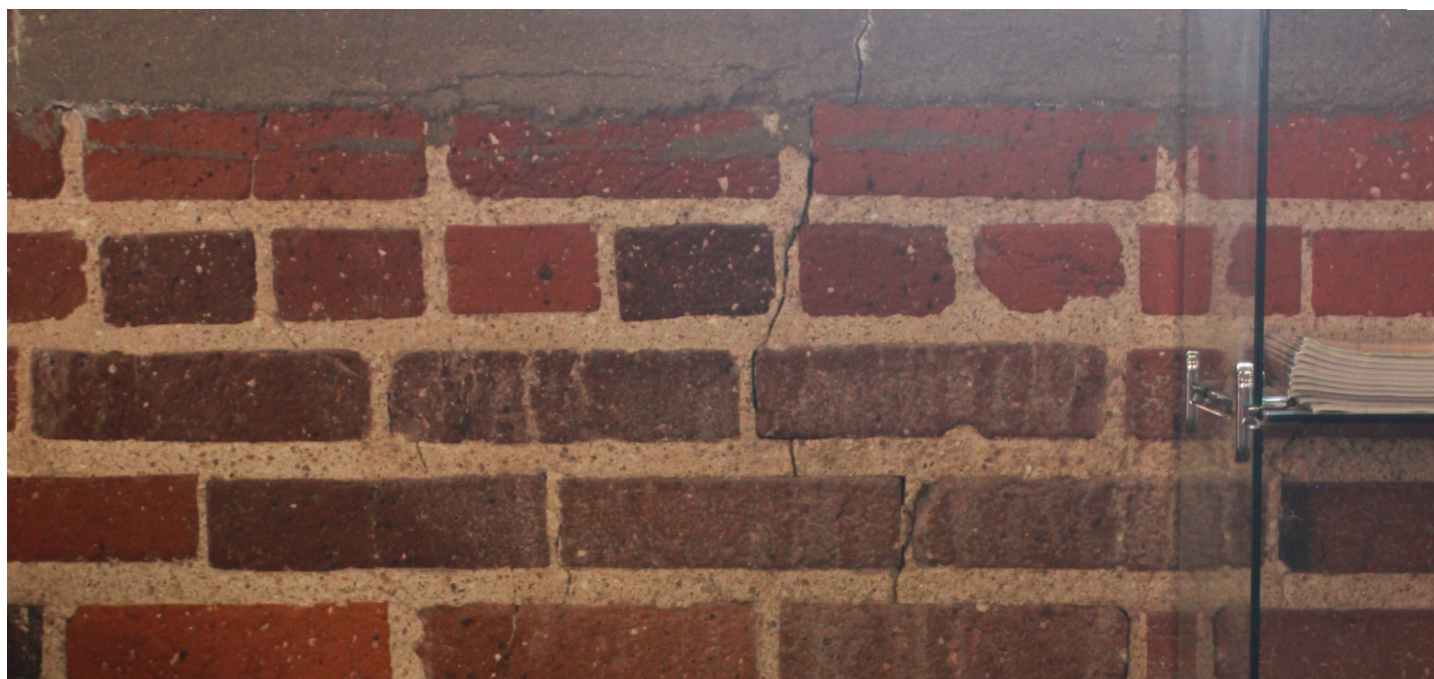
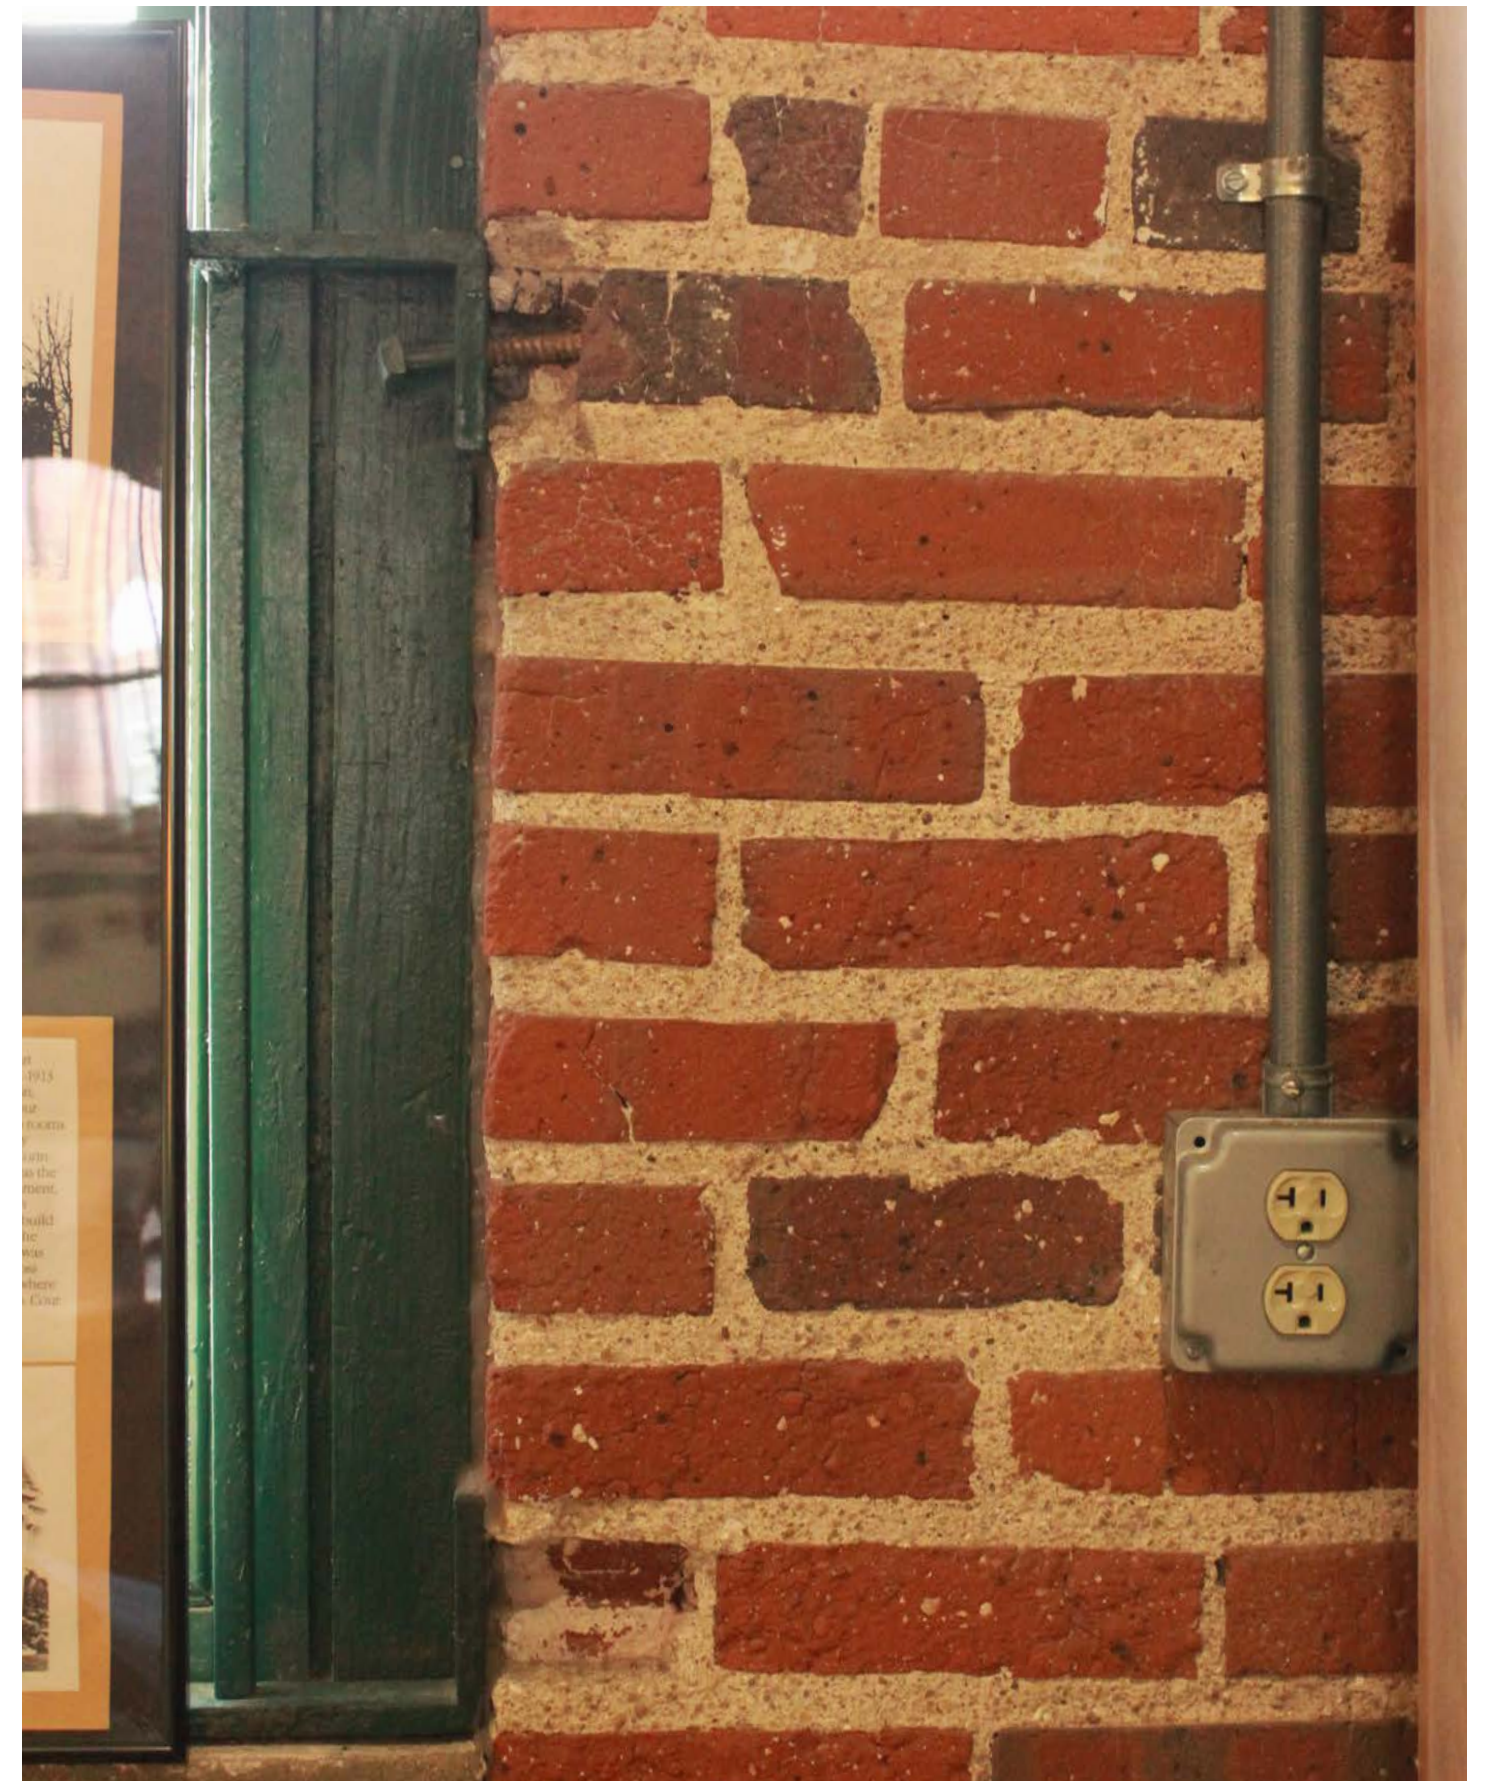
Walls within the Freight Room portion of the building consist of exposed brick. Walls exhibit minor mortar deterioration, cracking, and general wear. Damaged bricks are present at the location of interior window grill fasteners in multiple locations. Brick walls in the existing restrooms and conference room have been painted.

All mortar deterioration and cracking should be addressed as described in the applicable masonry treatment sections within this document. All repairs should be performed in an in-kind manner, ensuring that all mortar matches existing historic mortar in texture, color, profile, and composition as accurately as possible.

Window grill fasteners at damaged brick locations should be removed and retained for re-use. Damaged bricks should be replaced with compatible new bricks and repointed, as required. All repairs should be performed in an in-kind manner, ensuring that all mortar matches existing historic mortar in texture, color, profile, and composition as accurately as possible. Window grill fasteners should be re-installed, ensuring that drilling into brick and/or mortar does not cause any damage to bricks.

All paint should be removed from brick and mortar surfaces in restrooms and conference room using Back-to-Nature Double-Duty VII (or equivalent). **As the bricks and mortar are porous, it should be expected that some paint will remain. Under no circumstances should sand blasting be employed, as irreparable damage to brick faces will occur.**

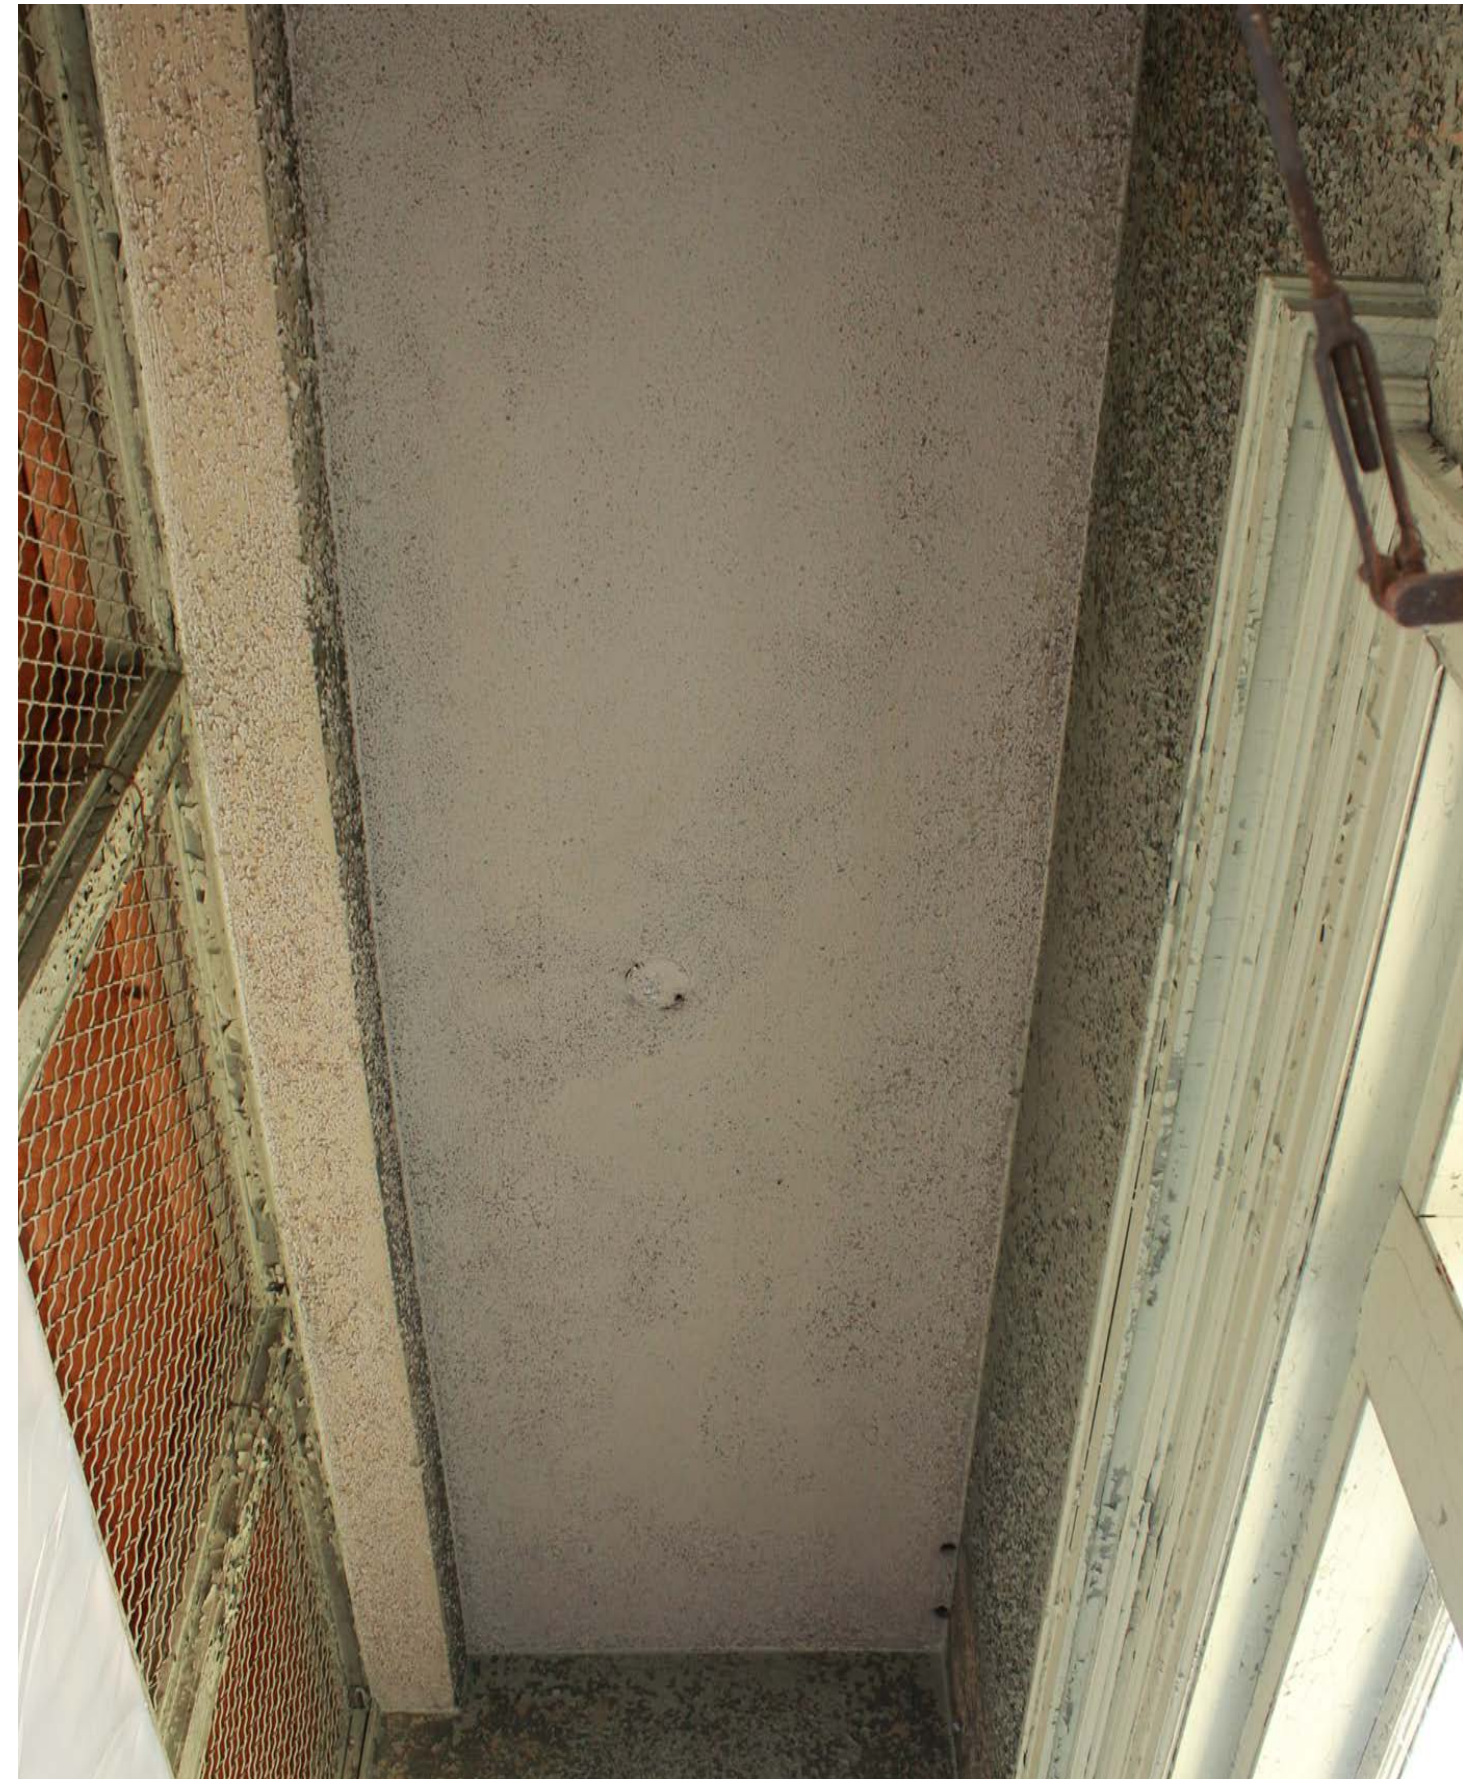
Original plaster ceilings are in place in all rooms within the passenger portion of the building. Plaster exhibits cracking and failed paint. Inappropriate prior repairs are evident which do not match adjacent historic plaster in plane or texture. Isolated areas of water damage are present.

All deteriorated/damaged plaster should be repaired in-kind. Loose and deteriorated material should be gently removed using hand tools only. Removal should be done only to the extent that a sound substrate is achieved. Patching should occur using in-kind materials, taking great care to match existing adjacent surfaces in plane, texture, and profile as accurately as possible. All water-damaged plaster should be repaired in-kind. Loose and deteriorated material should be gently removed using hand tools only. Removal should be done only to the extent that a sound substrate is achieved. Patching should occur using in-kind materials, taking great care to match existing adjacent surfaces in plane, texture, and profile as accurately as possible.

General cracking should be repaired to restore stability. Areas of cracking should be sounded to determine if plaster keys are broken (loss of adhesion to substrate). In such instances a case-by-case determination should be made as to the extent of plaster removal. Only the minimum amount of plaster should be removed in an effort to preserve as much original material as possible. Where plaster is removed, new in-kind plaster should be installed. New plaster should occur using in-kind materials, taking great care to match existing adjacent surfaces in plane, texture, and profile as accurately as possible.

Where plaster is still well adhered to the substrate, cracks should be repaired. Cracks should be excavated to achieve sound substrate. Cracks should then be injected with an acrylic adhesive to ensure soundness. Plaster should then be installed to infill the excavated areas using a bonding agent. Surface of repaired cracks should match existing adjacent surfaces in plane, texture, and profile as accurately as possible.

Once all plaster repairs have been made, surfaces should be prepared to a paint-ready surface by hand scraping loose paint and feathering paint remnant edges. All ceiling surfaces should then be primed with a stain blocking, alkyd-based primer. Two coats of acrylic-latex finish should then be applied. Color and sheen should be determined based on historic paint/finish analysis (see "Historic Finish Analysis" section).

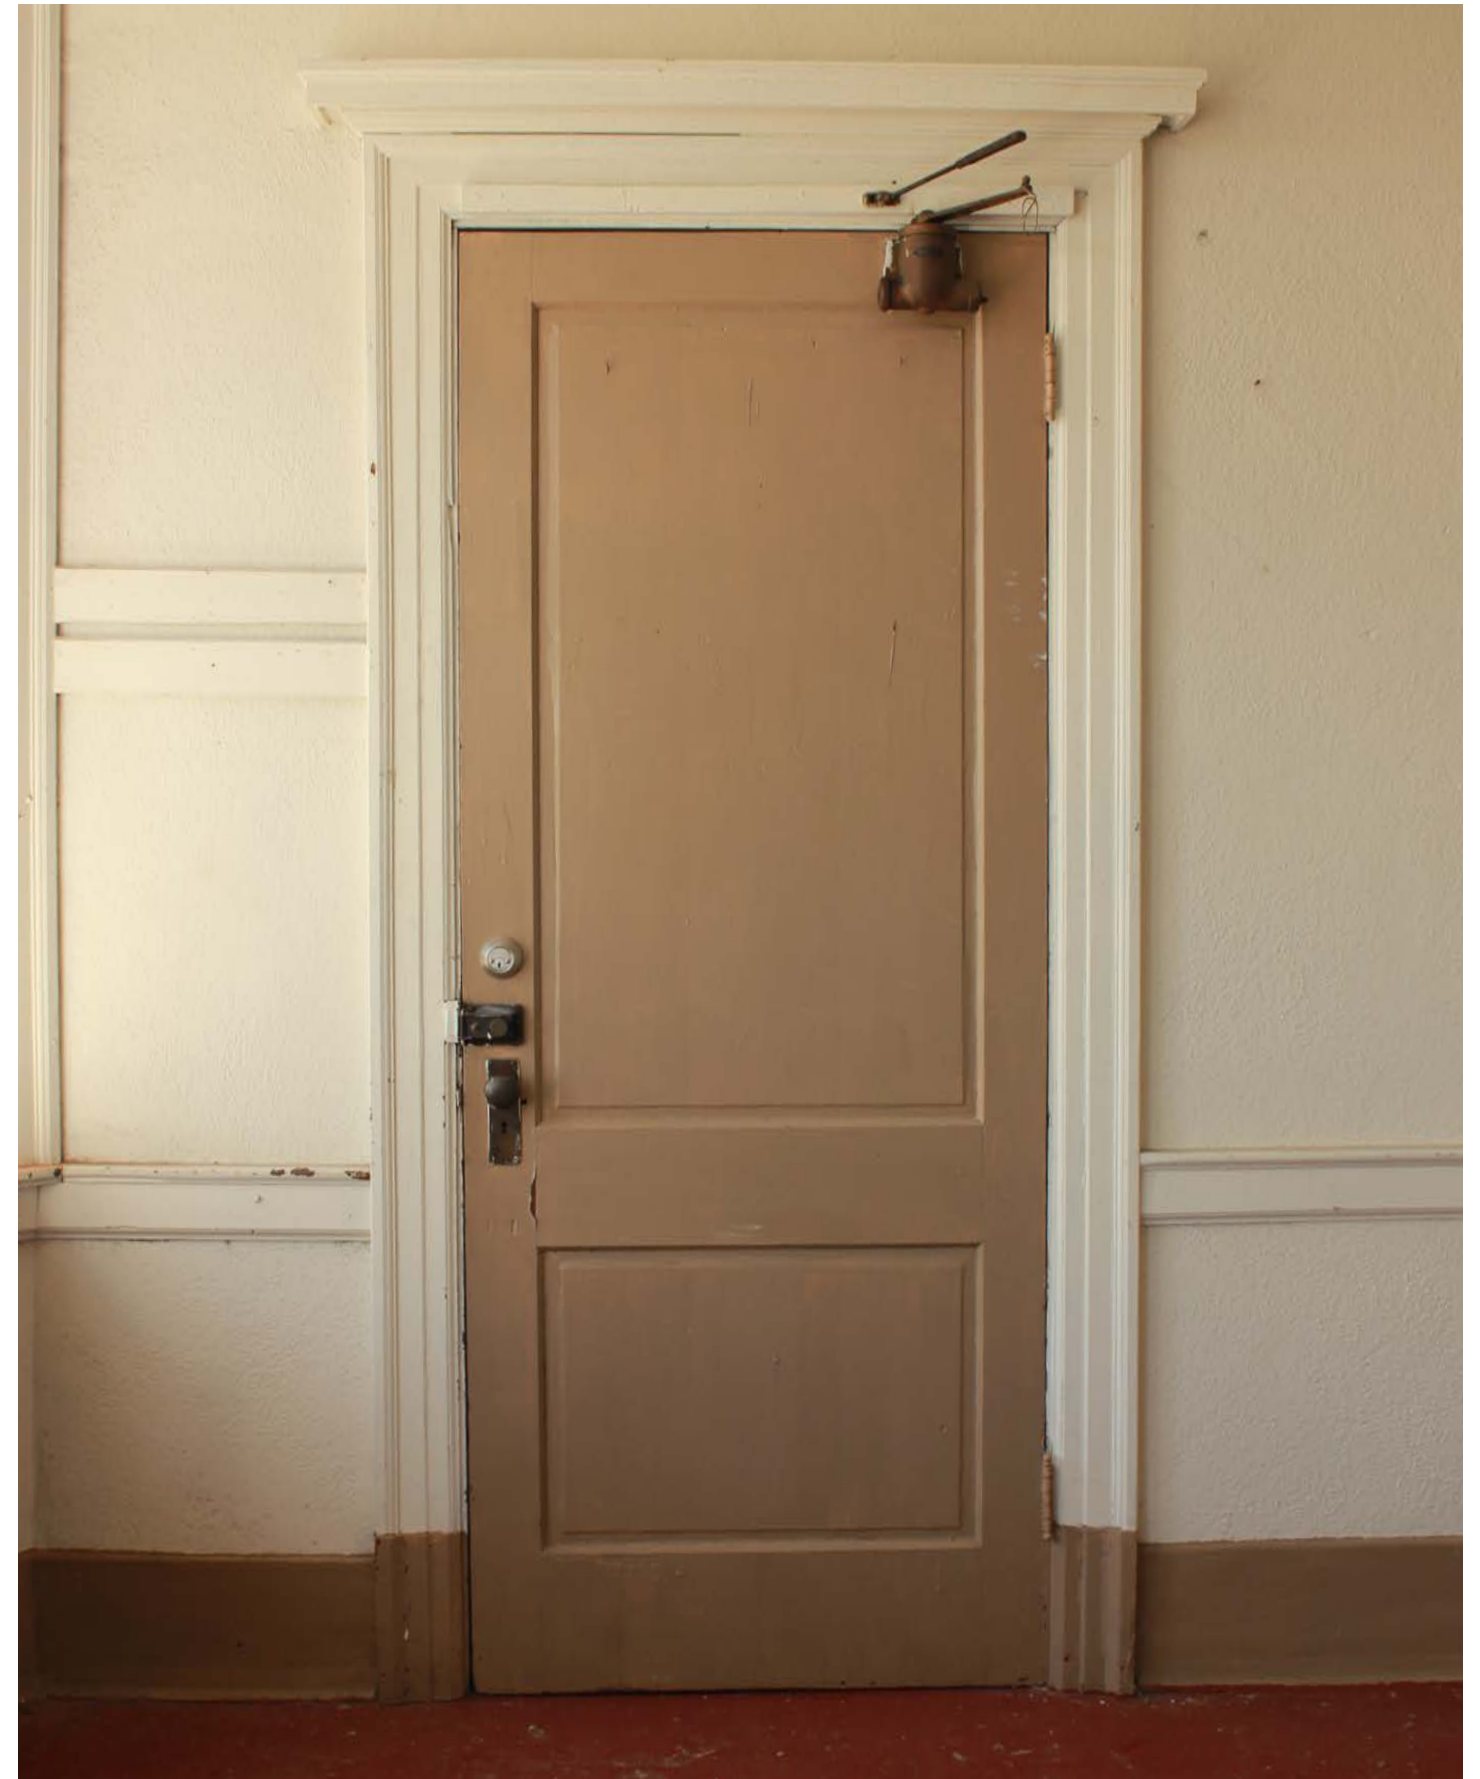
Original millwork including door casings, plinth blocks, window casings, baseboards, chair rails, soffit, crown molding, etc. are intact in the Passenger portion of the building. Overall, millwork elements are in good condition, exhibiting only paint failure and general wear. Breaks in chair elements in restroom areas identify the location of original stall partitions. Poorly infilled window casings in restrooms identify the location of early toilet tanks. Paint failure (crazing) is indicative of a poor bond between the paint and the substrate, and perhaps later paint coatings over early/original varnish or other clear finishes. Minor damage and/or missing elements is present in isolated locations.

Missing or poorly infilled millwork in restrooms will be alleviated when the restrooms are restored as further described in the “Restroom” section within this document. In general, any required repairs to existing millwork should be performed using in-kind materials, matching profiles of existing elements as accurately as possible. Re-finishing of millwork should not commence until historic paint/finish analysis is performed as further described in the “Historic Finish Analysis” section within this document. As original millwork finish may have been clear varnish or shellac, any repairs to millwork should be performed using in-kind species of wood, matching grain pattern as accurately as possible. Once original paint/finish has been determined, millwork will require throughout preparation to alleviate crazing prior to the application of any new finish. Millwork should be stripped to remove existing, failed paint finishes using Back to Nature Double-Duty VII (or equivalent). **Prior to paint removal, historic finish analysis should be performed as described in “Historic Finish Analysis” section above. Furthermore, as paint is removed, careful attention should be given to identifying original finish. Small samples of original finish should remain in place, without subsequent refinishing.** All stripped surfaces should be cleaned with denatured alcohol to remove residue. Millwork should then be finished per historic finish analysis findings.

Any new millwork required as a result of rehabilitation programming should be sympathetic to the historic characteristics of the building. New millwork should be wood and should possess similar detailing and scale as historic millwork but should not be a precise match.

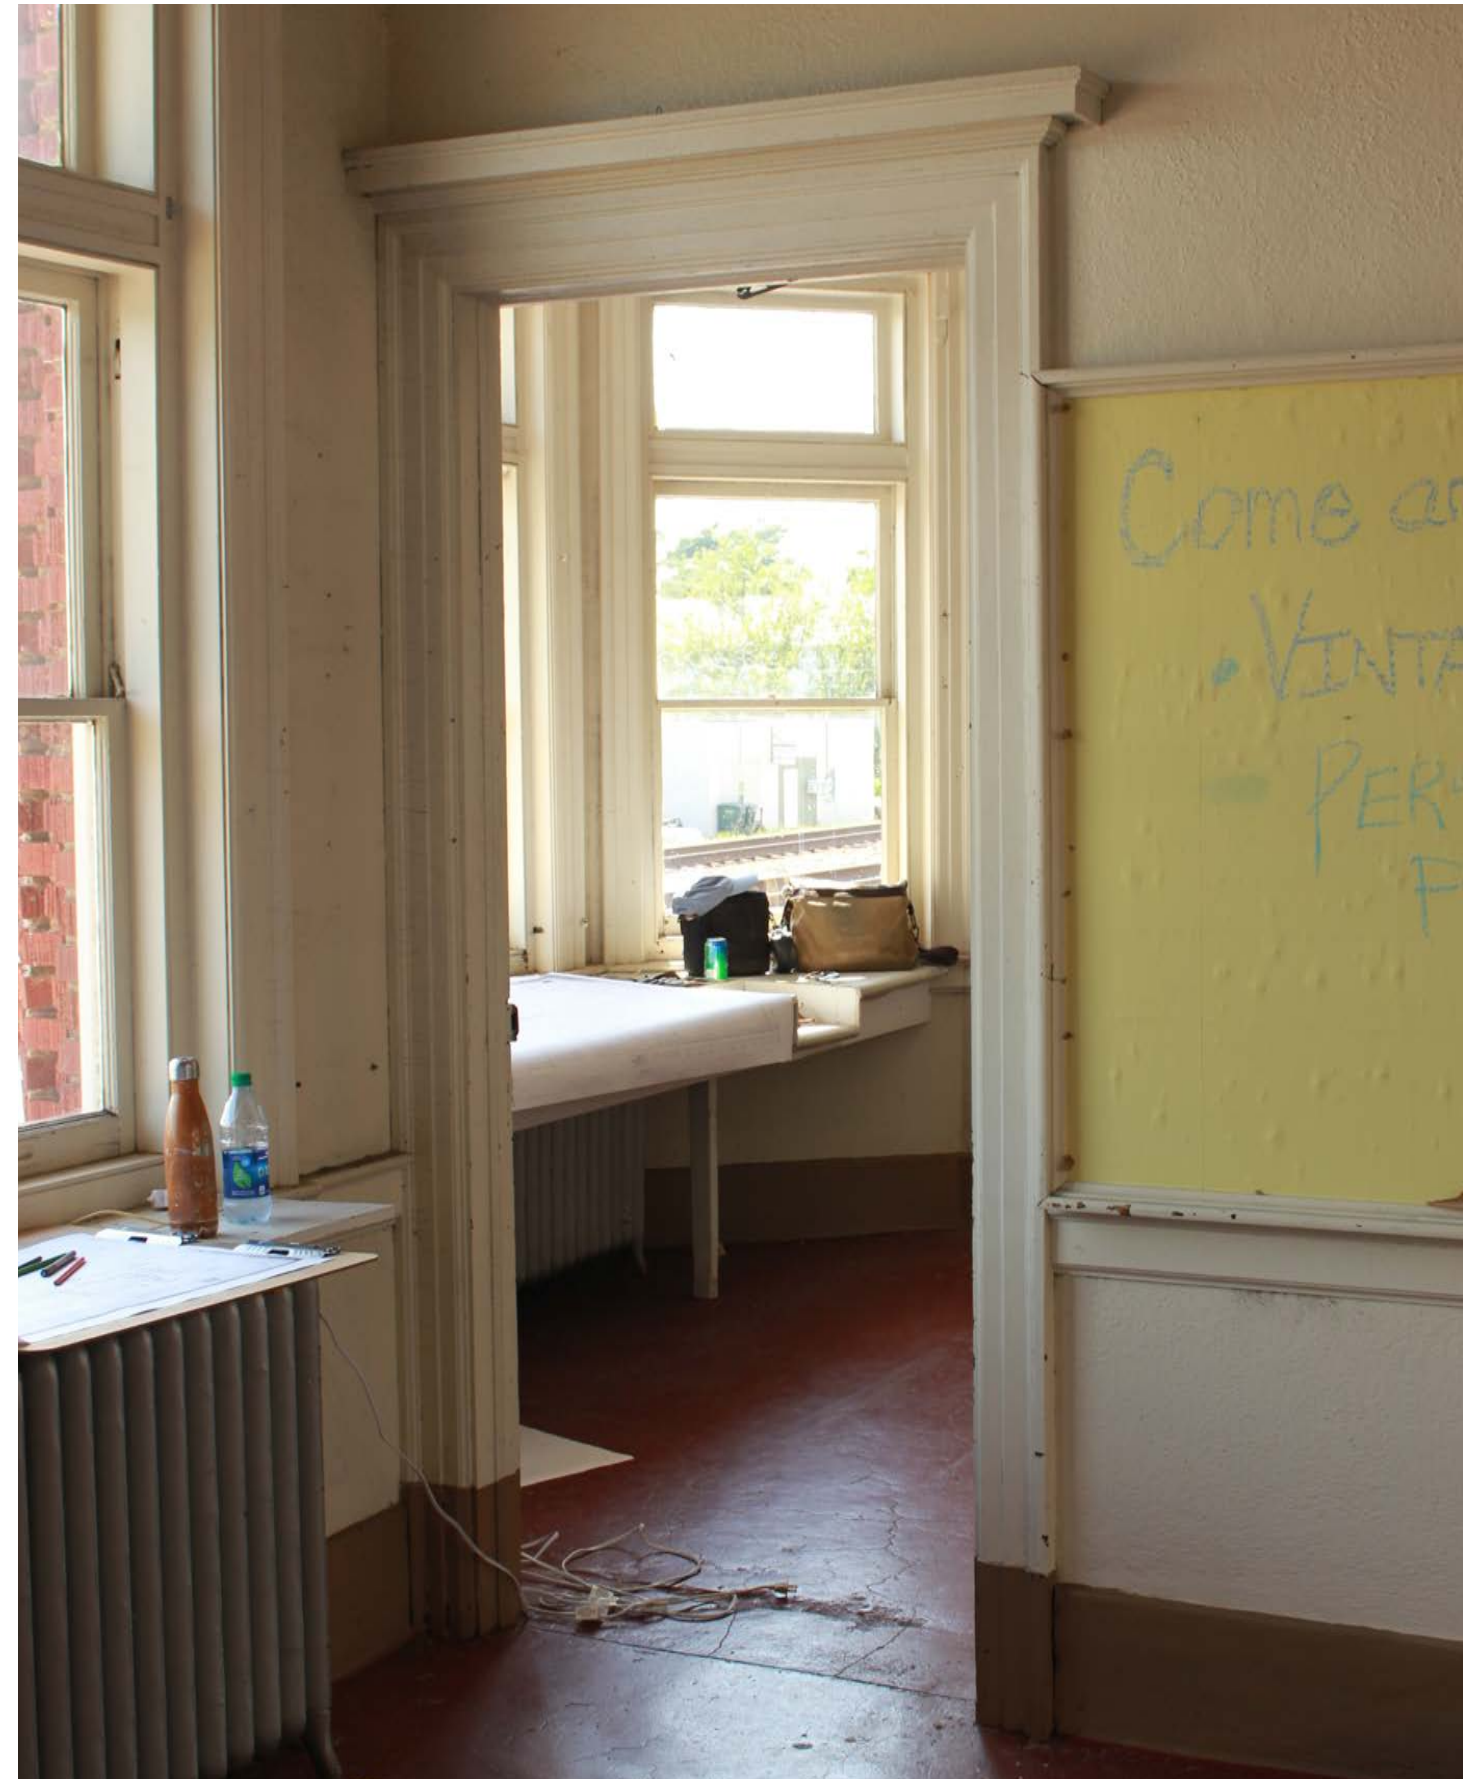
The passenger portion of the building possess most of its original interior, two-panel wood doors. Doors are in good condition overall, exhibiting only moderate wear and isolated deterioration warranting repair. Paint finishes are worn, and all doors are poised for refinishing. While original door hardware is in place on most historic doors, hardware elements require cleaning. Original door closers are present but are not functioning. Doors the Women's Toilet (White) and Ticket Office (from the White Waiting Room) are missing.

Re-finishing of doors should not commence until historic paint/finish analysis is performed as further described in the "Historic Finish Analysis" section within this document. As original door finish may have been clear varnish or shellac, any repairs to doors should be performed using in-kind species of wood, matching grain pattern as accurately as possible. Once original paint/finish has been determined, doors will require throughout preparation to alleviate crazing prior to the application of any new finish. Doors should be stripped to remove existing, failed paint finishes using Back to Nature Double-Duty VII (or equivalent). **Prior to paint removal, historic finish analysis should be performed as described in "Historic Finish Analysis" section above. Furthermore, as paint is removed, careful attention should be given to identifying original finish. Small samples of original finish should remain in place, without subsequent refinishing.** All stripped surfaces should be cleaned with denatured alcohol to remove residue. Doors should then be finished per historic finish analysis findings.

New Women's Toilet (White) and Ticket Office (from the White Waiting Room) doors should be installed, matching existing doors in design, detailing, and finish. New hardware should likewise match exiting hardware as accurately as possible.

Clean all historic hardware (locksets, handles, and hinges), using great care to avoid scratching or otherwise marring the metal surfaces. Repair door closers to proper function, if possible. Any missing or irreparable hardware elements should be replaced in-kind where possible.

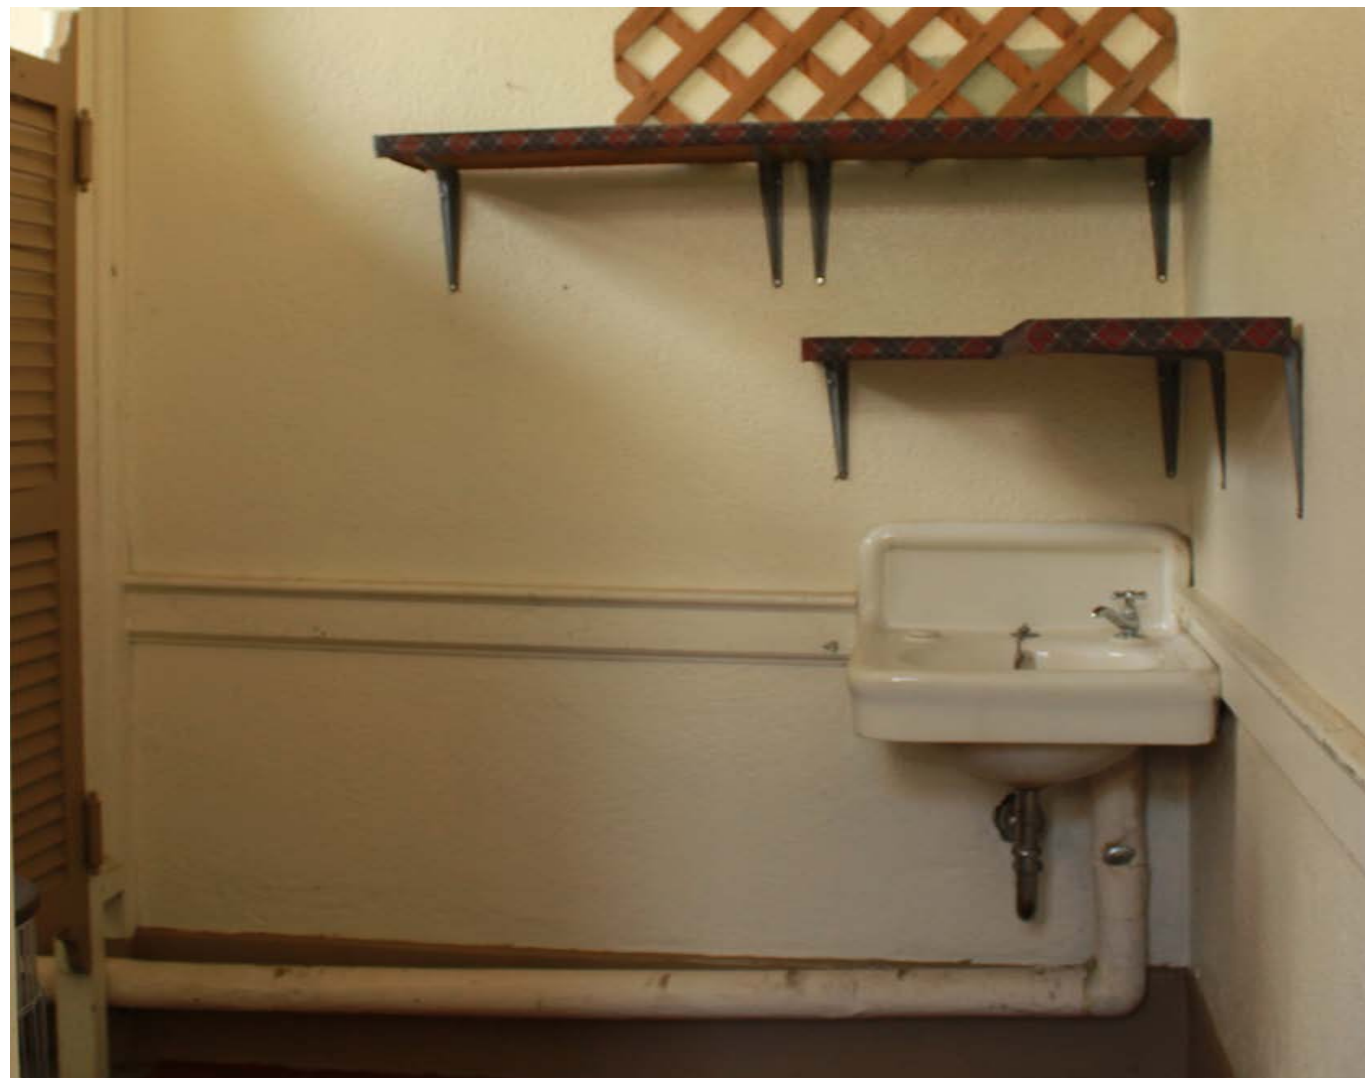
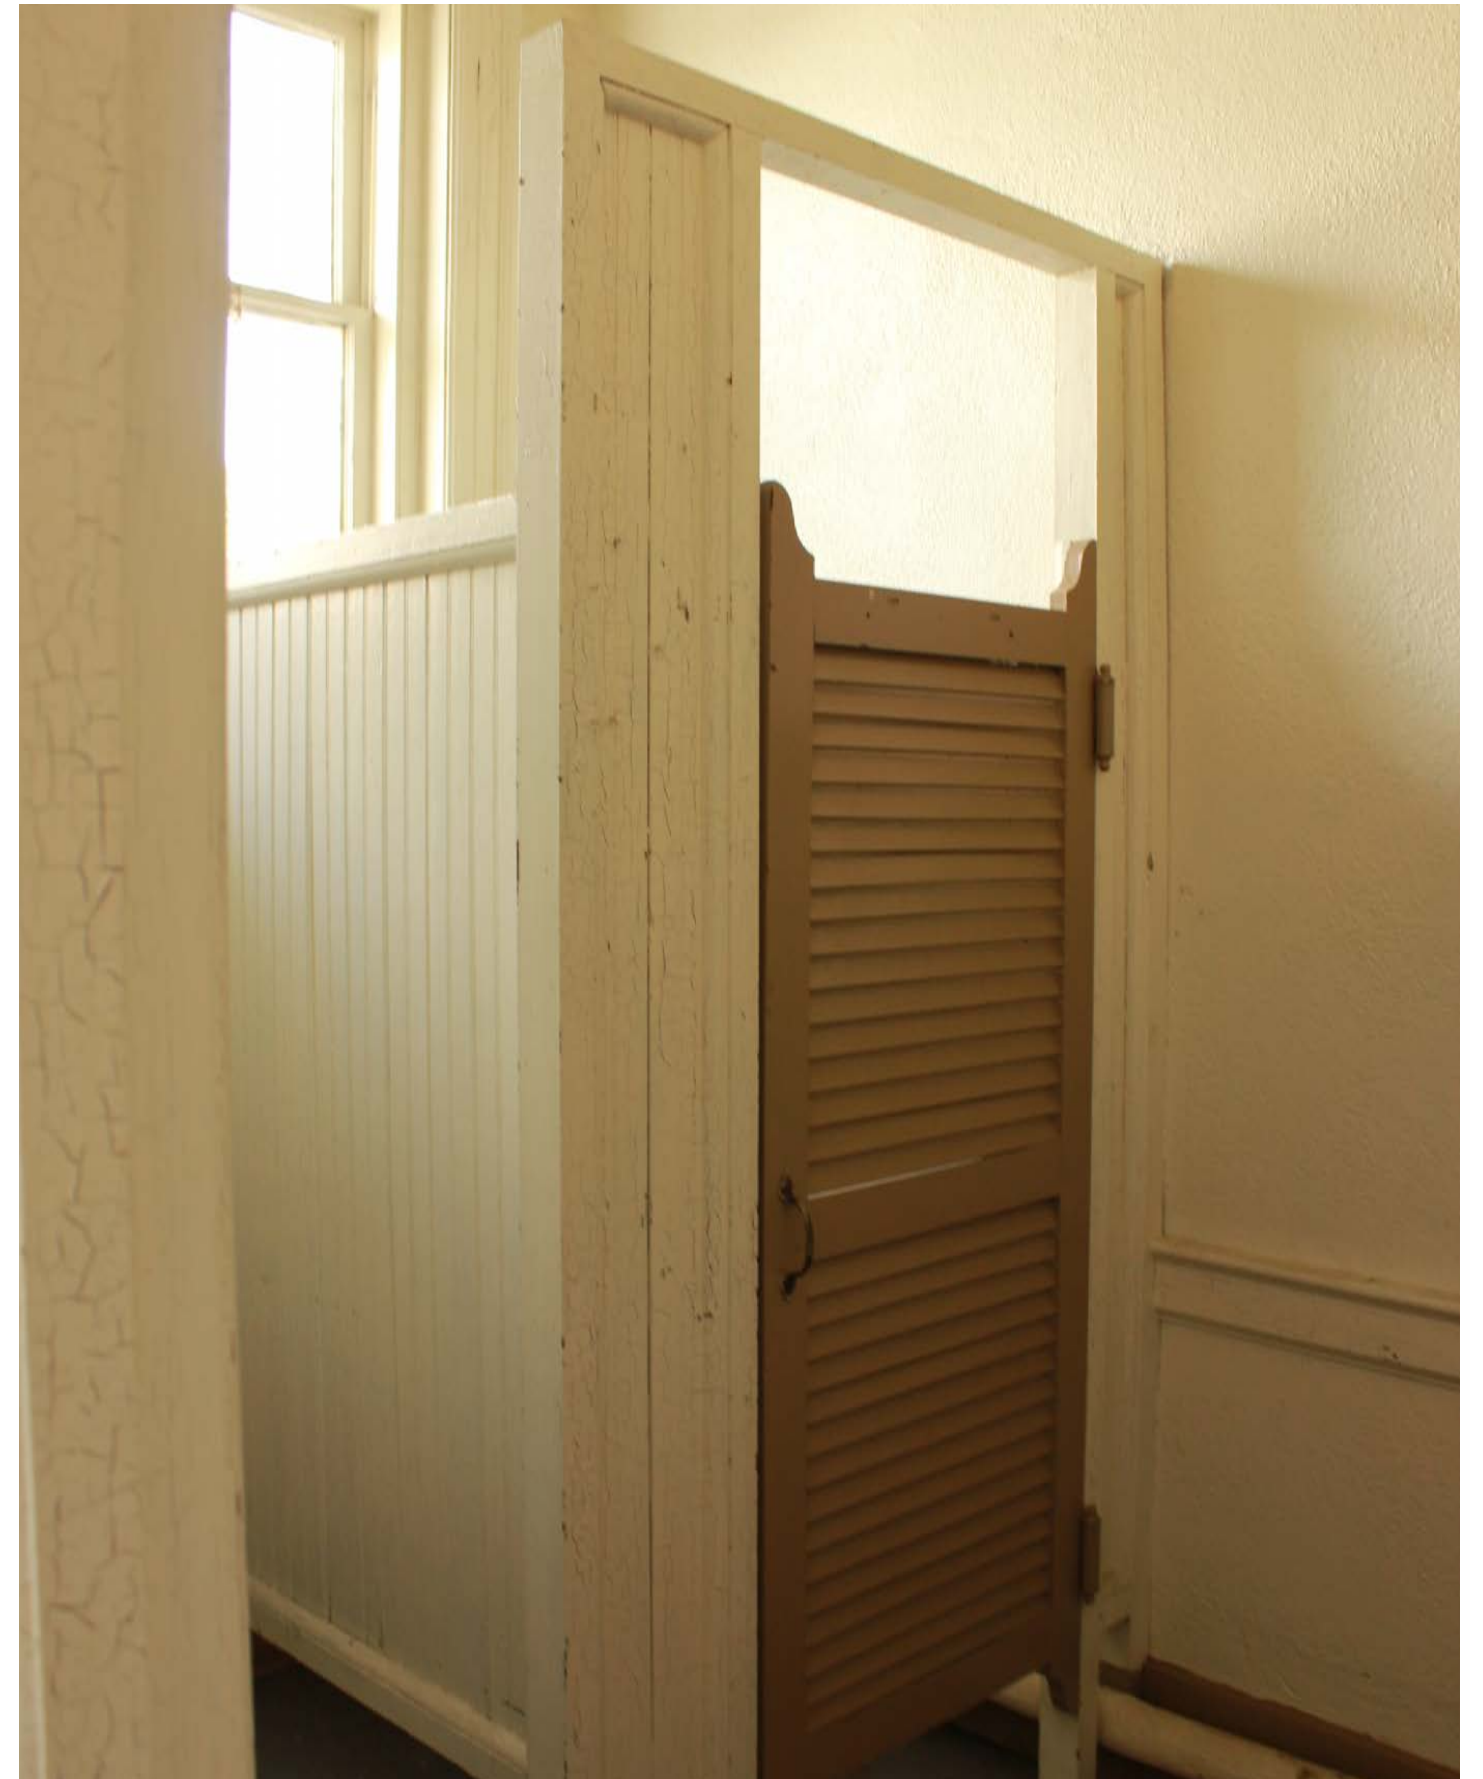
Four original restrooms are in place within the passenger portion of the building, and include men's and women's toilet rooms, with separate segregated spaces designated for "white" and "colored" patrons. Furthermore, there is a Women's Retiring Room (White) connected to the Women's Toilet (White). Much of the original detailing remains intact including stall partitions, stall doors, sinks, urinals, faucets, toilet paper holders, and a mop sink. The original benches in the Women's Retiring Room (White) are particularly notable for their intact condition, although they exhibit failed paint and general wear. All existing fixtures are in poor condition, requiring refinishing, with many fixtures altogether missing. Partitions, partition doors and hardware, where present, exhibit failed/crazed paint, missing louvers, general wear, etc.

All historic restrooms and their detailing should be restored to their original appearance using original 1923 architectural drawings for fixture locations and general dimensional references. Historic fixtures still in place should be repaired and re-enameled, where possible. Missing fixtures should be replaced with period-correct substitutes. New plumbing should be installed in a concealed manner where possible. Existing partition frames and doors should be repaired in-kind where possible to include louver repairs, hardware repairs, and refinishing according to the results of the historic finish analysis (see "Historic Finish Analysis" section). Missing partitions should be reconstructed to match existing as accurately as possible (including design, materials, profiles, hardware, finishes, etc.). Existing, historic toilet paper holder should be repaired and polished/re-chromed and used as a design basis for replacing missing accessories. Any additional required accessories, fixtures, or features should be historically sympathetic.
