Historic Structures Report

**APPOMATTOX DEPOT**

APPOMATTOX, VIRGINIA

JANUARY 8, 2019

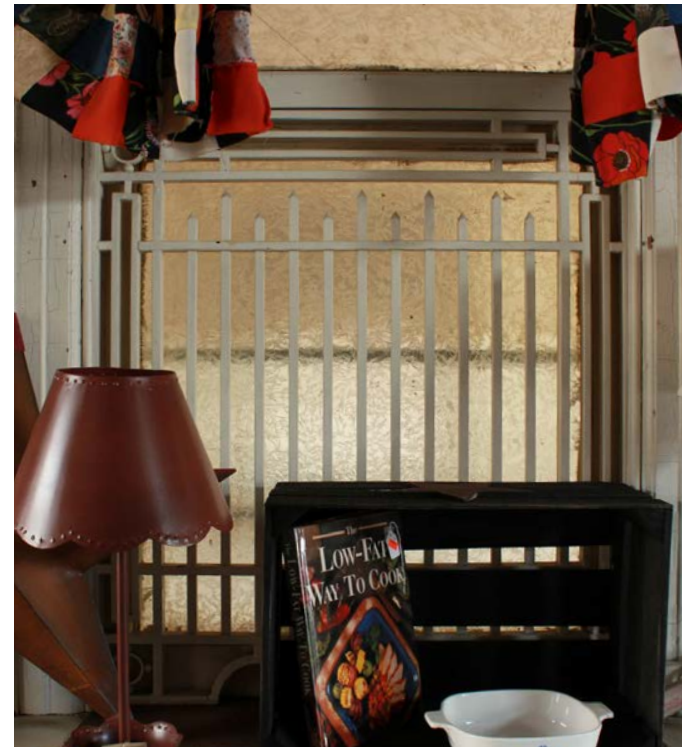
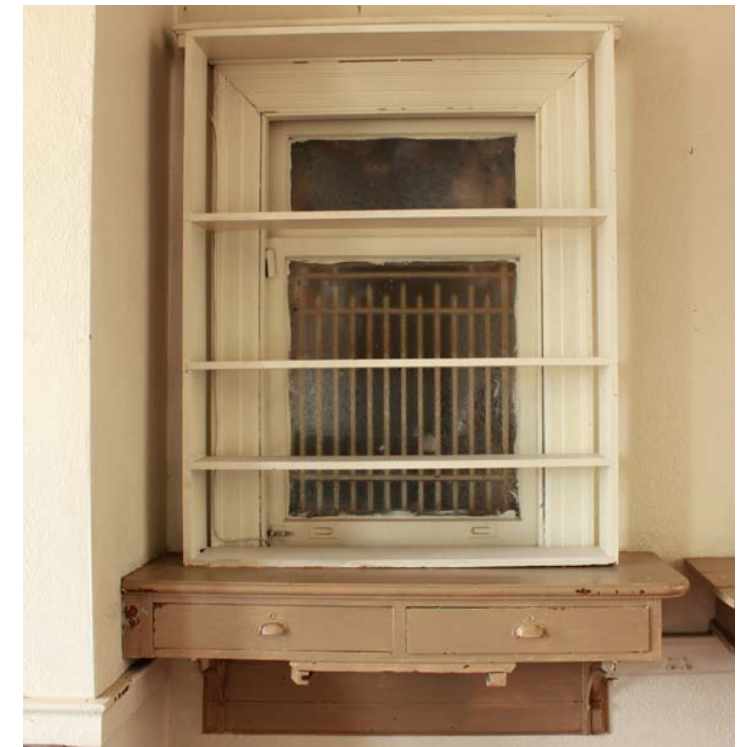
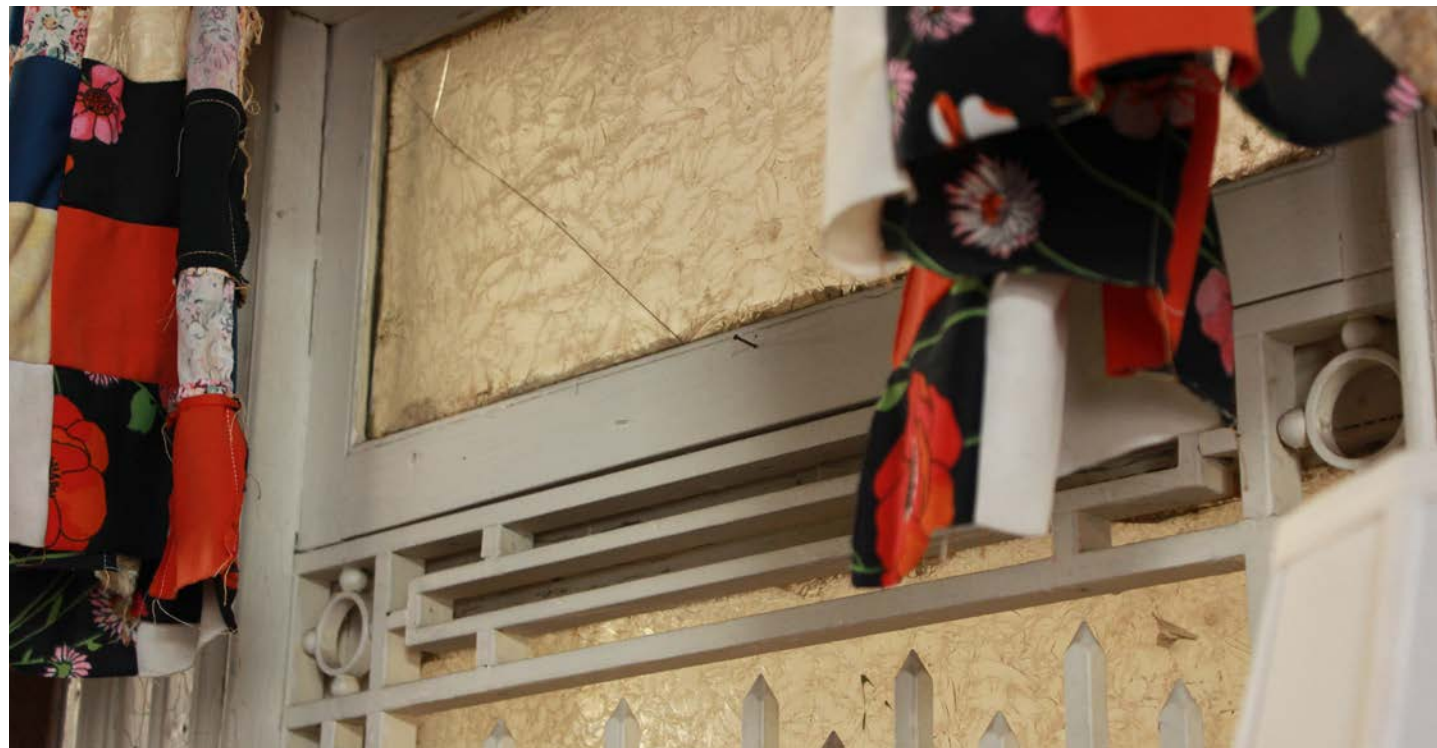
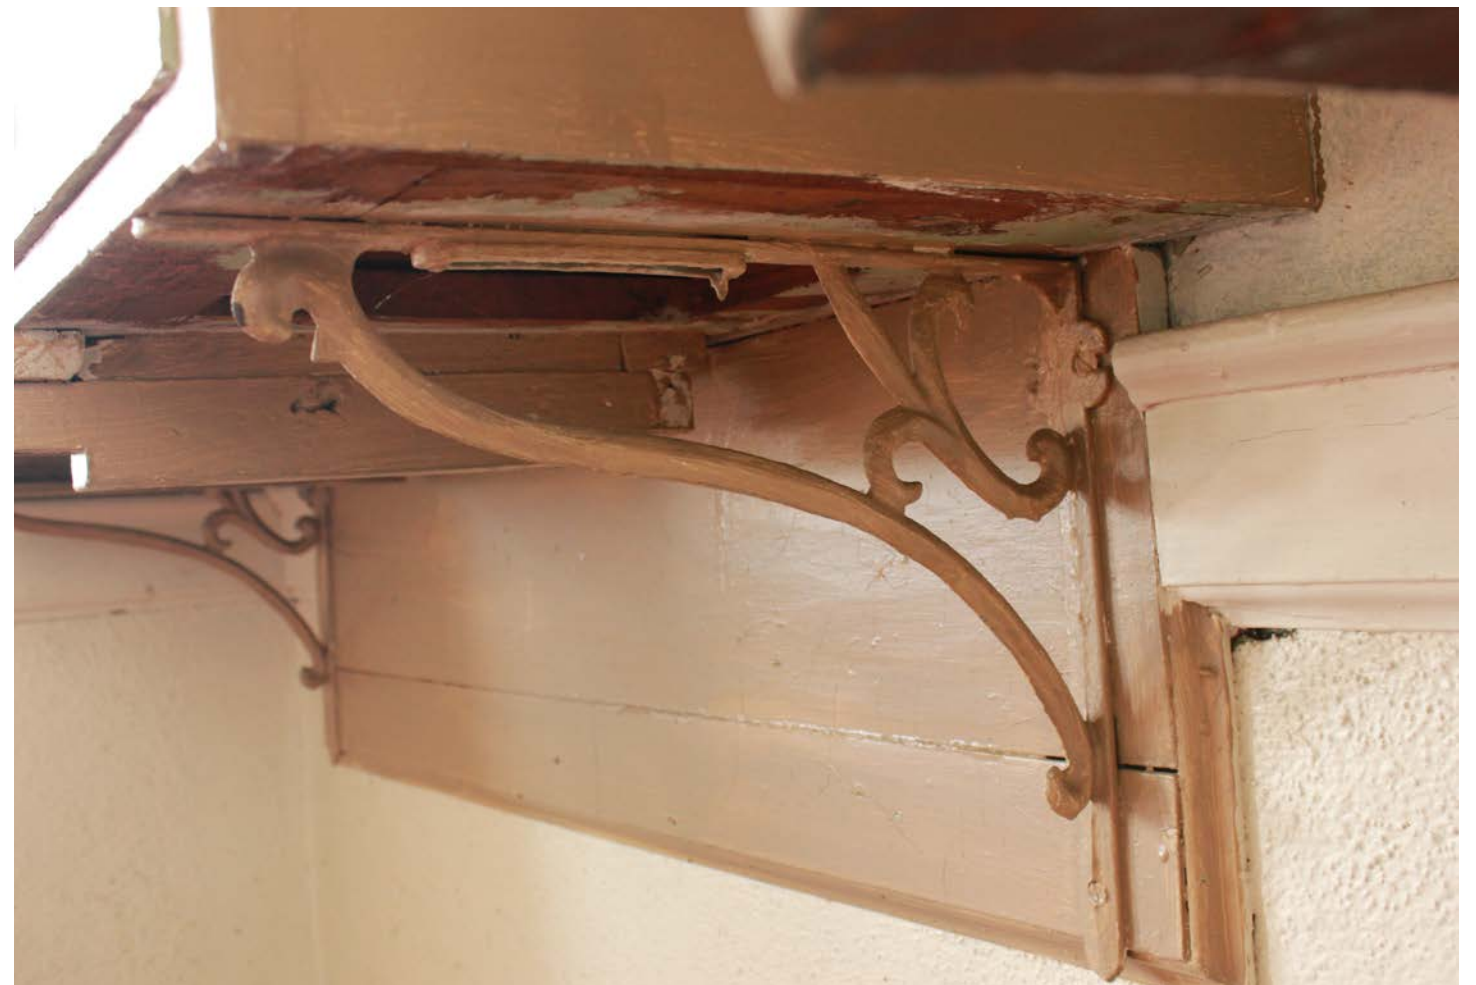
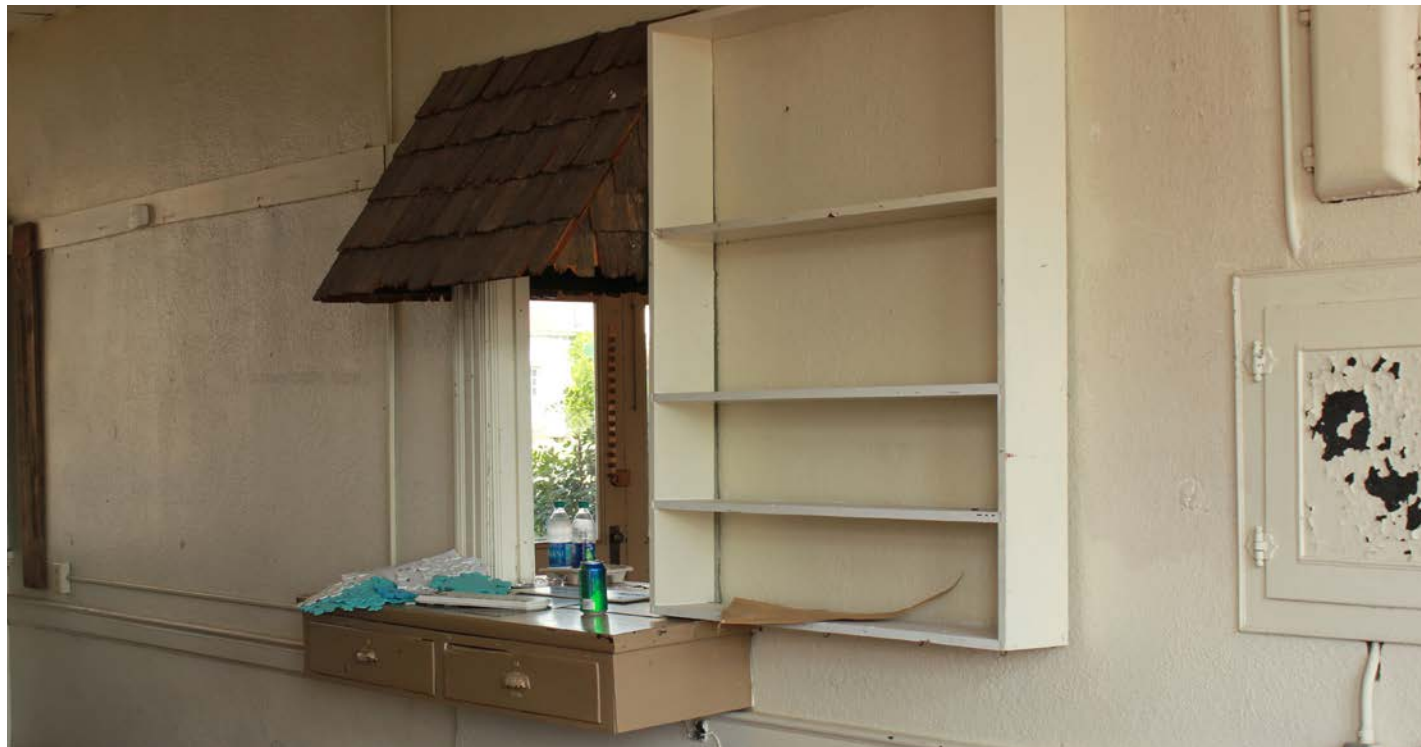
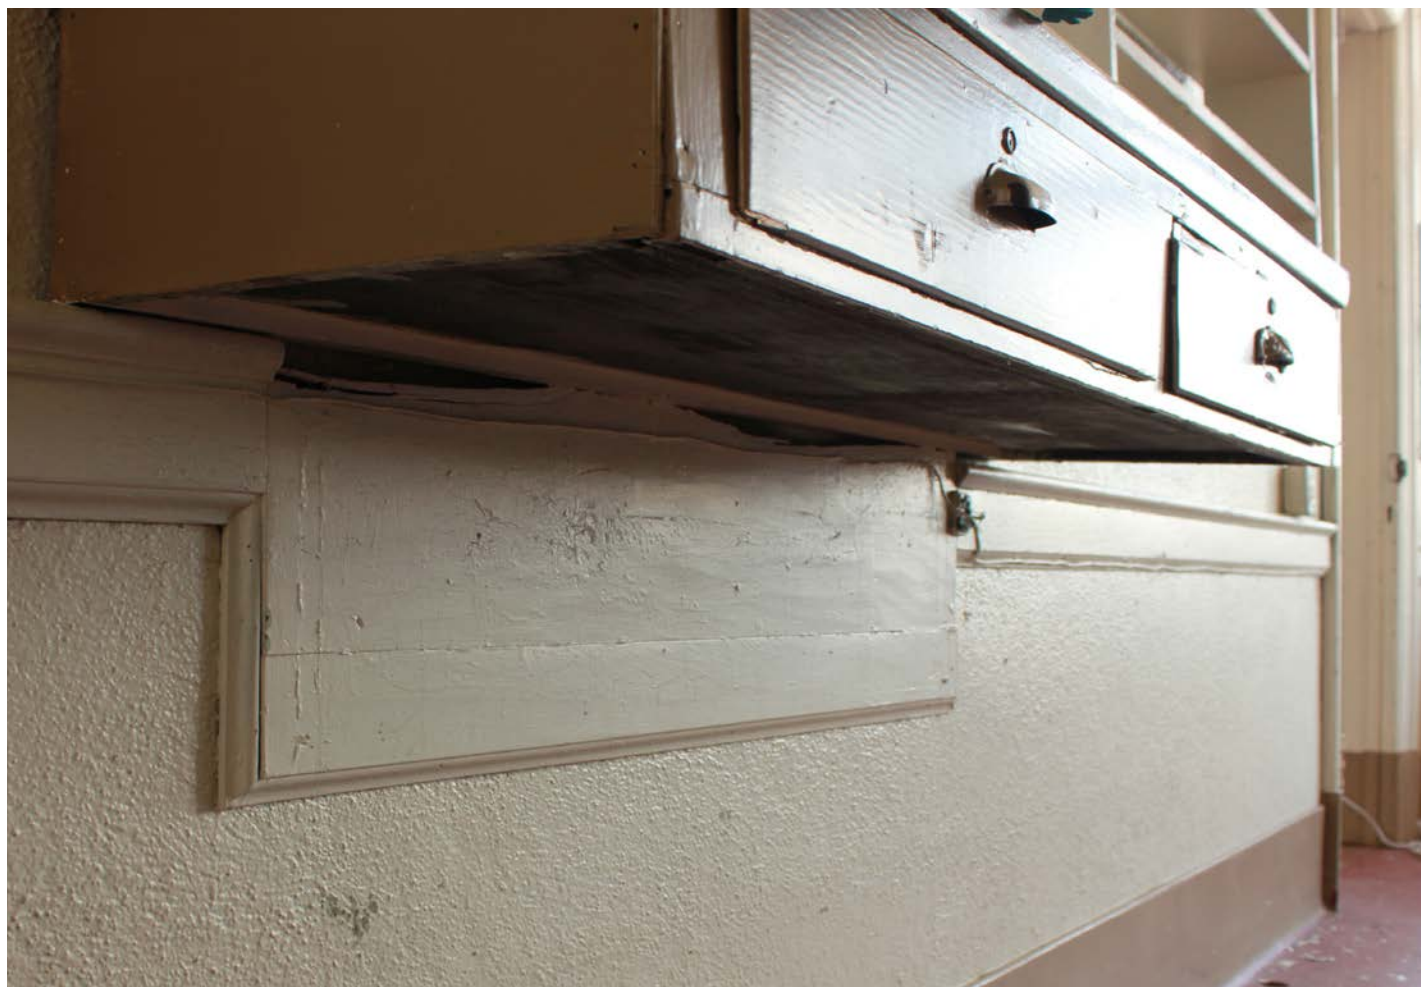
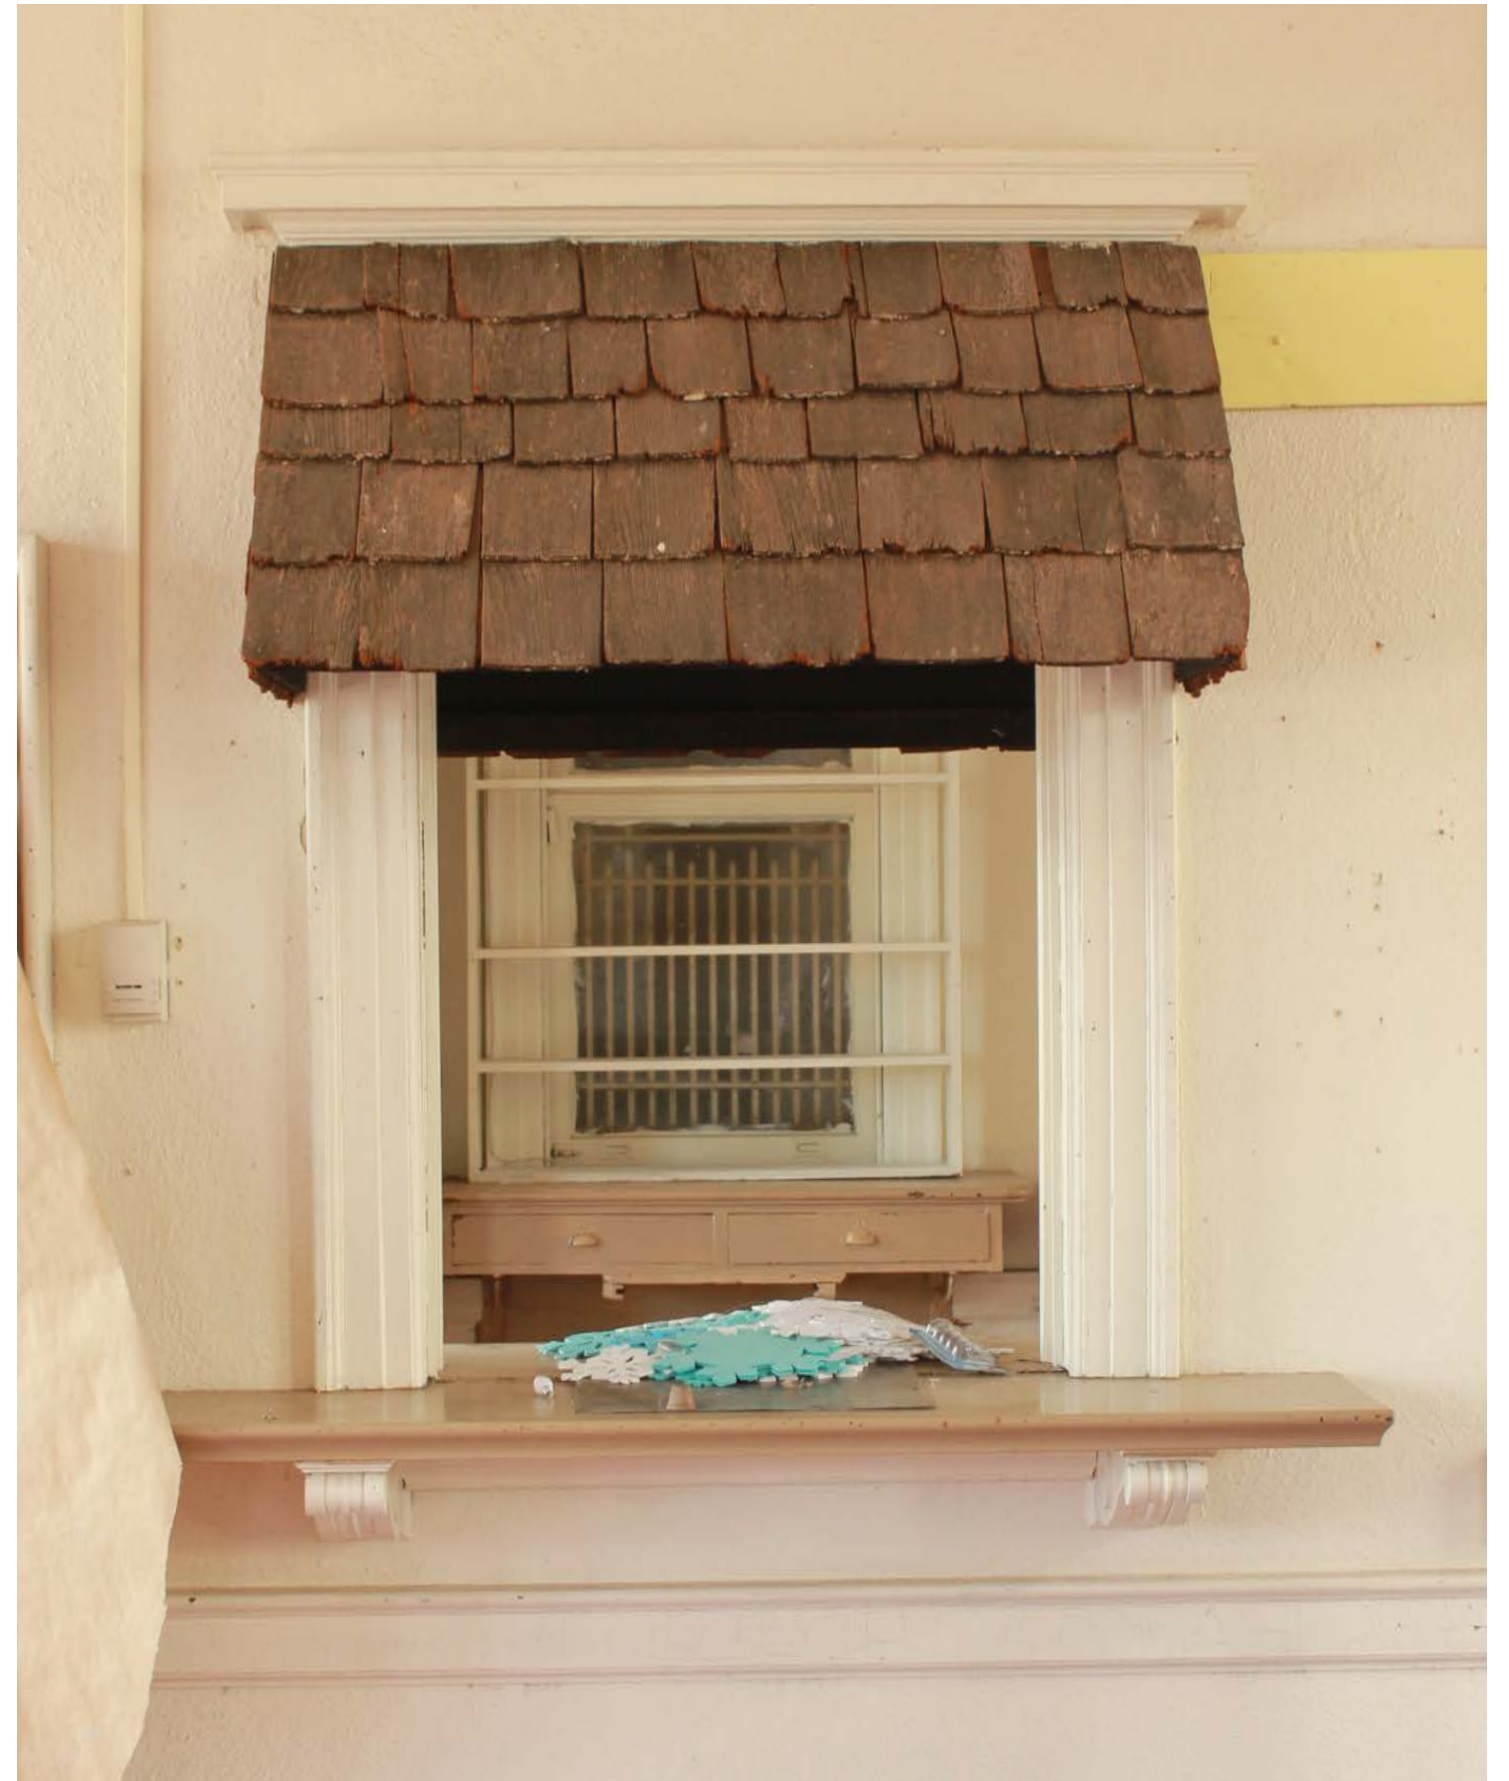
## Ticket Windows

The original ticket windows (“White” and “Colored”) are in place and in fair condition. The colored ticket window is nearly entirely intact including an operable sash with transom, decorative cast iron window grill, built-in desk/drawers with decorative cast iron brackets, and counter with decorative wooden brackets. Its transom possesses cracked glass. The white ticket window is missing its decorative cast iron window grill, decorative cast iron desk/drawer brackets, and sash with transom. Existing features are in fair condition but exhibit general wear and failing paint.

Cracked glass found in the colored ticket window transom should be replaced, if possible, using sympathetic glass. The sash and transom should be repaired and refinished as described in the “Window & Transom” section of this documents. Elements missing from the white ticket window should be replicated to match those still intact in the colored ticket window, including the decorative cast iron window grill, decorative cast iron desk/drawer brackets, and sash with transom. All ticket booth window elements should be refinished. Wood and metal members should be stripped to remove existing, failed paint finishes using Back to Nature Double-Duty VII (or equivalent). **Prior to paint removal, historic finish analysis should be performed as described in “Historic Finish Analysis” section above. Furthermore, as paint is removed, careful attention should be given to identifying original finish. Small samples of original finish should remain in place, without subsequent refinishing.** All stripped surfaces should be cleaned with denatured alcohol to remove residue. Elements should then be finished per historic finish analysis findings.

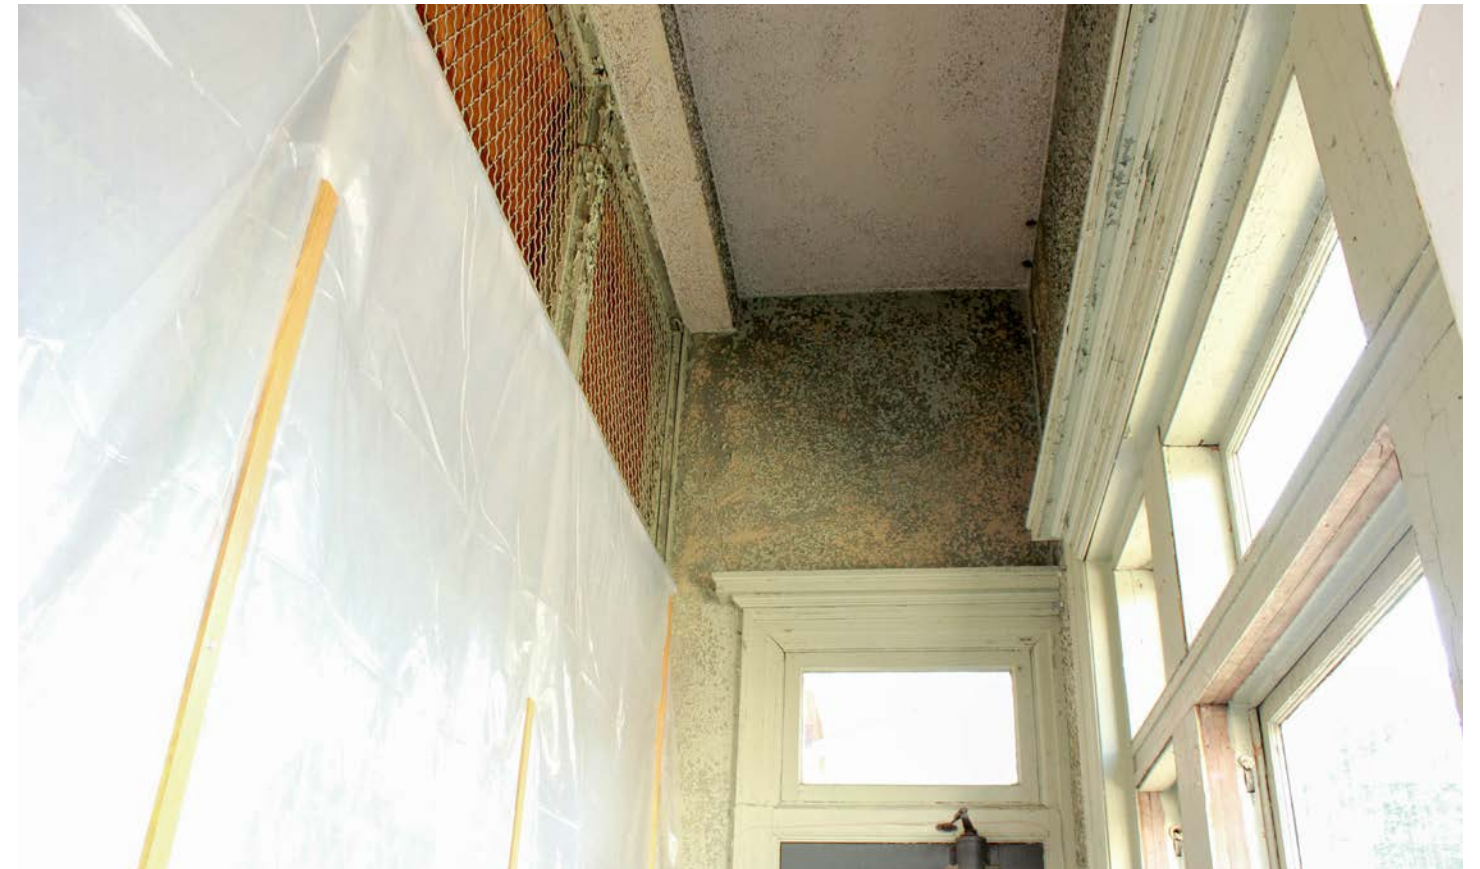
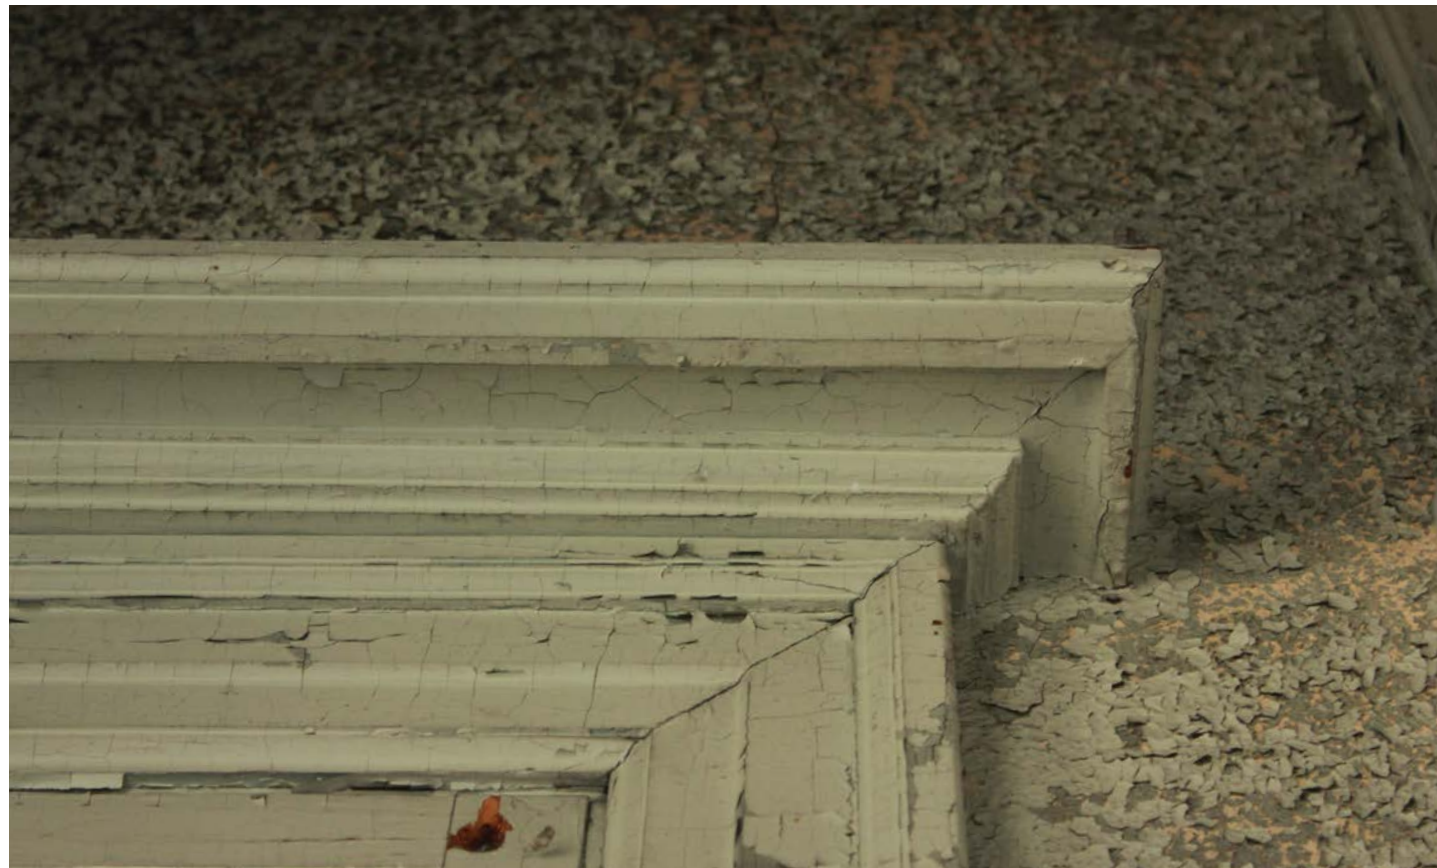
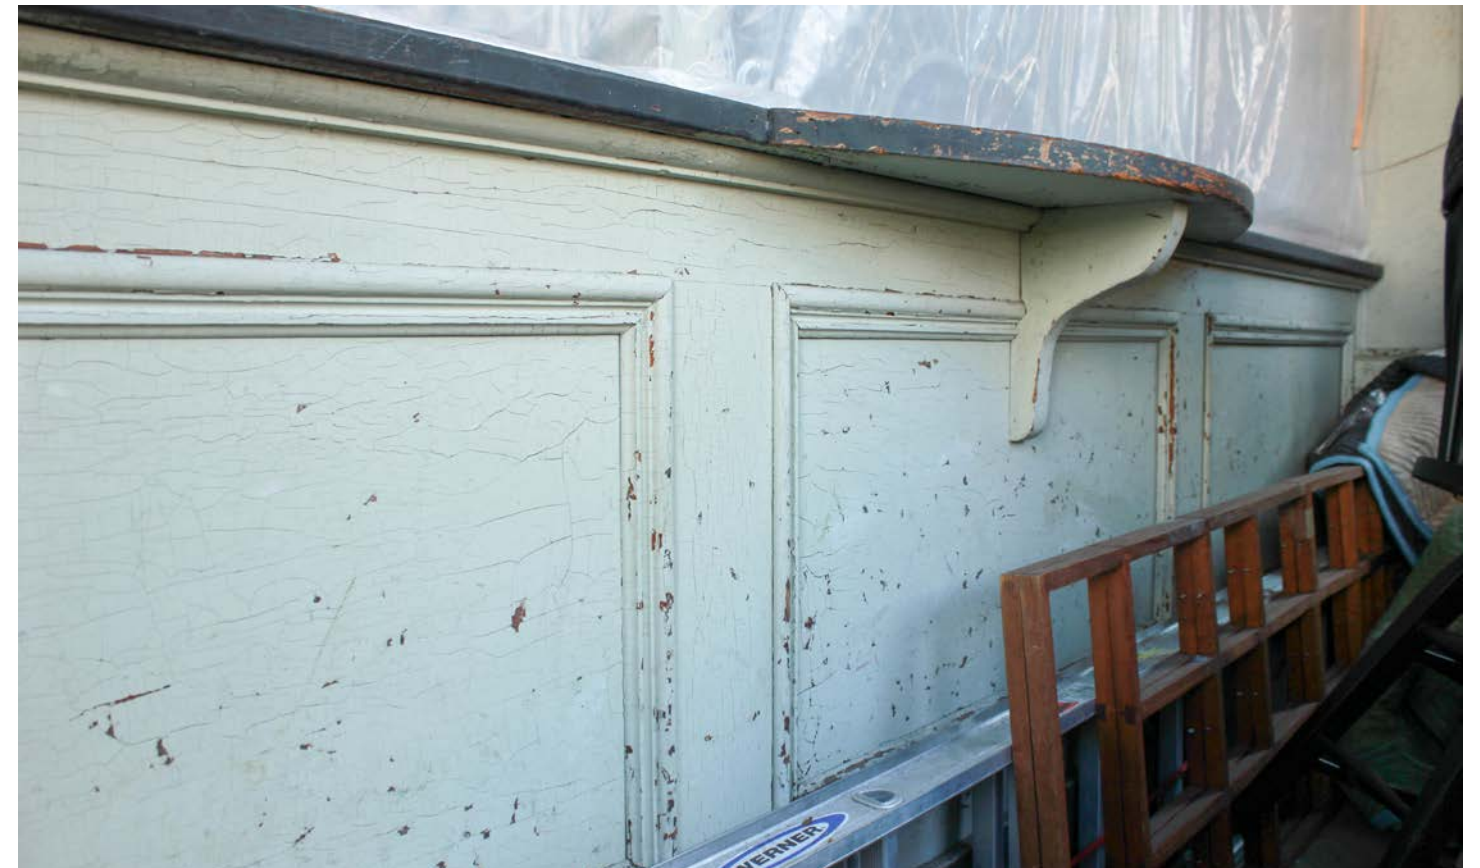
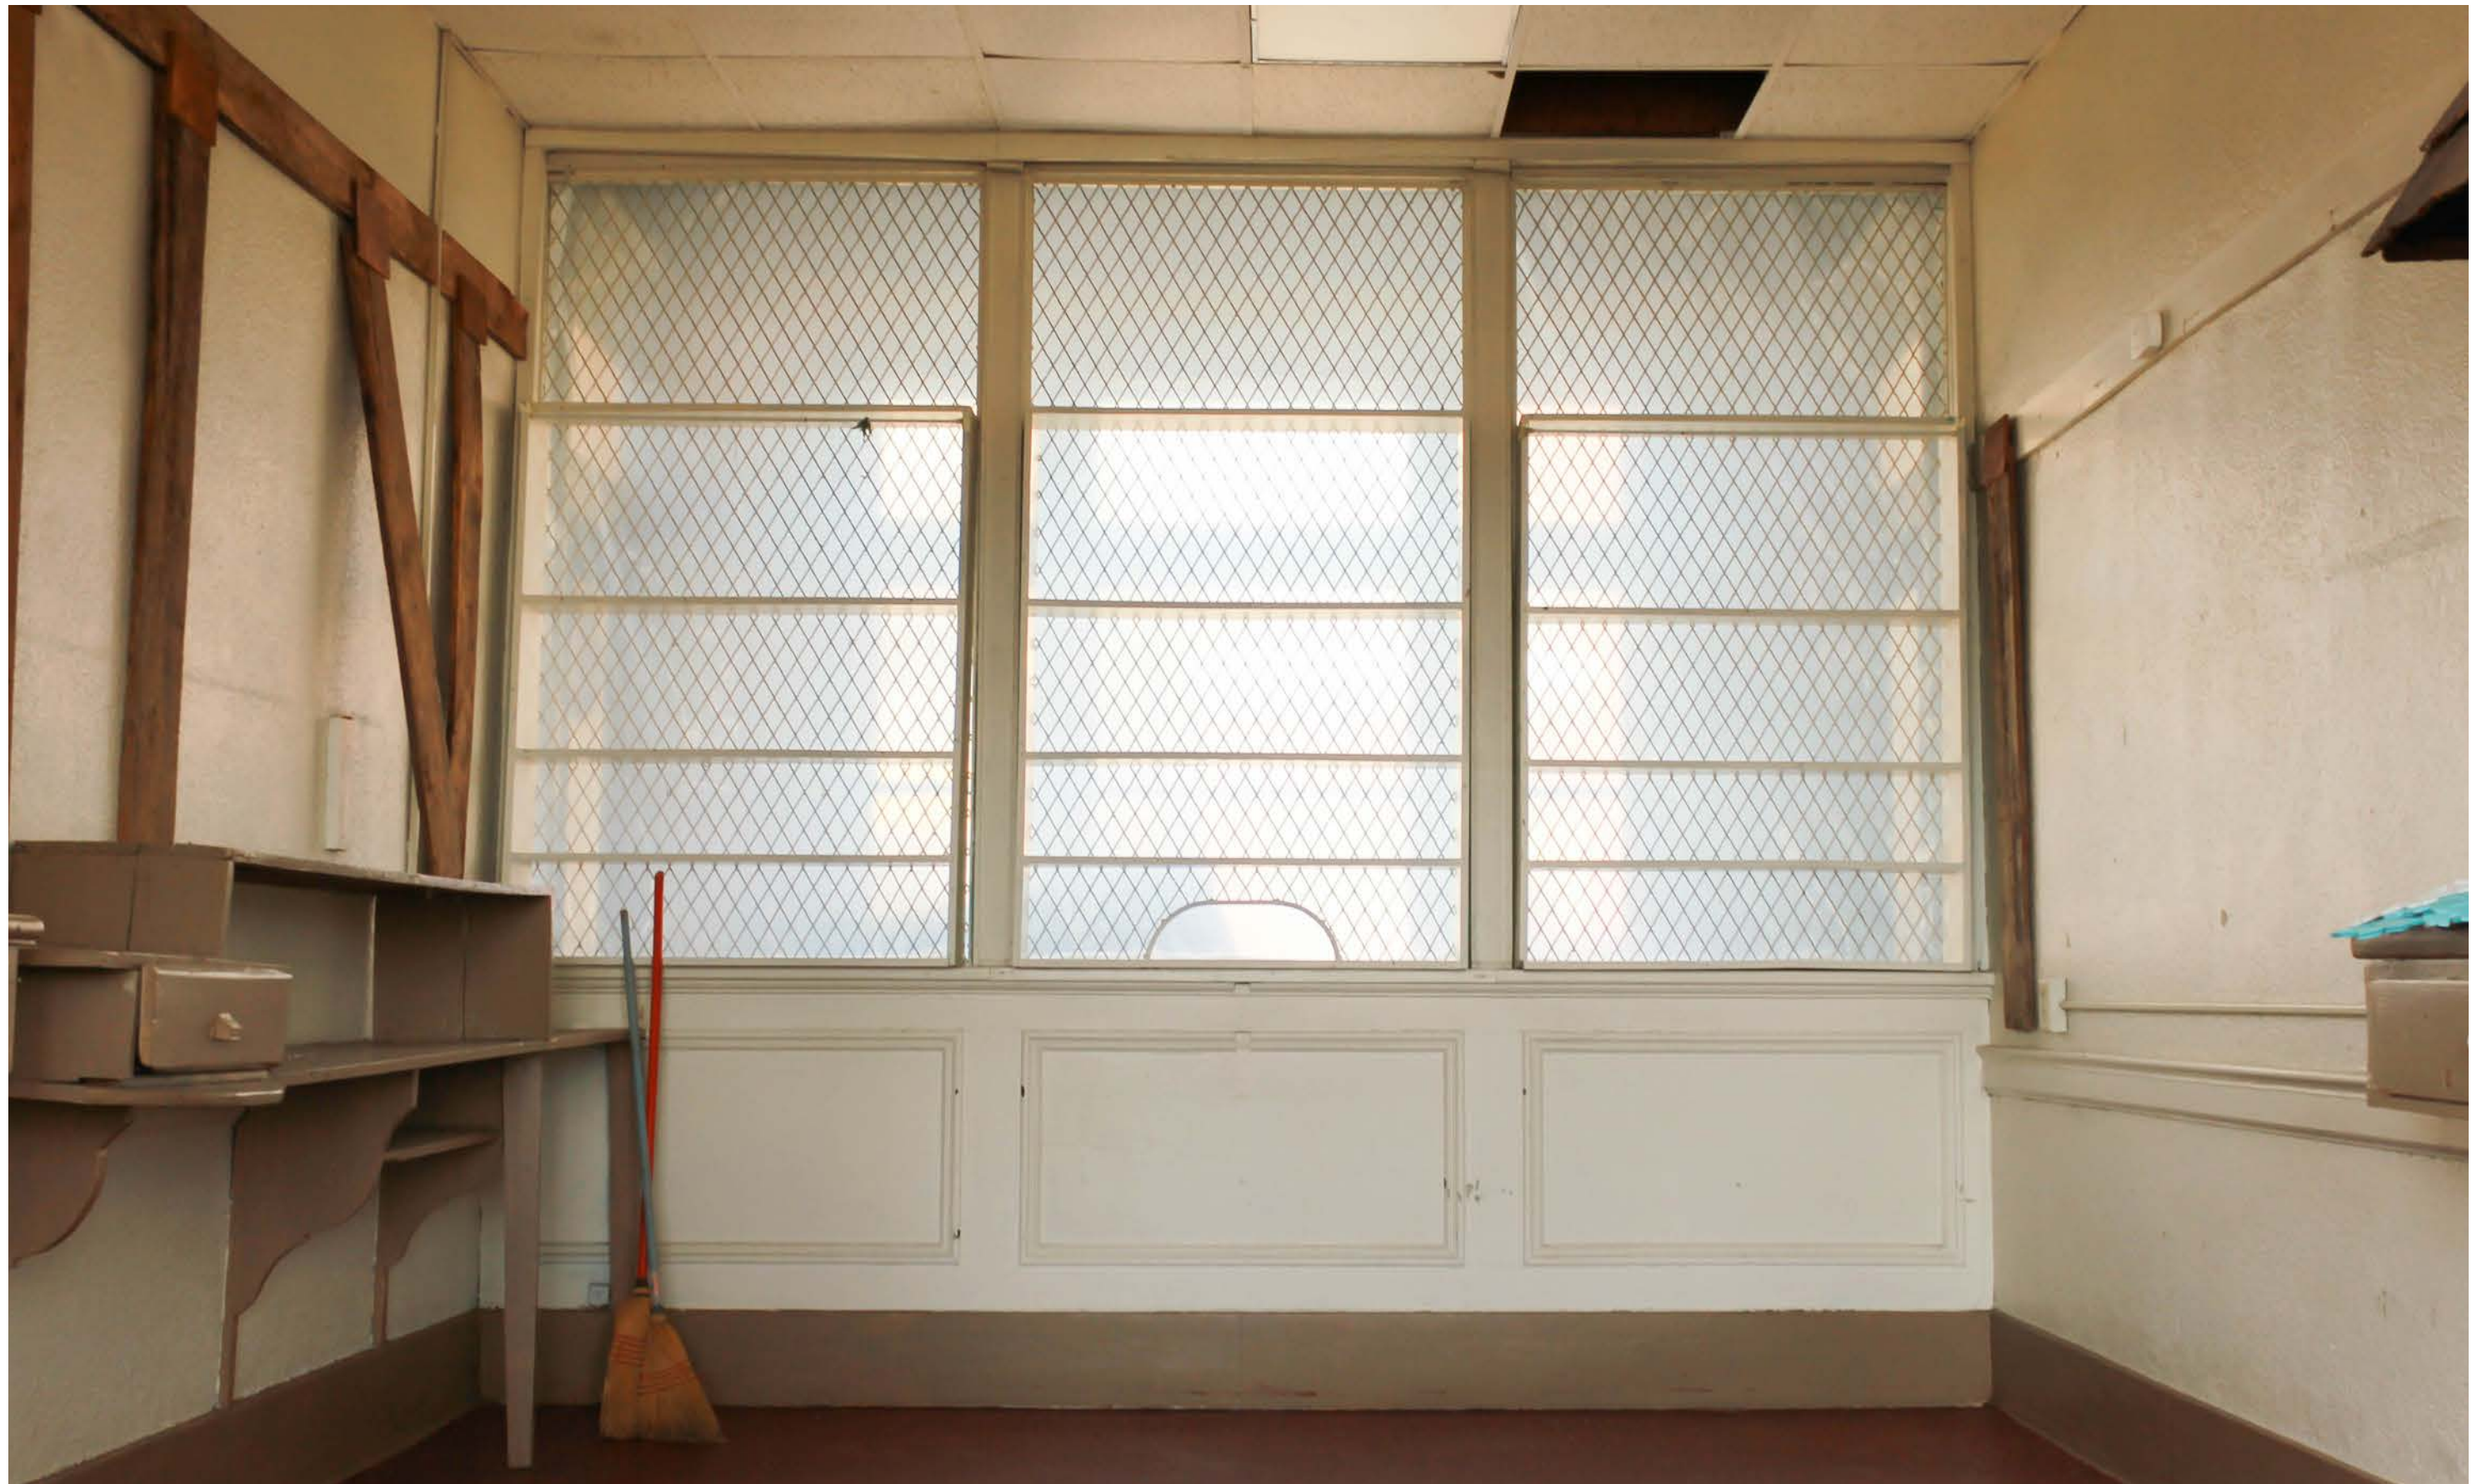
## Freight Window

The original freight window is in place at the north end of the Ticket Office. It is nearly entirely intact including decorative metal screens, built-in counter with decorative wooden bracket (Freight Lobby side), and recessed paneling. The counter and decorative wooden bracket is missing from the Ticket Office side. Existing features are in fair condition but exhibit general wear and failing paint.

Missing counter and decorative wooden bracket on the Ticket Office side of the window should be replaced to match the counter and bracket in place on the Freight Lobby side of the window. All freight window elements should be refinished. Wood and metal members should be stripped to remove existing, failed paint finishes using Back to Nature Double-Duty VII (or equivalent). **Prior to paint removal, historic finish analysis should be performed as described in "Historic Finish Analysis" section above. Furthermore, as paint is removed, careful attention should be given to identifying original finish. Small samples of original finish should remain in place, without subsequent refinishing.** All stripped surfaces should be cleaned with denatured alcohol to remove residue. Elements should then be finished per historic finish analysis findings.

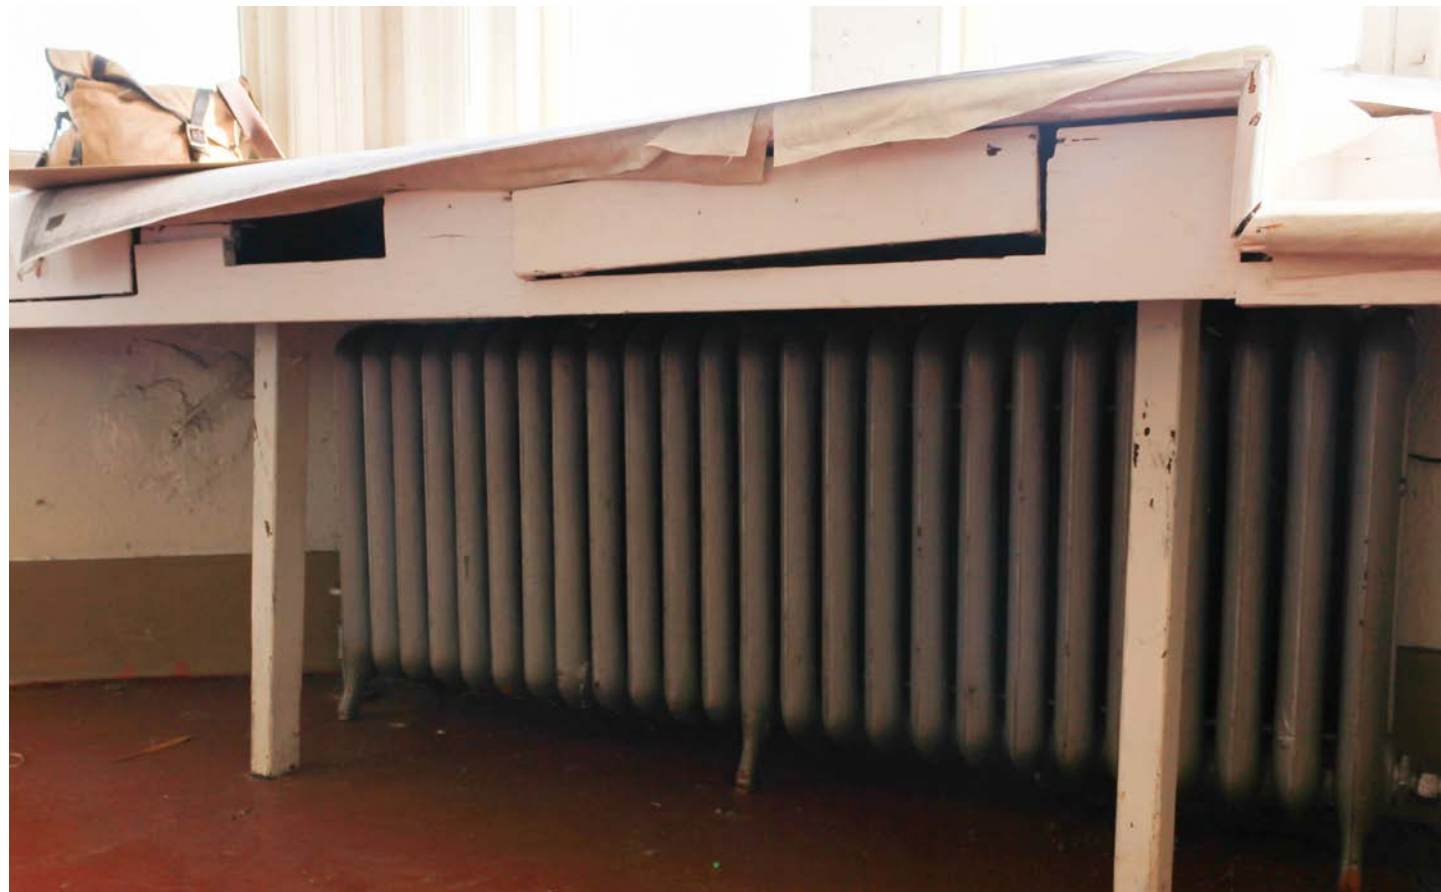
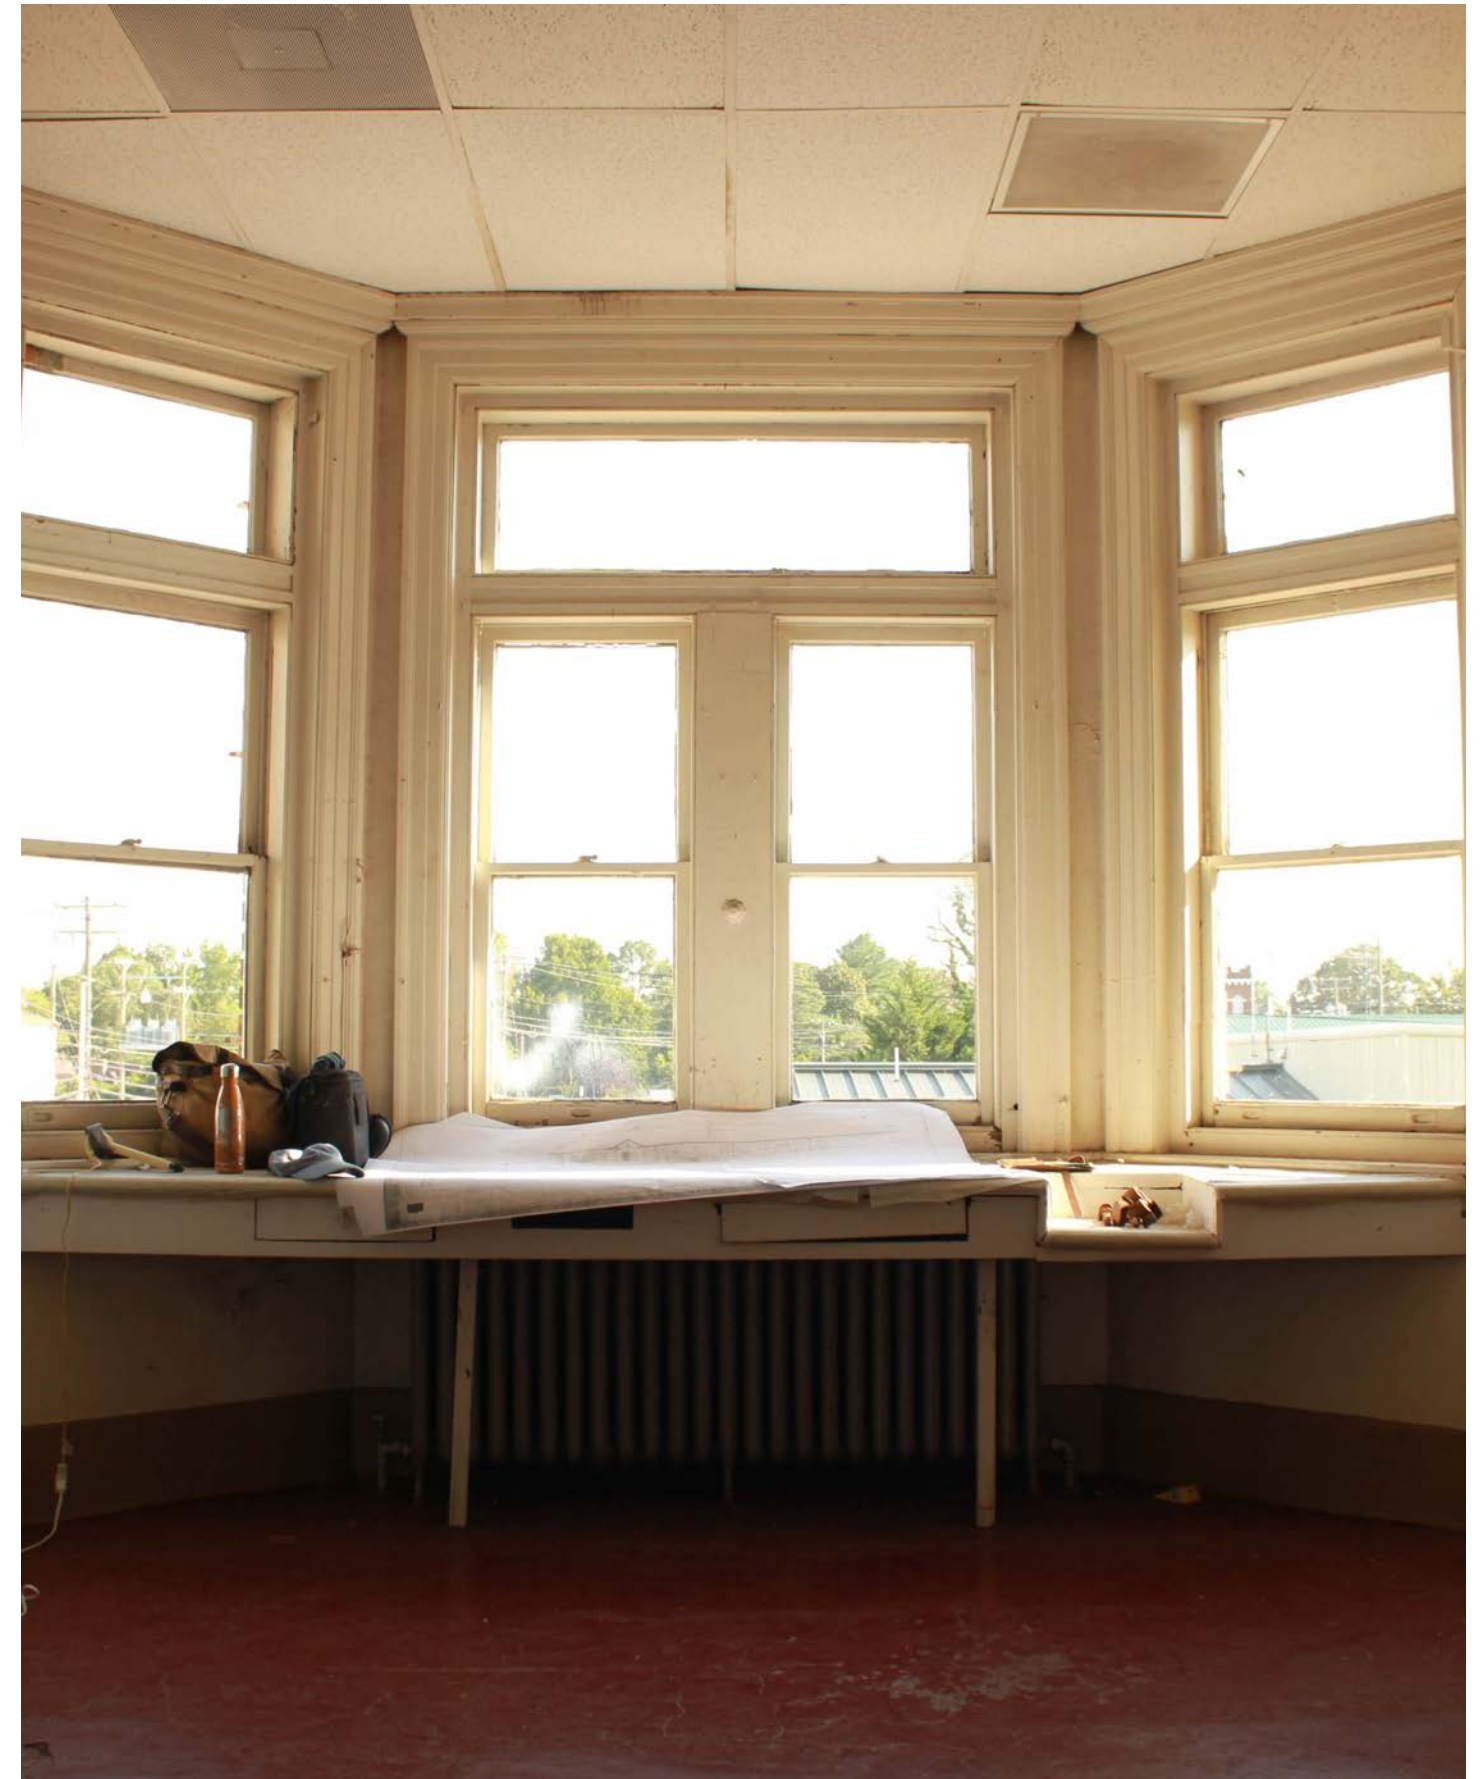
## Station Master's Desk

A built-in Station Master's desk with drawers is in place at the south end of the Ticket Office. While it is not believed to be original, it is sympathetic to the historically significant character of the building and its original use. Existing features are in fair condition but exhibit general wear, broken drawers, a missing drawer, deflection, and failing paint. Repairs, bracing, and refinishing are required.

Missing and broken drawers should be repaired or replaced in an in-kind manner. Missing hardware should be replaced with in-kind substitutes where possible or sympathetic substitutes where required. Concealed reinforcements should be added to alleviate deflection. Legs should be plumbed to ensure integrity. All wooden elements should then be refinished. Wood should be stripped to remove existing, failed paint finishes using Back to Nature Double-Duty VII (or equivalent). **Prior to paint removal, historic finish analysis should be performed as described in "Historic Finish Analysis" section above. Furthermore, as paint is removed, careful attention should be given to identifying original finish. Small samples of original finish should remain in place, without subsequent refinishing.** All stripped surfaces should be cleaned with denatured alcohol to remove residue. Elements should then be finished per historic finish analysis findings.
