Historic Structures Report

**APPOMATTOX DEPOT**

APPOMATTOX, VIRGINIA

JANUARY 8, 2019

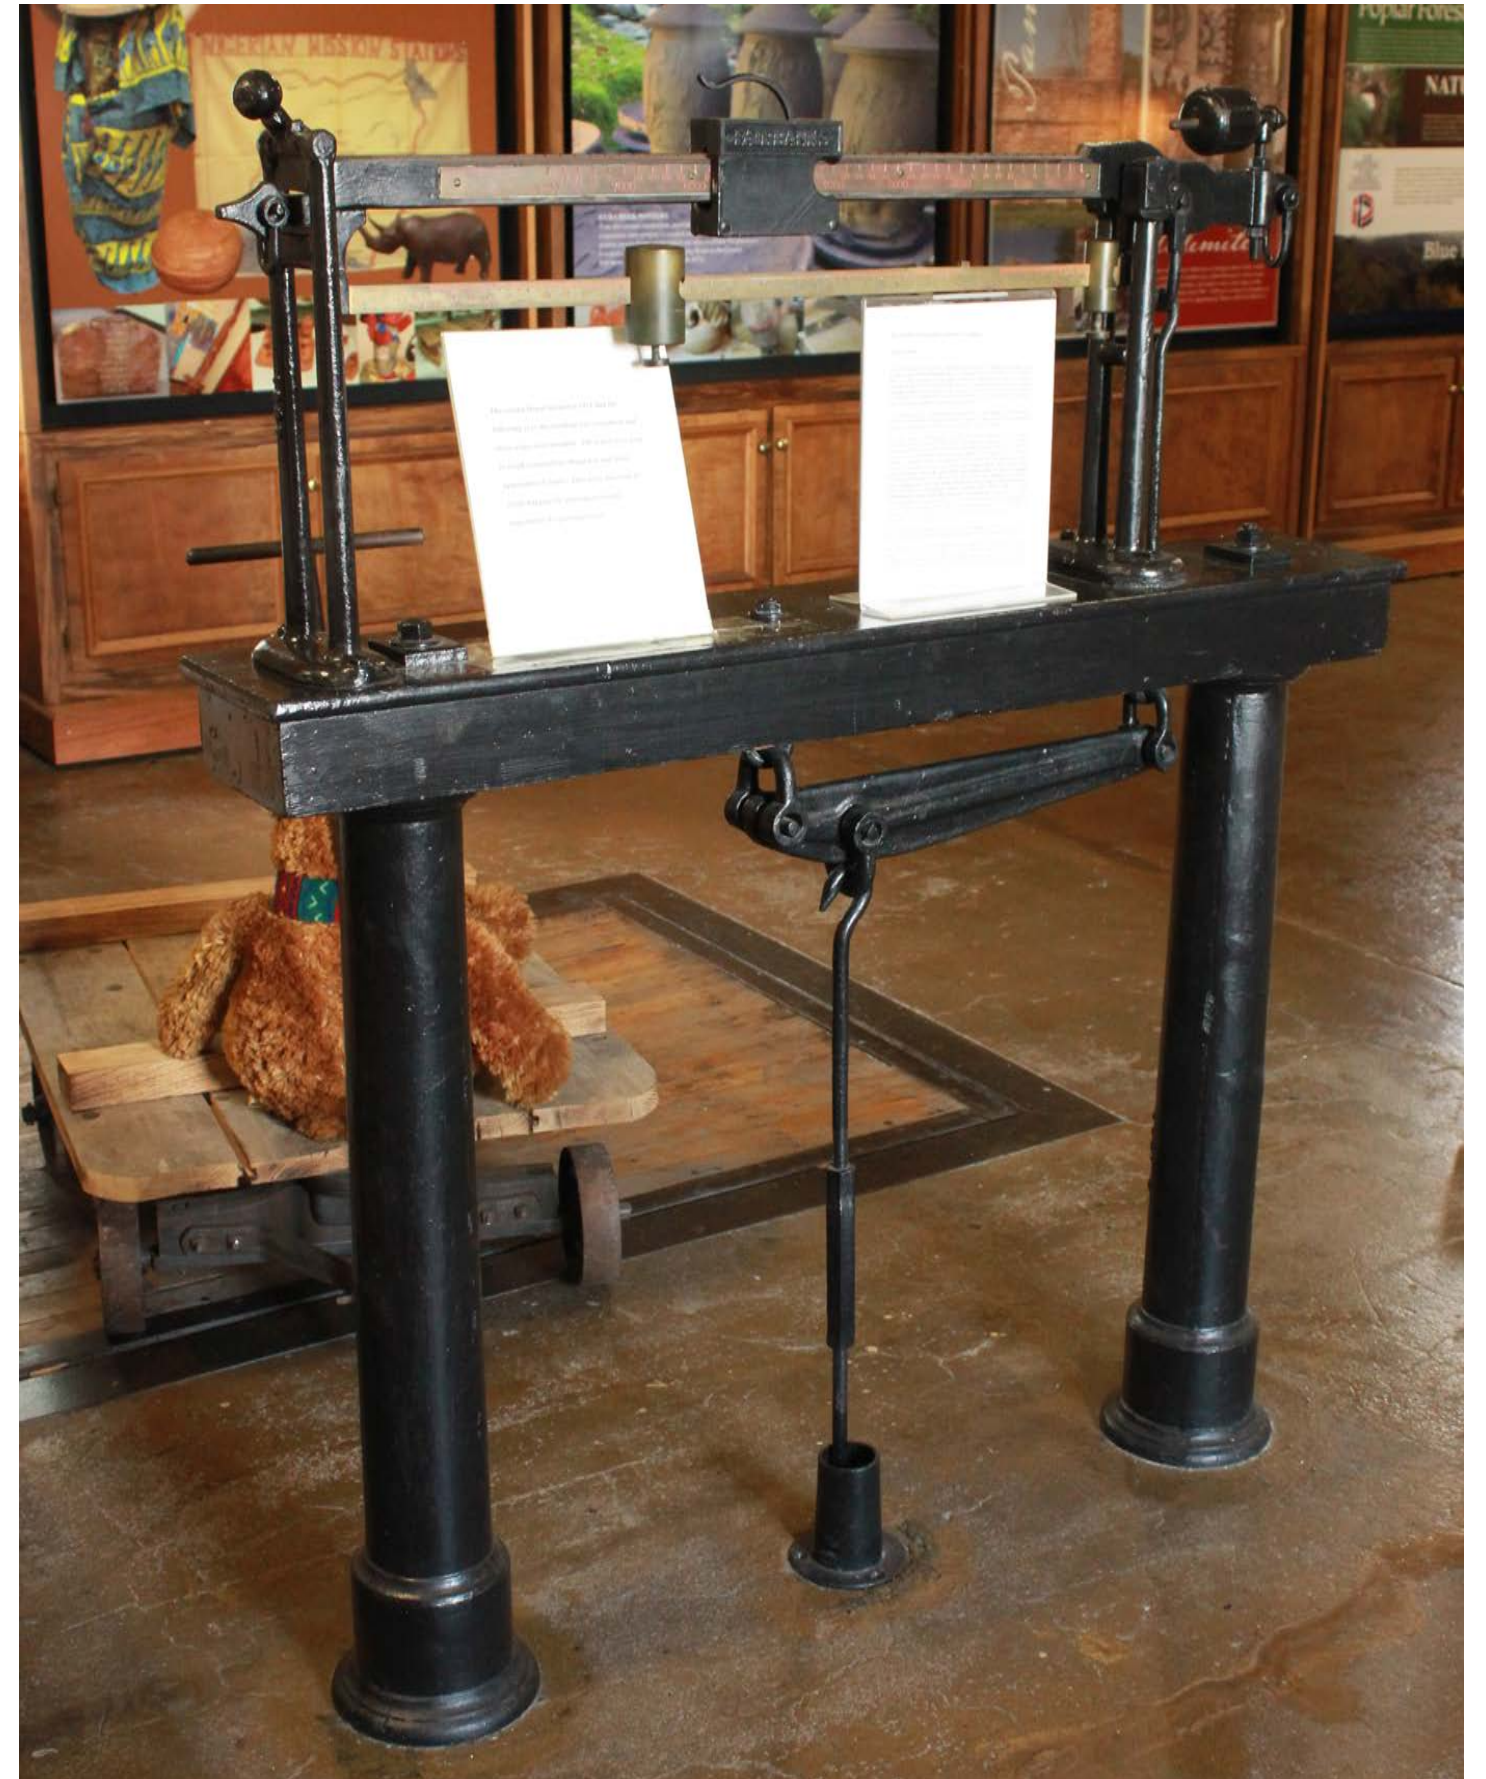
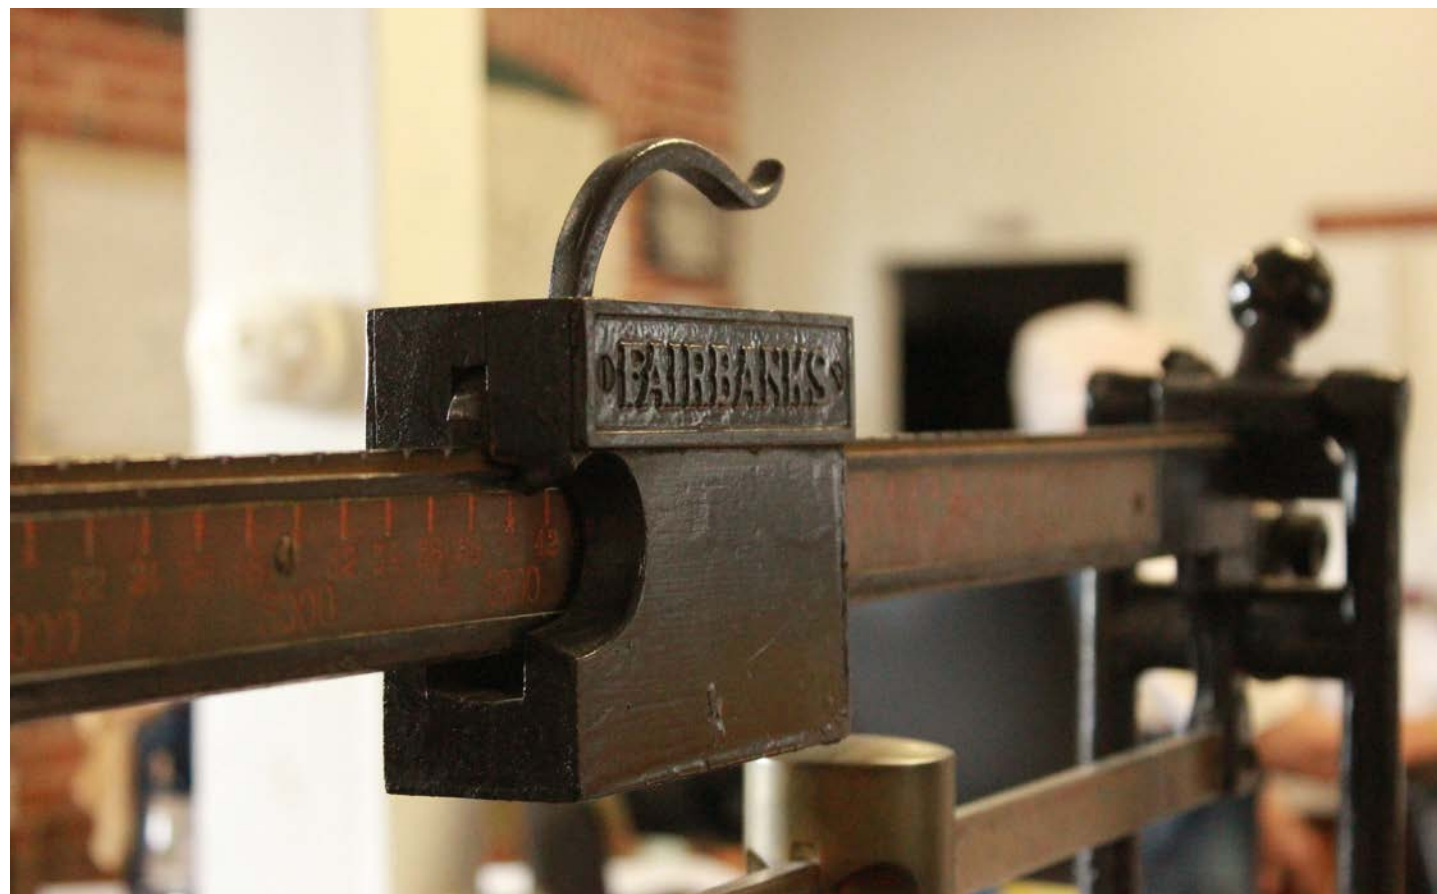
## Freight Scale

The original freight scale is in place within the Freight Room. It is in good condition overall.

As the scale is an original feature of the Depot, every effort should be made to keep it in place and in good condition. Future rehabilitation plans should be sensitive to the scale's presence and location. All future spatial programming should make provisions for proper interpretation of the scale and its relevance to the historic function of the Depot. **Under no circumstances should it be removed or altered from its original configuration or finish.**

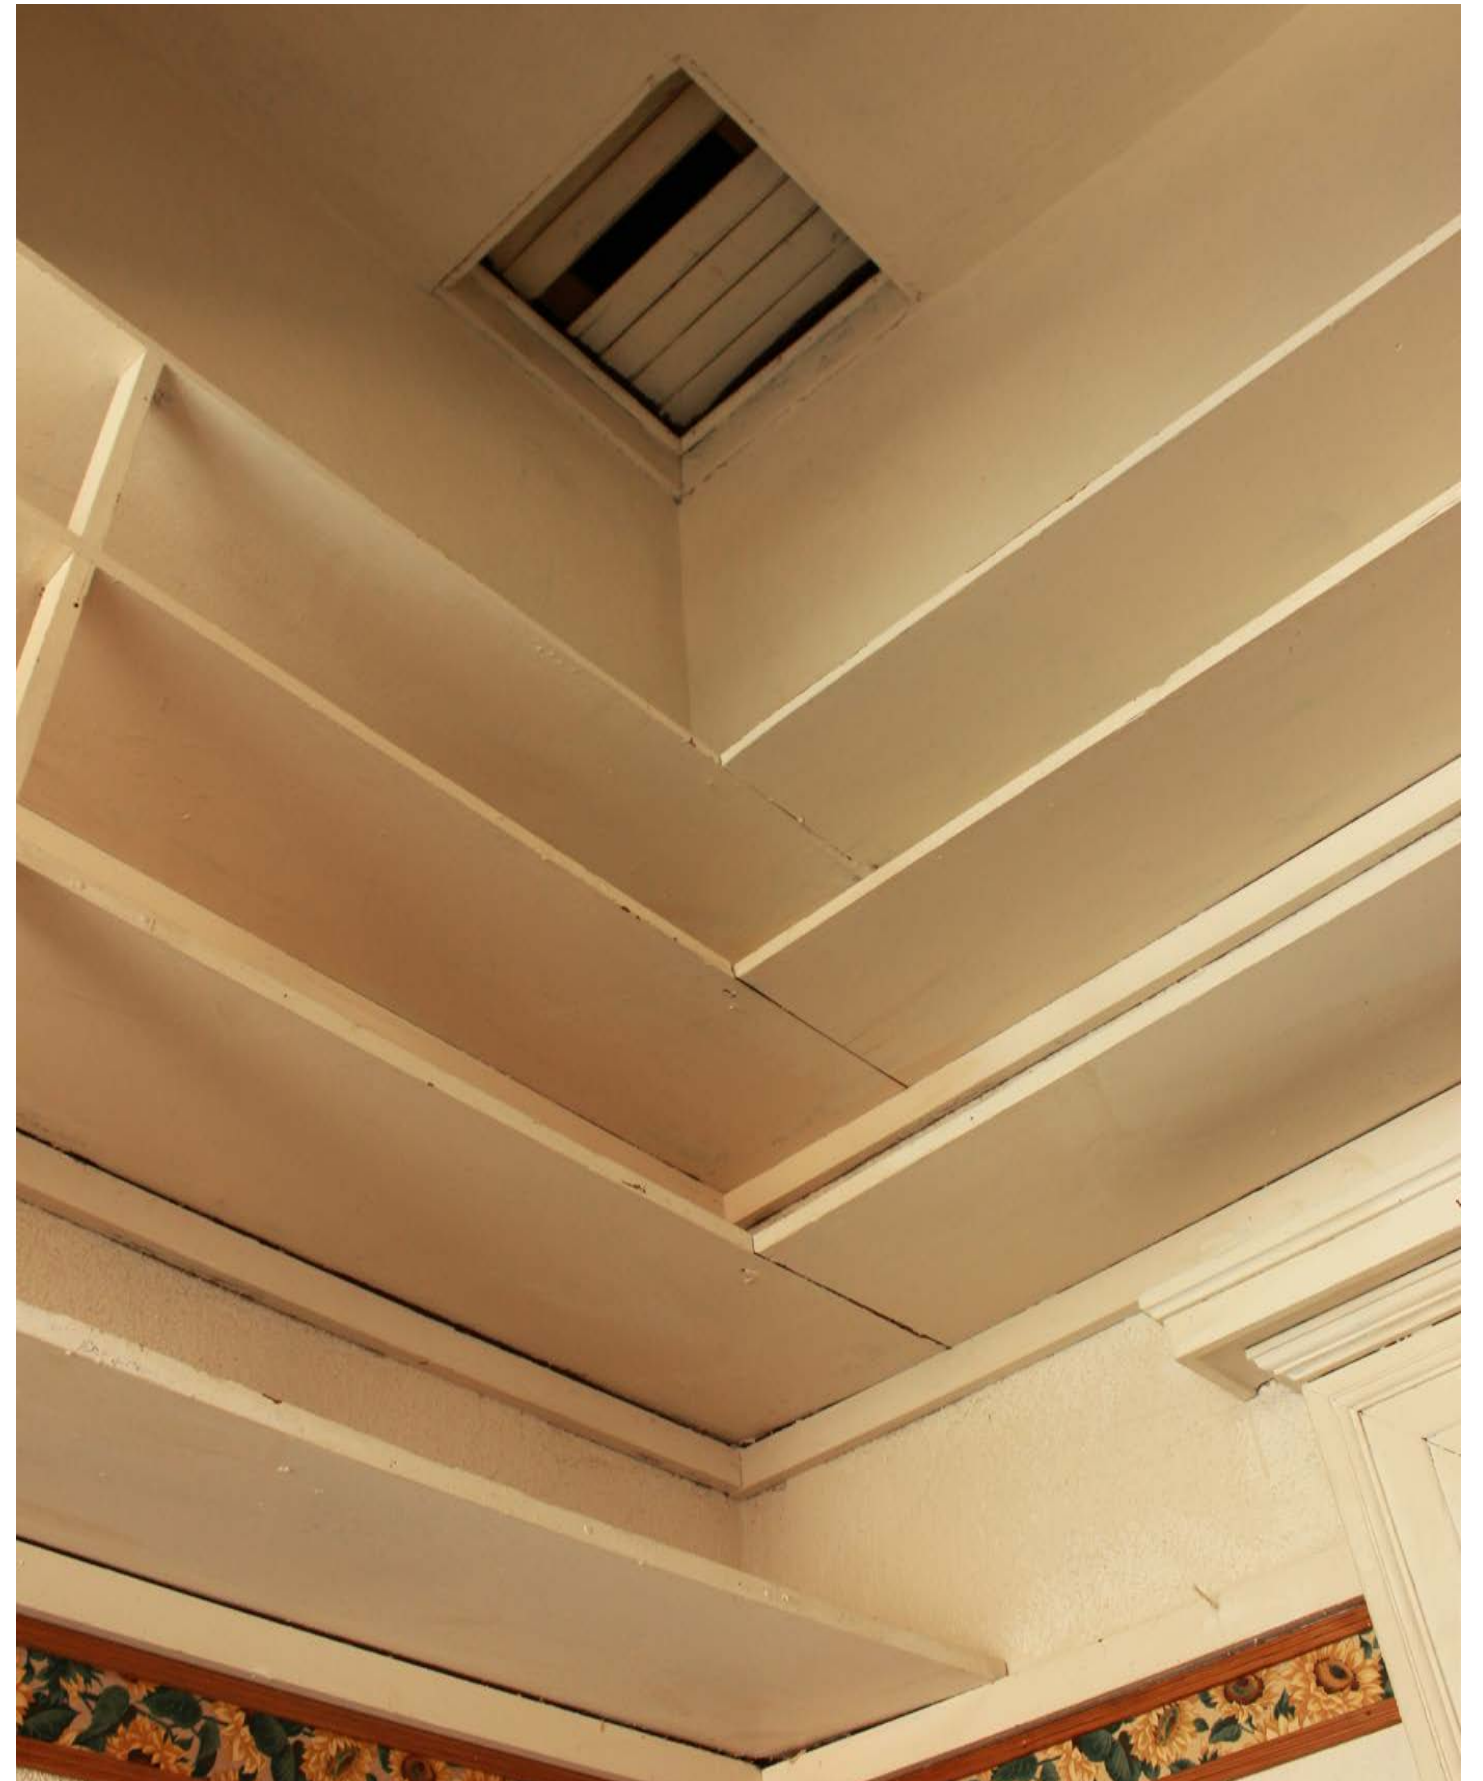
## Attic

The attic space remains largely unused. The small, inadequately-sized access is present in the ceiling of the Records Room. Attic level louvers in the roof dormers require concealed screening to alleviate bird, rodent, and insect intrusion.

The attic should remain unused except in a manner that aids in keeping building services concealed from view within the occupied spaces below. The future installation of HVAC, electrical, plumbing, and low voltage systems should utilize the attic space with strict adherence to building codes. A code-compliant attic access should be installed in an inconspicuous location, and in the least intrusive manner possible. Screening should be installed behind the attic dormer louvers to alleviate bird, rodent, and insect intrusion.

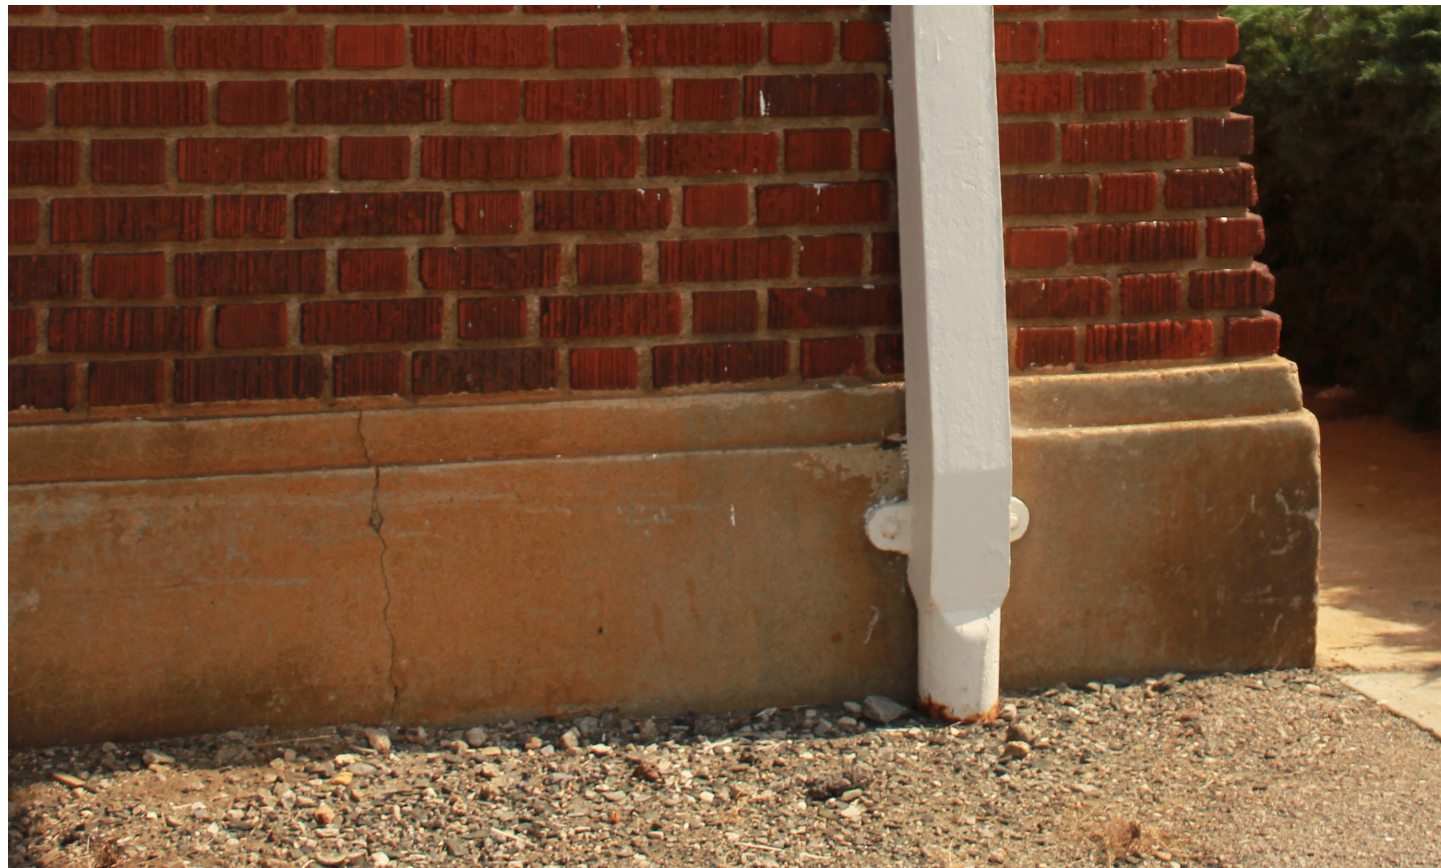
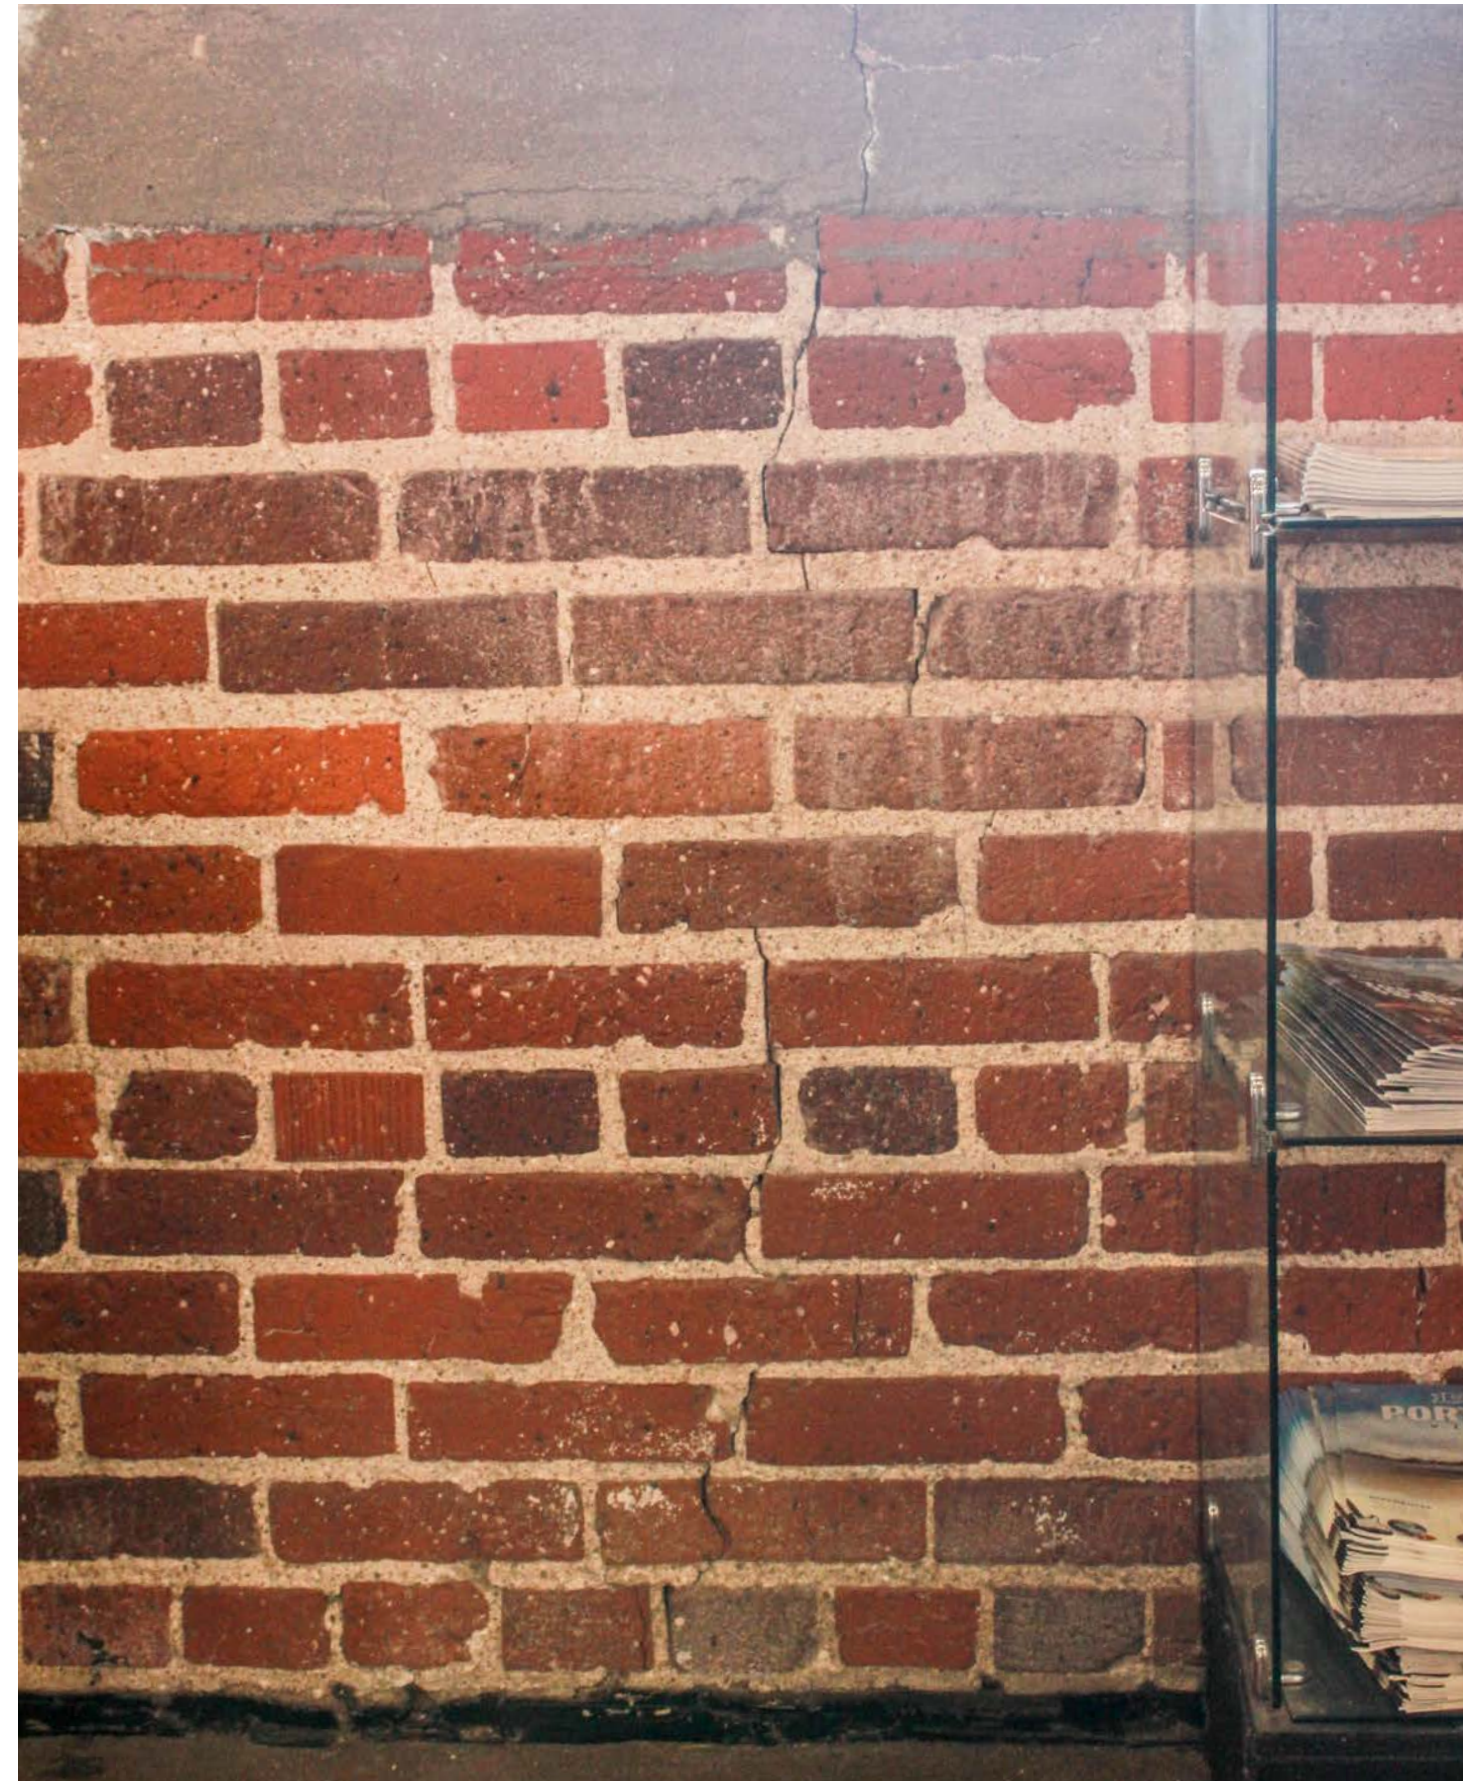
## Structural

Nolen Frisa Associates Consulting Engineers performed a structural assessment of the building's condition (see Appendix D). The report identifies multiple minor deficiencies but deems the building to be in good condition overall.

All of the deficiencies identified by the consulting engineer are addressed within the relative treatment recommendations within this conditions assessment. During the course of future preservation campaigns, any additional deficiencies identified should be brought to the engineer's attention immediately.

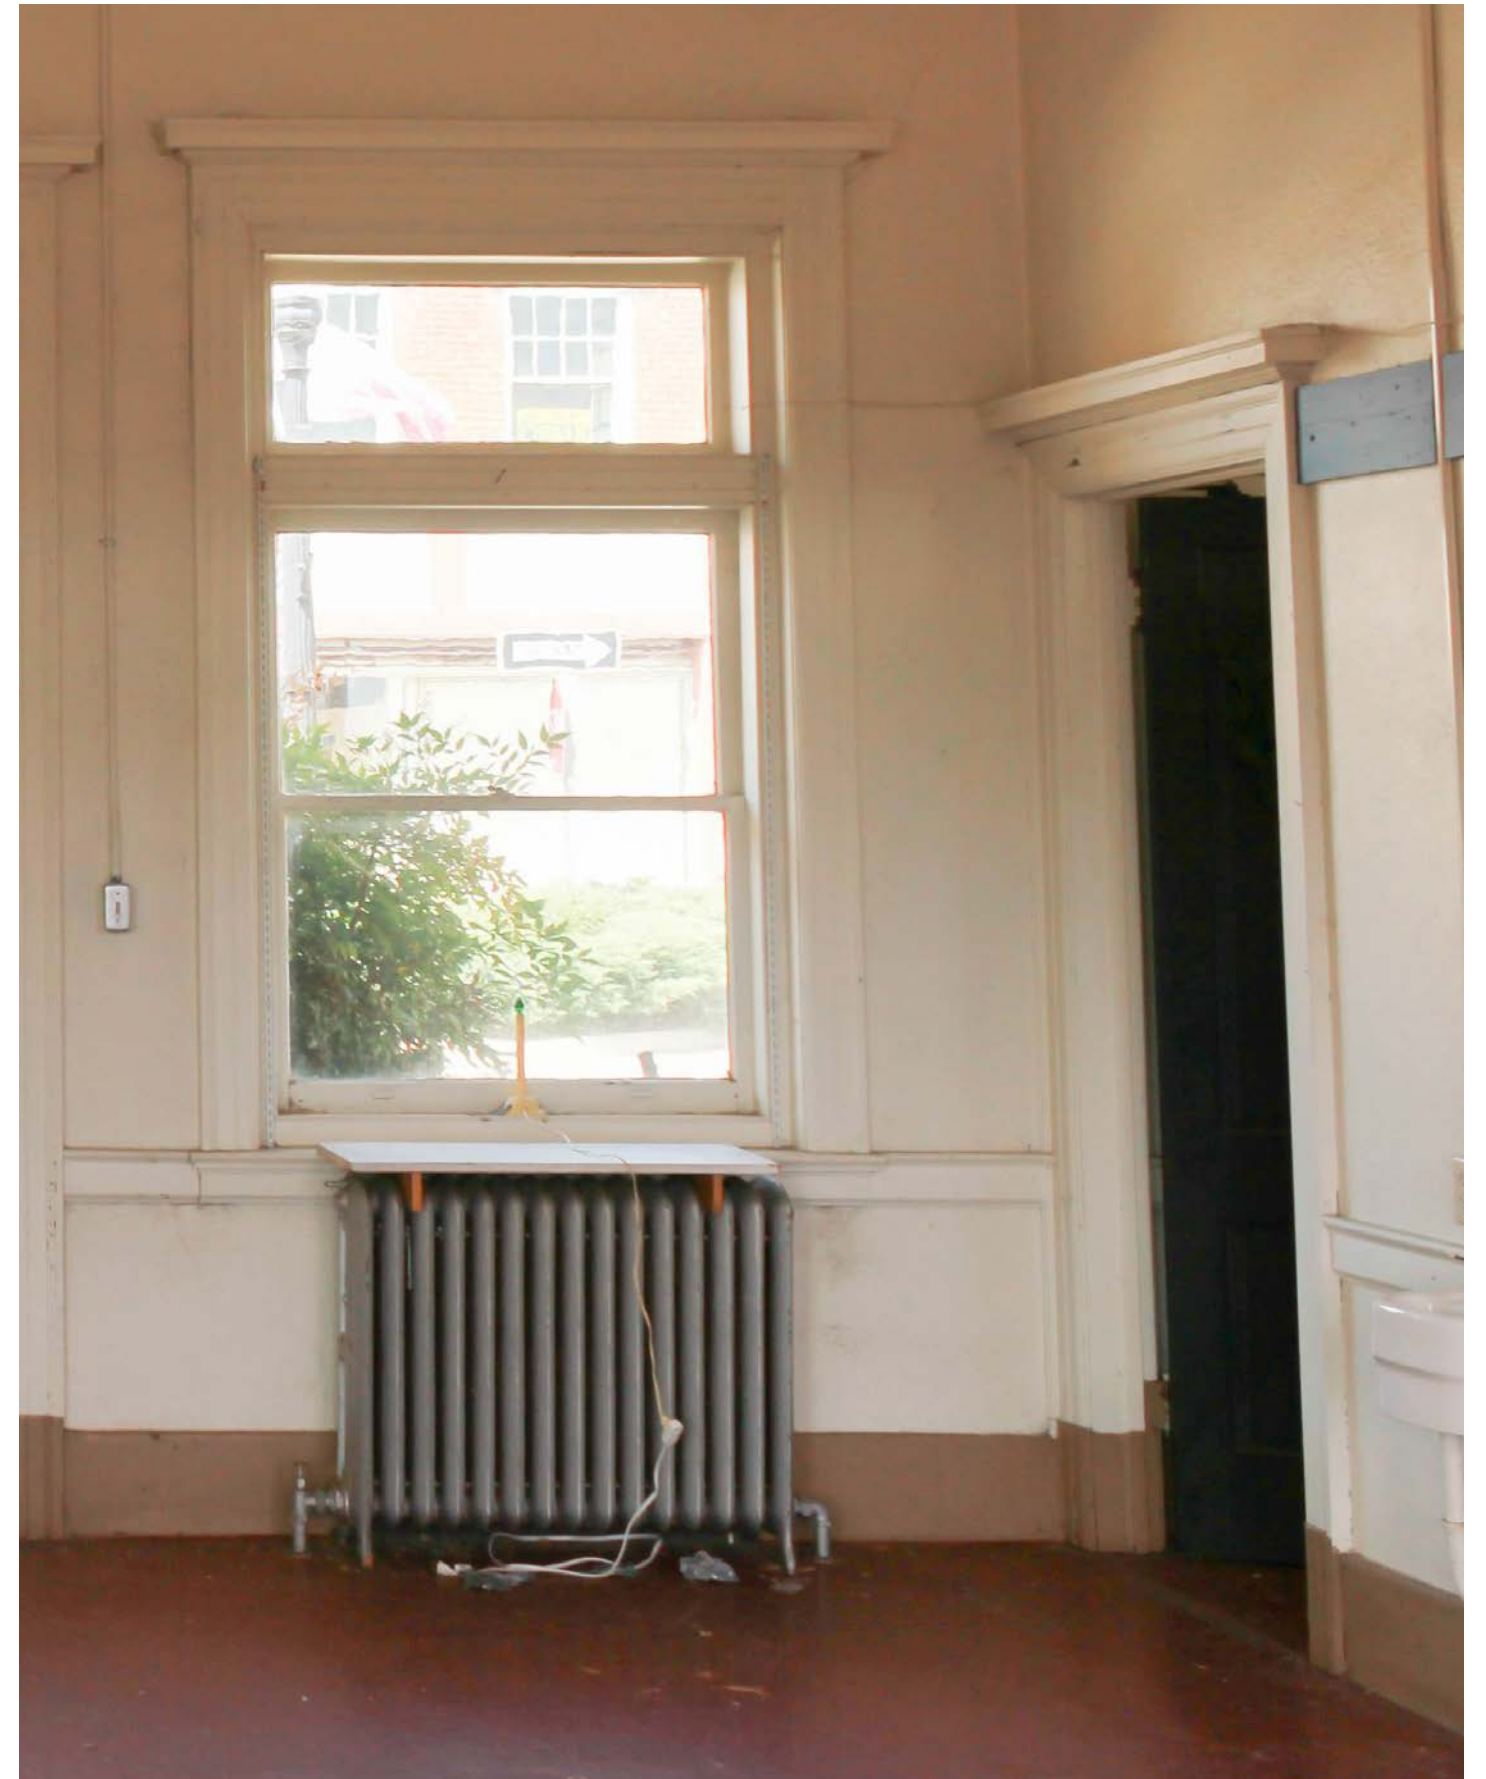
## HVAC

Original radiators are in place in most rooms of the passenger side of the building, although they are no longer in use. While existing HVAC systems provide adequate service for existing building uses, the systems are aging and will likely be inadequate for rehabilitated building uses. Existing systems are installed in an historically unsympathetic manner that detracts from the historic character of the building (interior and exterior). A detailed technical assessment has been conducted by Suter Engineering, PC of Bridgewater, Virginia (see Appendix C). While the assessment is accurate, it does not consider the historic characteristics of the building or make specific recommendations for future enhancements.

Original radiators should be retained where present. Missing radiators should be replaced in-kind as shown on 1923 architectural plans. Ghost lines of original stove heater in Ticket Office should be documented and retained as an historic record of missing elements.

During the course of a future rehabilitation planning process, new HVAC systems should be engineered to meet current building and energy code requirements. Every effort should be made to design and install the systems in a concealed manner without harm to historic fabric and detailing. These efforts should serve to meet the Secretary of the Interior's Standards for Rehabilitation. The basement and attic spaces should be used where possible to keep system components concealed from view within the occupied spaces of the building. If deemed absolutely necessary, the soffit in the passenger section of the building could be implemented for chase ways. All exterior components should be installed in the least conspicuous manner possible and screened from view. All line-sets, conduit, piping, vents, tanks, etc. should be installed in a sensitive inconspicuous manner. Attaching equipment or components to the exterior of the building should be avoided. **Under no circumstances should historic fabric be removed in order to accommodate modern equipment.**

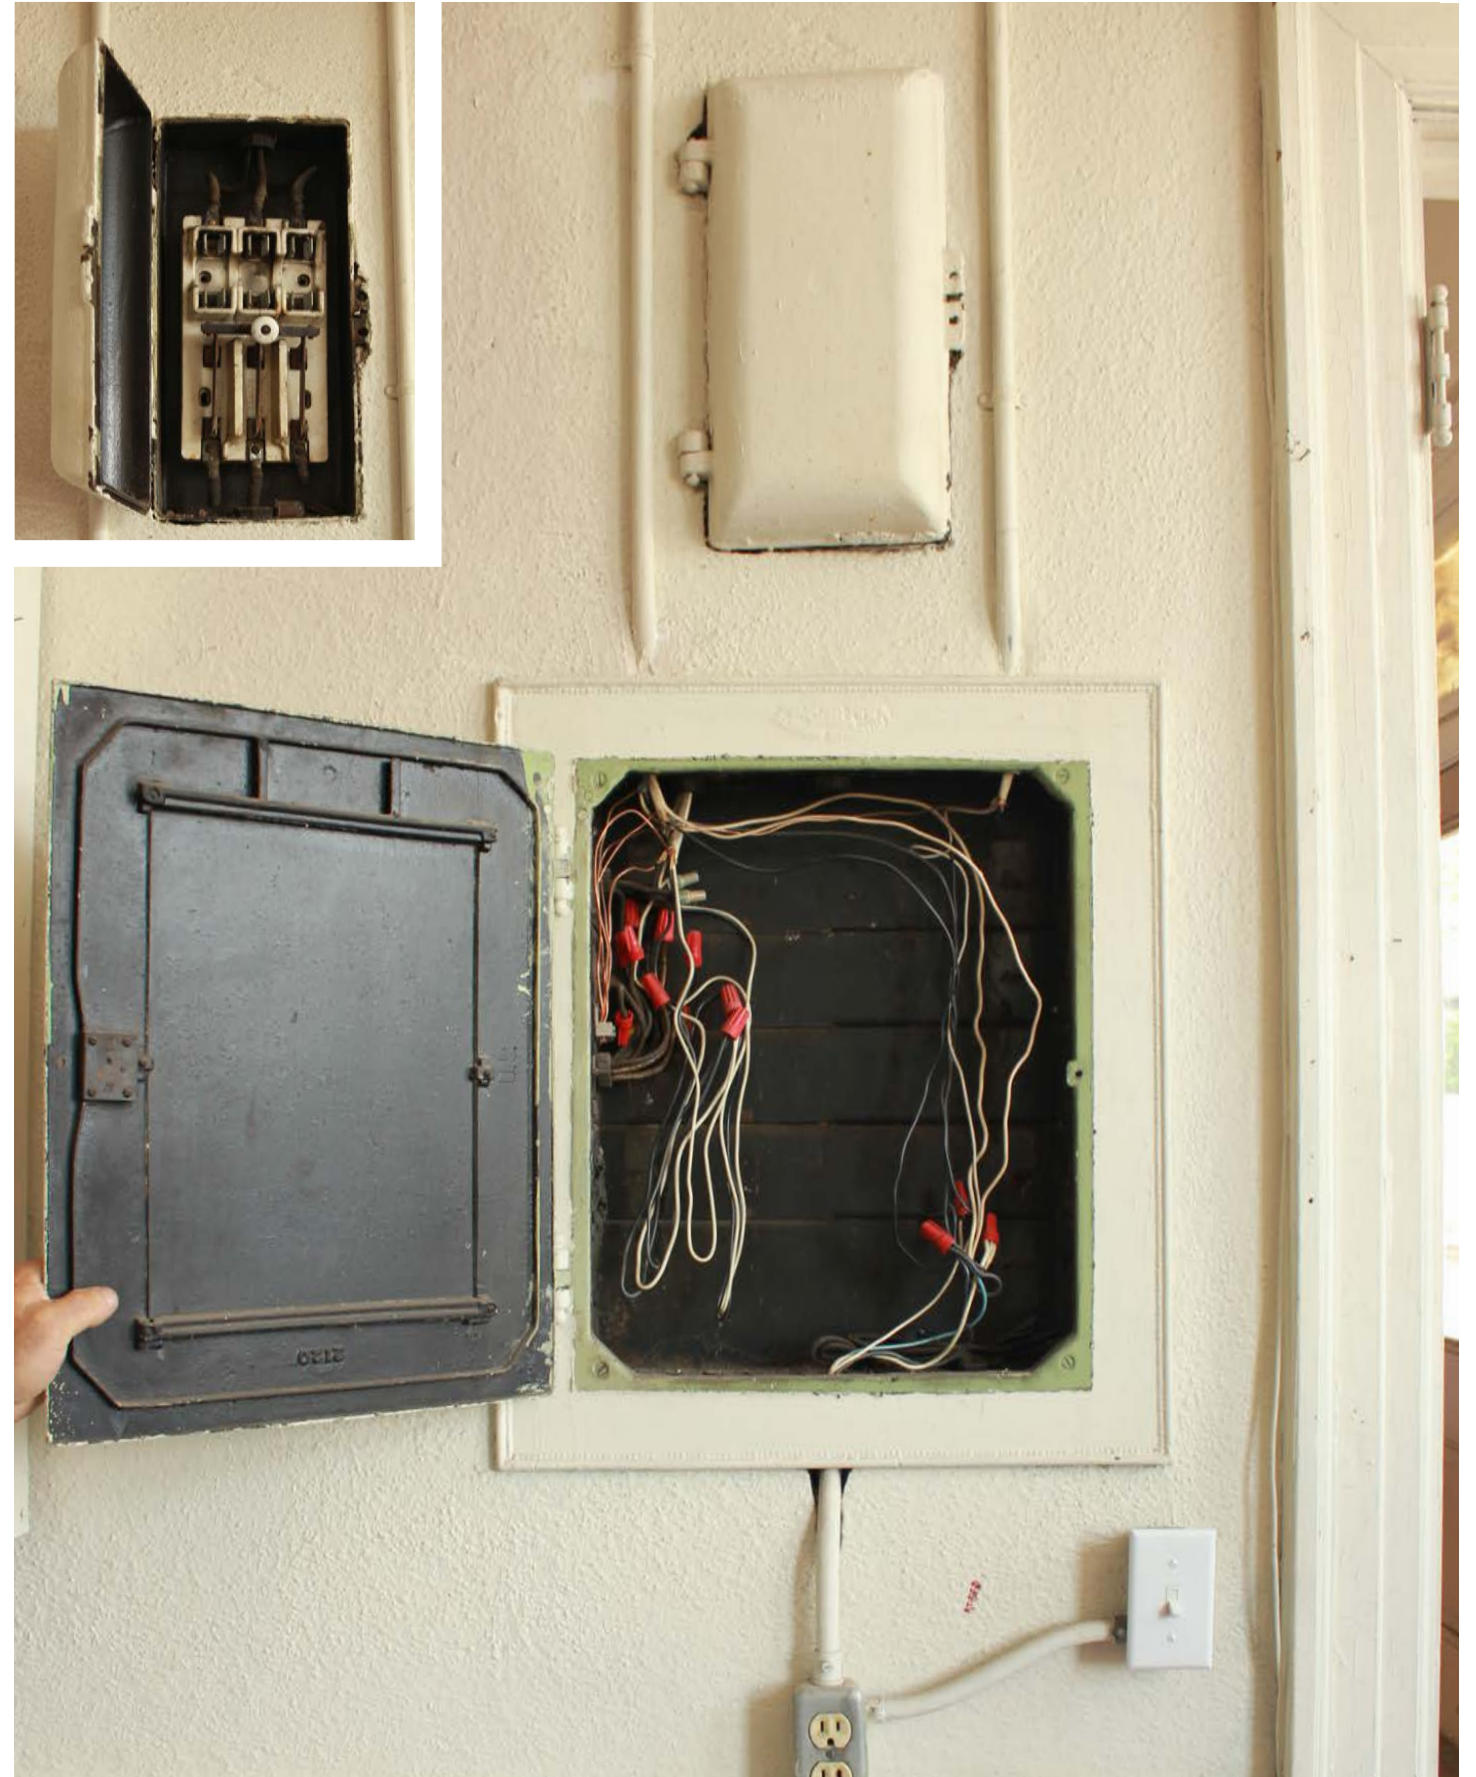
## Electrical

A thorough assessment of the existing electrical system has been conducted by William R Jennings, Jr., Consulting Engineering, PC of Forest, Virginia (see Appendix E). Furthermore, Jennings identifies deficiencies with the current system that require immediate attention (see section 2.a. in Appendix E). Specifically:

Some original electrical fixtures remain place, although they require repairs in order to be used in a safe manner. Most in-service lighting fixtures are historically inappropriate; lacking a style that is in keeping with the historic architectural significance of the building.

The feeder deficiency identified by Jennings should be remedied by replacing the existing feeders with “conductors in conduit as required by code.”

During the course of a future rehabilitation planning process, a new electrical system should be engineered to meet current building code requirements. Every effort should be made to design and install the systems in a concealed manner without harm to historic fabric and detailing. These efforts should serve to meet the Secretary of the Interior’s Standards for Rehabilitation. The basement and attic spaces should be used where possible to keep system components concealed from view within the occupied spaces of the building. If deemed absolutely necessary, the soffit in the passenger section of the building could be implemented for chase ways. All exterior components should be installed in the least conspicuous manner possible and screened from view. All meters, disconnects, conduit, piping, etc. should be installed in a sensitive, inconspicuous manner. Attaching equipment or components to the exterior of the building should be avoided. Under no circumstances should historic fabric be removed in order to accommodate modern equipment.

All historic lighting fixtures should be repaired and returned to service. All historically inappropriate lighting fixtures should be replaced with sympathetic substitutes that are in keeping with the historic architectural significance of the building.

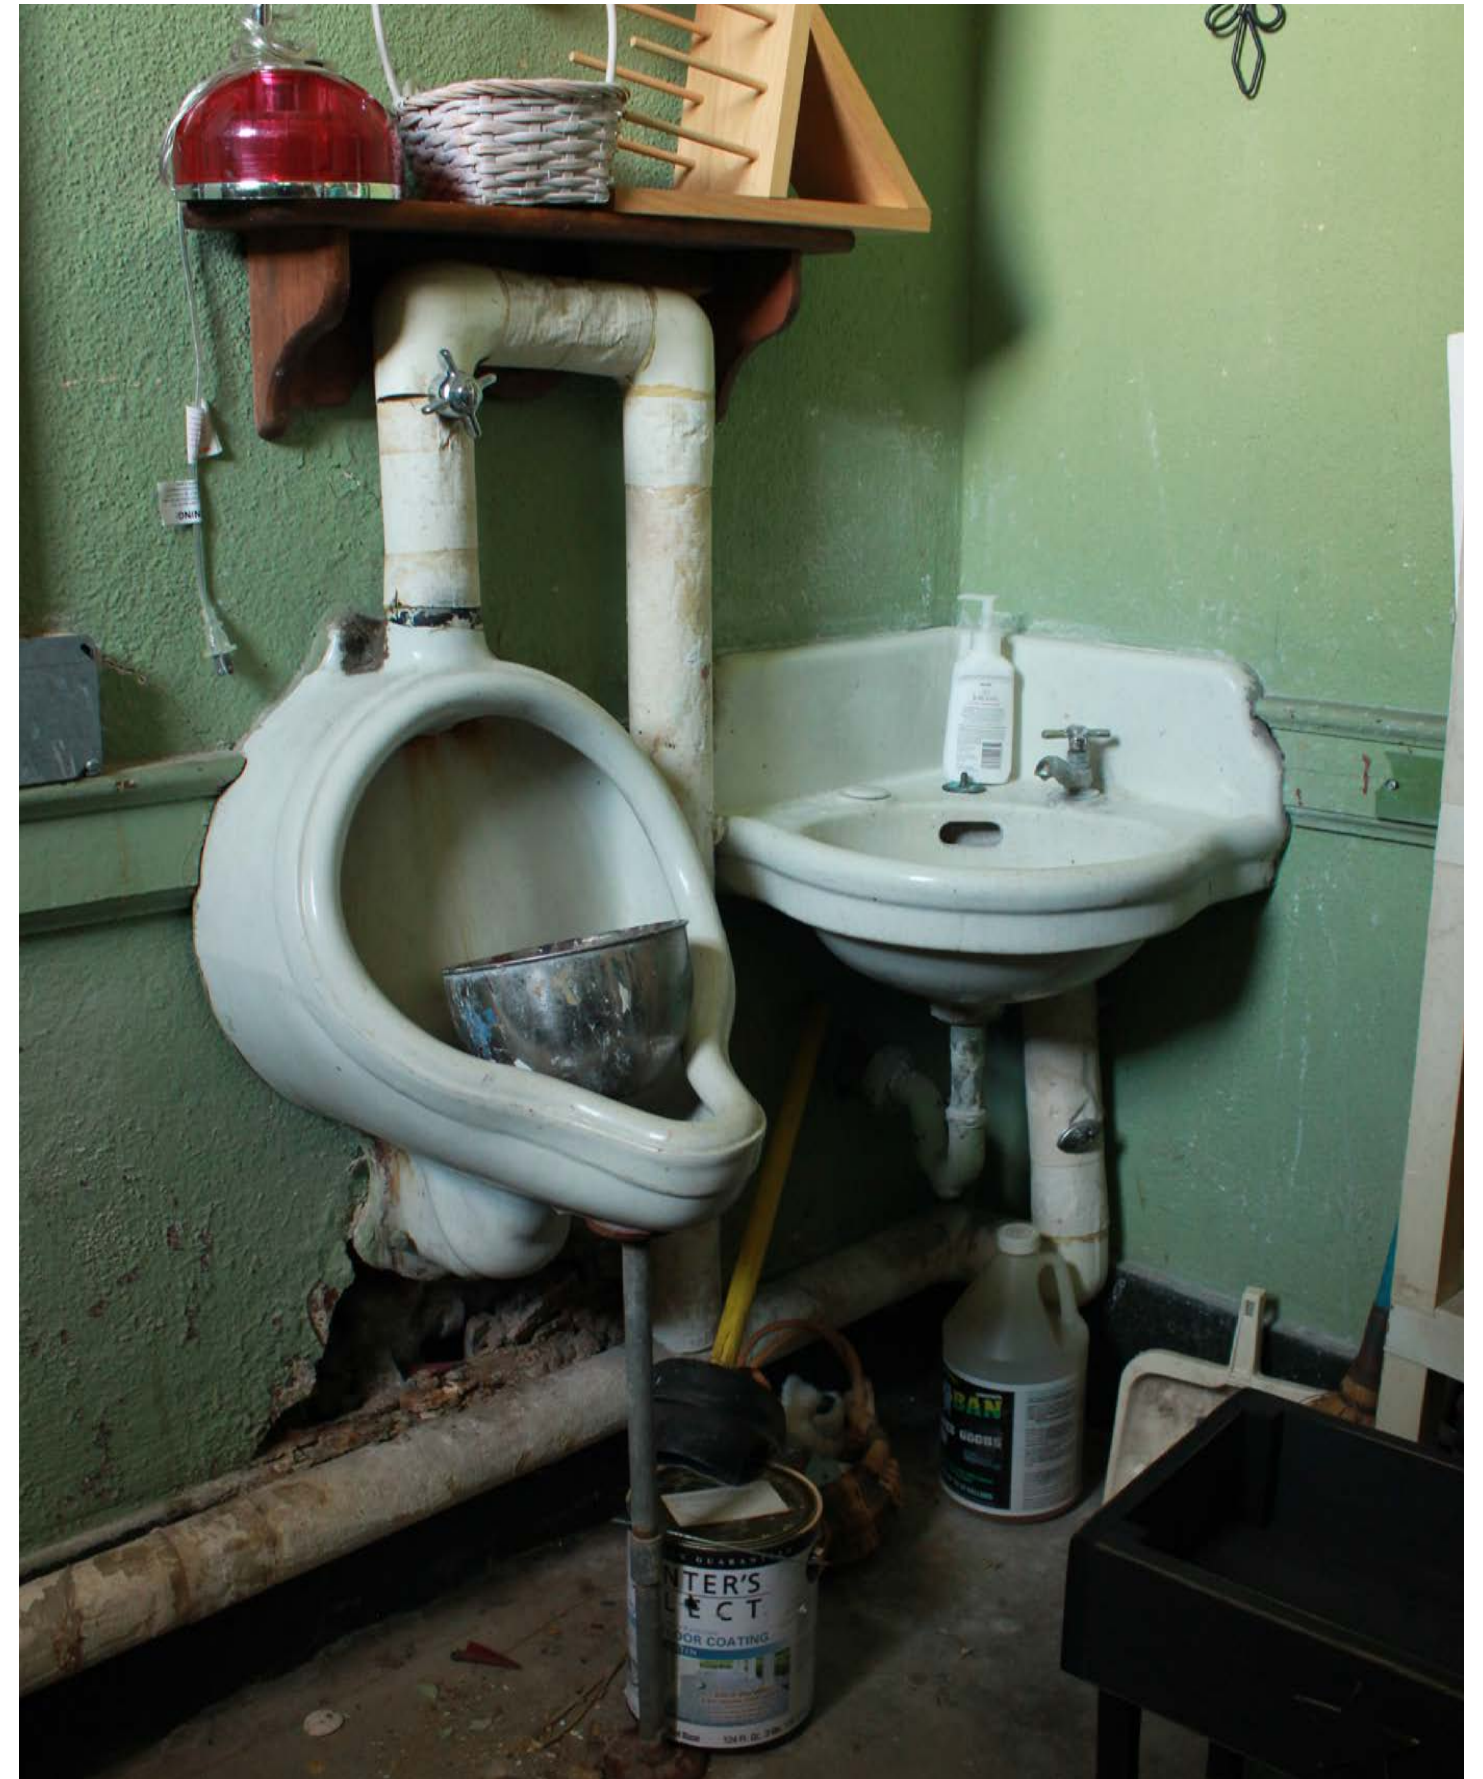
## Plumbing

As described in the “Restroom” section within this document, original restrooms and fixtures are in place. They are in poor condition and are no longer in service. Modern, ADA-compliant restrooms are in service on the west end of the Freight Room. Historic drinking fountains are in place in the passenger portion of the building but are no longer in service. The original 1923 architectural drawings identify the location of a water cooler within the Women’s Retiring Room (White), which is no longer in place.

Historic restrooms in the passenger portion of the building should be restored as described in the “Restrooms” section of this document. New plumbing will be required and should be installed in a concealed, inconspicuous manner. Any new fixtures required should be historically sympathetic to the period of architectural significance.

During the course of a future rehabilitation planning process, new plumbing systems should be engineered to meet current building code requirements. Every effort should be made to design and install the systems in a concealed manner without harm to historic fabric and detailing. These efforts should serve to meet the *Secretary of the Interior’s Standards for Rehabilitation*. The basement and attic spaces should be used where possible to keep system components concealed from view within the occupied spaces of the building. If deemed absolutely necessary, the soffit in the passenger section of the building could be implemented for chase ways. All exterior piping should be installed in the least conspicuous manner possible and screened from view. All piping, vents, etc. should be installed in a sensitive inconspicuous manner. Attaching equipment or components to the exterior of the building should be avoided. The routing of all piping should be concealed from view both inside and outside the building. Under no circumstances should historic fabric be removed in order to accommodate modern equipment.

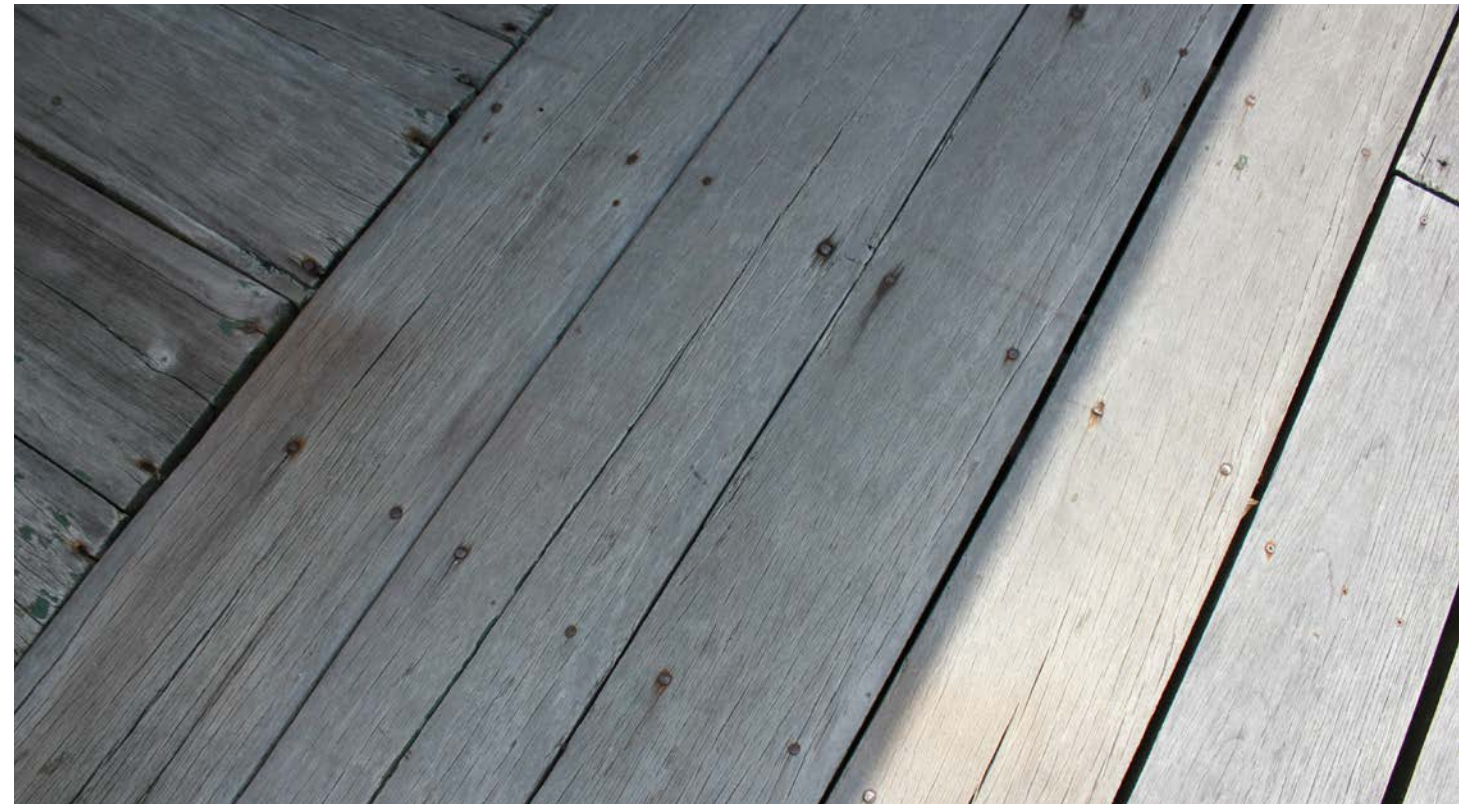
## Pest Control Wood Destroying Organisms

In general, very few signs of wood destroying organisms are evident, and no active infestation was observed. However, some damage is present in isolated locations, although not to the degree that there is a visible loss of structural or material integrity.

The building must have bonded treatment for wood destroying organisms with a reputable pest control company. A thorough inspection should be conducted yearly. Any signs of active infestation observed between inspections must be reported to the pest control company immediately.

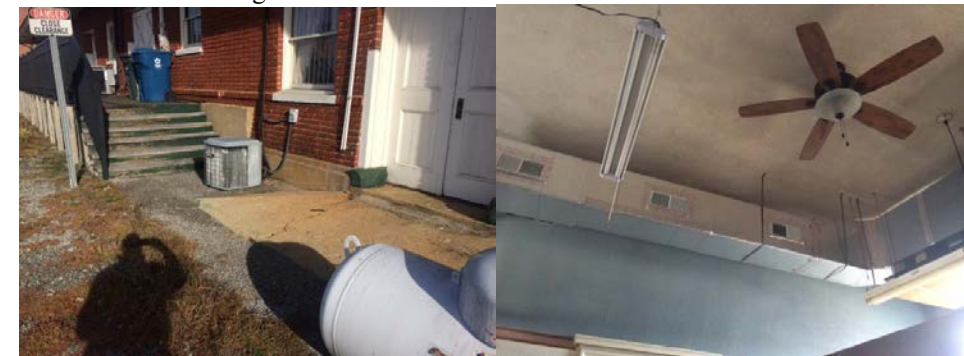
The condenser units is old and tags are no longer legible. It appears to be a Heil 2.5 ton and probably about 25+ years old. It is an R-22 system, no longer made and expensive to service. The furnace appears to be in good working order and of the same vintage as the condenser unit. LP gas is furnished from a tank behind the building, between railroad tracks and the building.

Antique Shop Condenser Unit

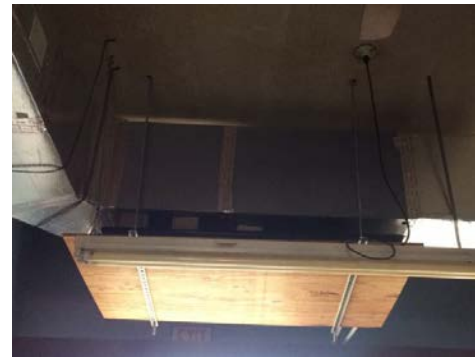
Furnace in antique shop

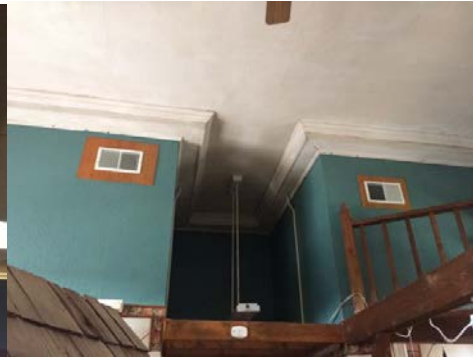
Diffusers in other room of antique shop
