Historic Structures Report

**APPOMATTOX DEPOT**

APPOMATTOX, VIRGINIA

JANUARY 8, 2019

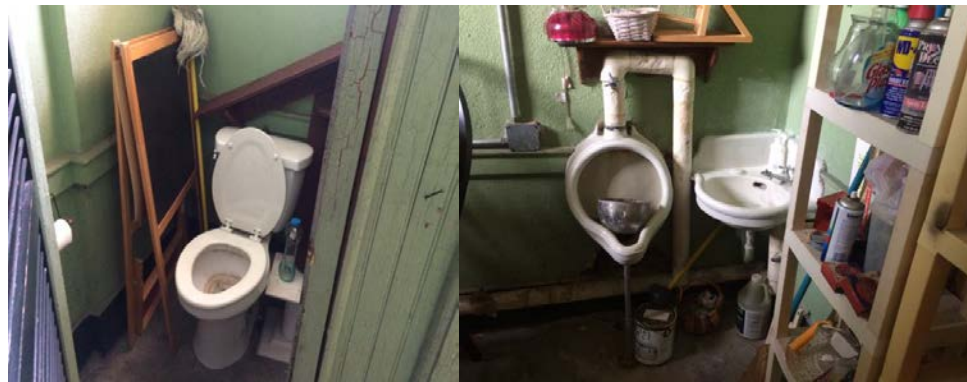
Plumbing and plumbing fixtures in antique shop

The middle section, Antique Shop plumbing and plumbing fixtures are very old and are of little value. They seem to be barely adequate for the present tenant and would not meet present codes or standards.

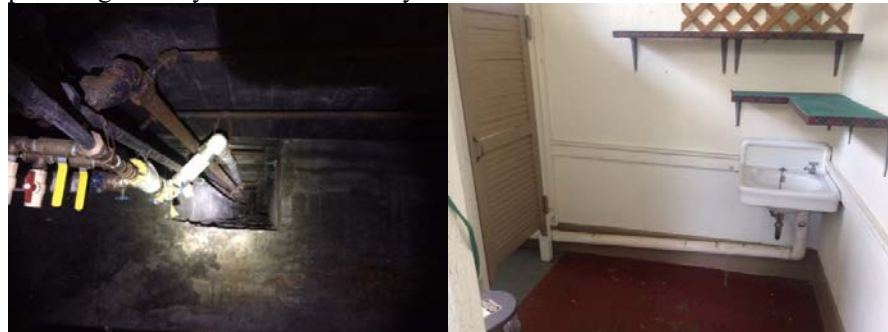
The church street end of the building is the Historic ticket office, waiting room and restrooms. This end of the building has not been occupied in a long time. The Hvac and plumbing in this end of the building is of little use or value. The plumbing fixtures and plumbing are very old and are of very little use or value.

Church Street end of building plumbing fixtures

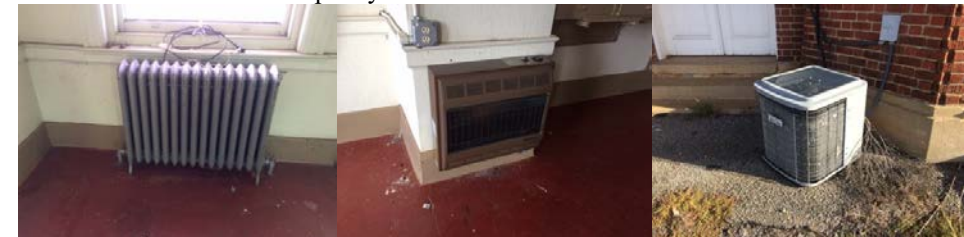
The Hvac, heating and cooling appear to be mostly removed and mostly nonfunctioning. There are eight existing radiators for heating. But the boiler has been removed and only traces of the old boiler system still exist. This system is so antiquated that it would not be of real use today. The only heating source in this end of the building is a wall mounted gas heater in the historic ticket office. It has a 30,000 Btu/hr input, about 24,000 Btu/hr output. It appears to be about 21 years old. Its value or usefulness would be limited because of the small size. During this site visit we did not attempt to turn on the LP gas or operate this heater.

Ticket Office Radiator

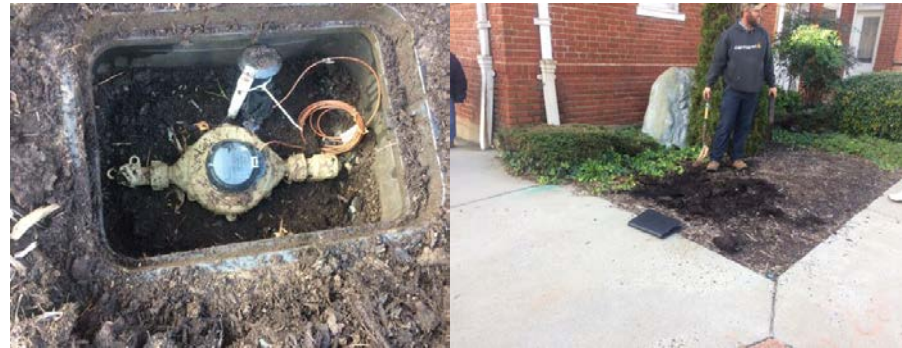
These water meters and services look good and adequate for this building. But the service from NE end of the building and piping in the basement is very old. The Visitor Center end of the building appears to be upgraded and working very well.

Church Street Water Meter

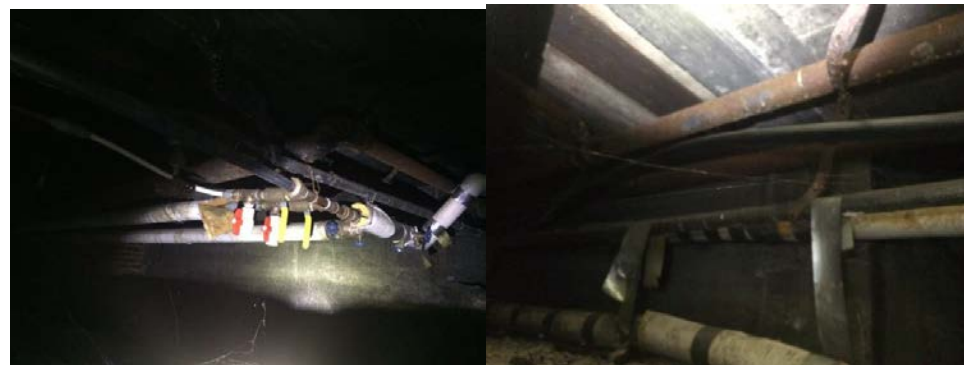
Domestic plumbing in basement

old plumbing and piping in basement

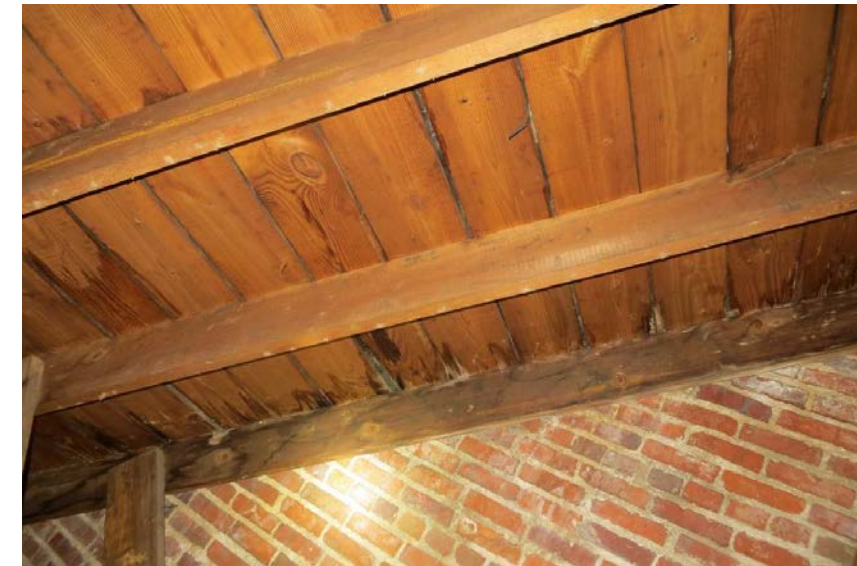
The roof trusses are spaced at 24" O.C. and are in good condition. The trusses on the east side of the firewall and sections on the west side of the firewall are concealed above a ceiling. We noticed some water stains from roof leaks but no structural damage. The trusses above the 50' long public reception area on the west side of the firewall are exposed and painted white with no visible damage. Plywood panels were painted and installed between the exposed trusses to conceal the wood sheathing above. Small wood strips were nailed to the trusses to hide the gaps between the new plywood and the trusses. The condition of the sheathing and the truss top chords could be evaluated during a roof replacement.

1. Roof Trusses East of Firewall Above Ceiling

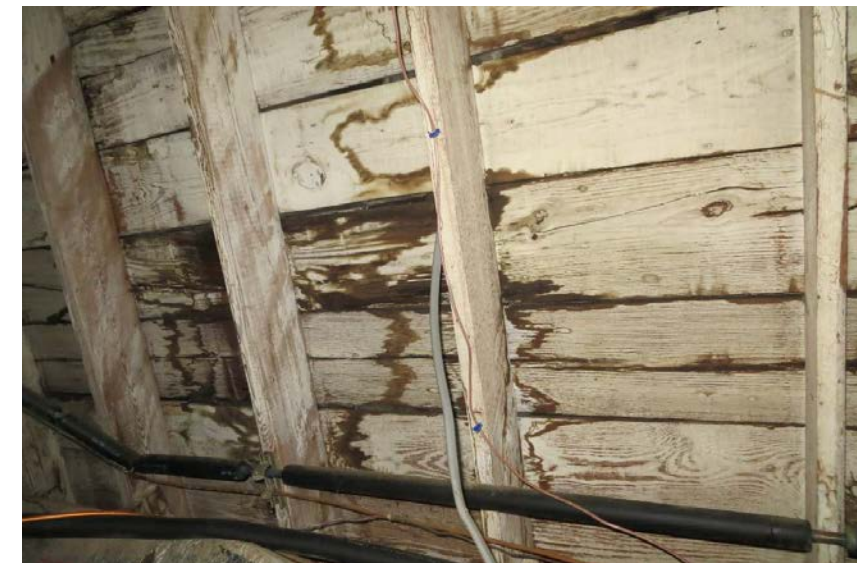
2. Roof Trusses West of Firewall Above Office Ceiling

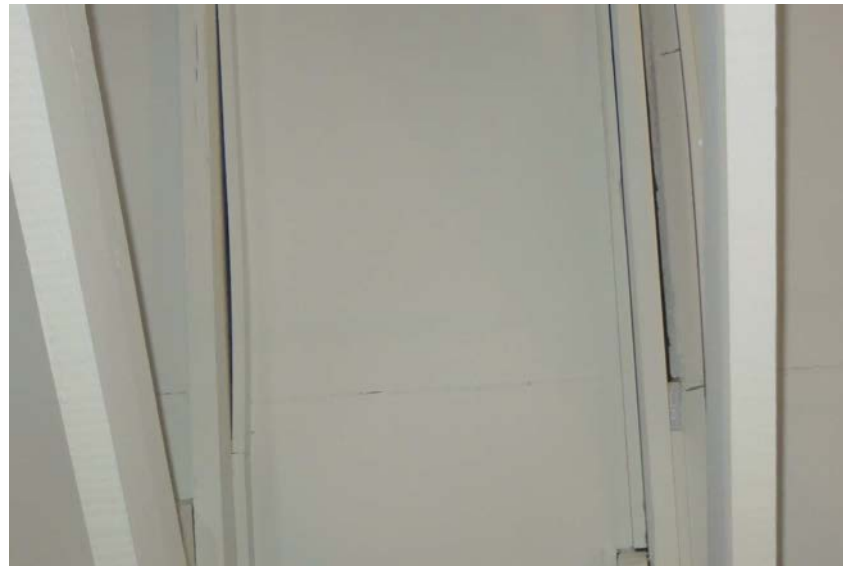
3. Exposed Roof Trusses with Plywood Panels and Loose Wood Strips Attached to Trusses

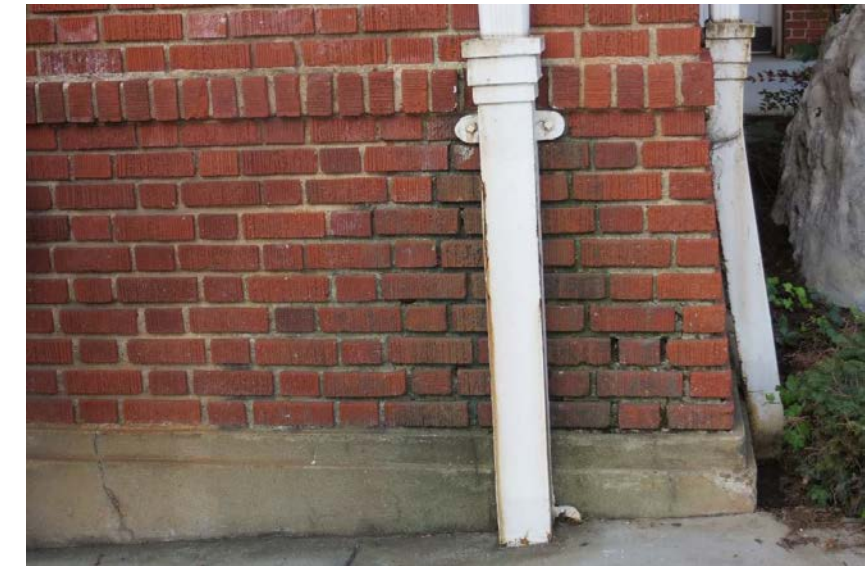
The brick is in good condition with a few exceptions. We found mortar eroded from the joints in a few places. We found significant mortar erosion near the two downspouts at the NE corner of the building. The outer wythe of the bottom 10 courses of brick is corbeled outward and down to the base course. The downspouts empty into drain pipes at the top of the corbeled brick. The drain pipes have been clogged enough to cause water to back up and overflow the tops of the drains. This has allowed the water to flow down the sloped brick faces long enough to cause the mortar erosion.

5. Mortar Erosion at NE Corner Downspouts

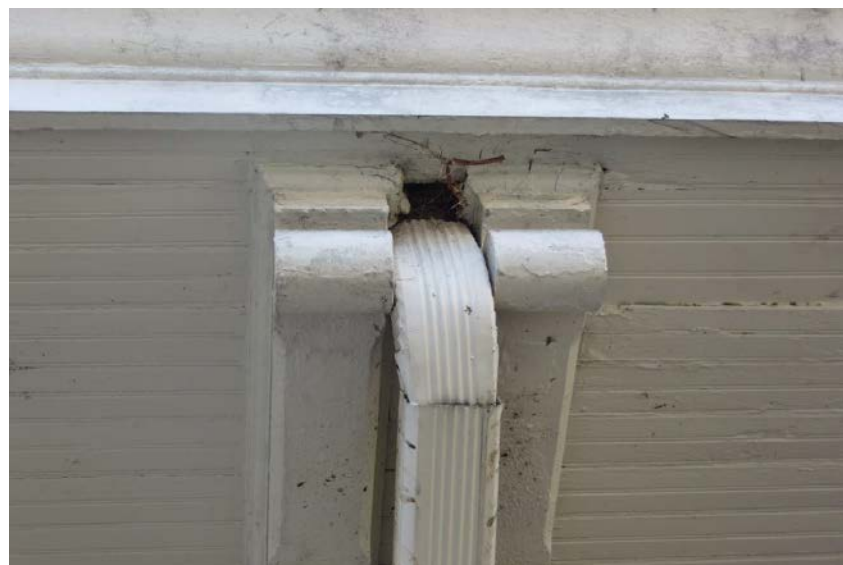
The 4'-6" overhangs are attached to the trusses and the framing was not visible for examination. The overhangs provide a lower sloped roof beyond the trusses and they contain a hidden gutter. Based on the condition of some of the soffit boards and downspout connections to the hidden gutter, there could be rotten wood framing in the overhang support framing.

4. Water Damaged Overhang Soffit with Bad Downspout Connection at Internal Gutter

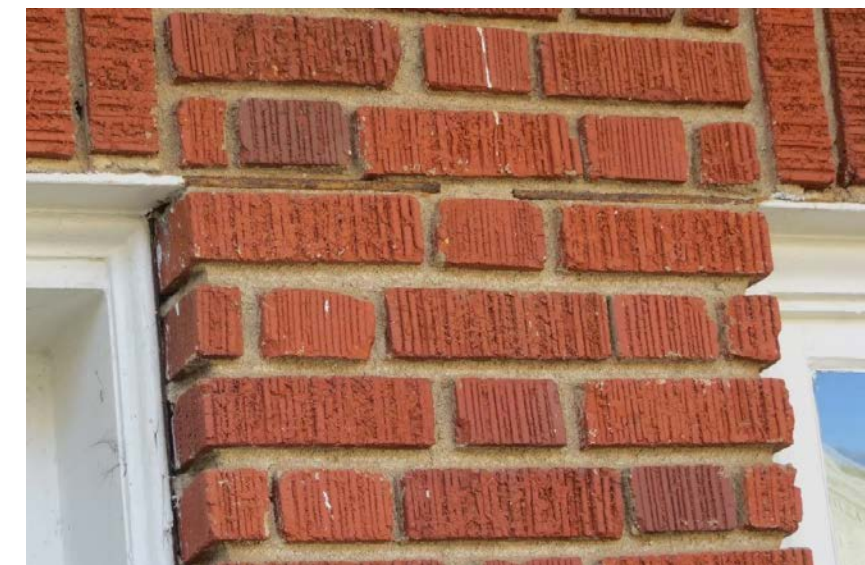
The outer wythe bottom course of brick above the windows and doors is turned on end and supported on a steel lintel. In most cases, the edge of the steel is exposed at the bearings instead of being covered by the mortar. The mortar could have covered the steel originally and eroded over the last 95 years or it may have been installed this way. We found light rust on the typical steel lintel. The rust would have been worse if the overhang was much shorter. The inner wythes of brick at the openings are supported by brick arches.

6. Exposed Rusty Steel Lintels with No Mortar Cover

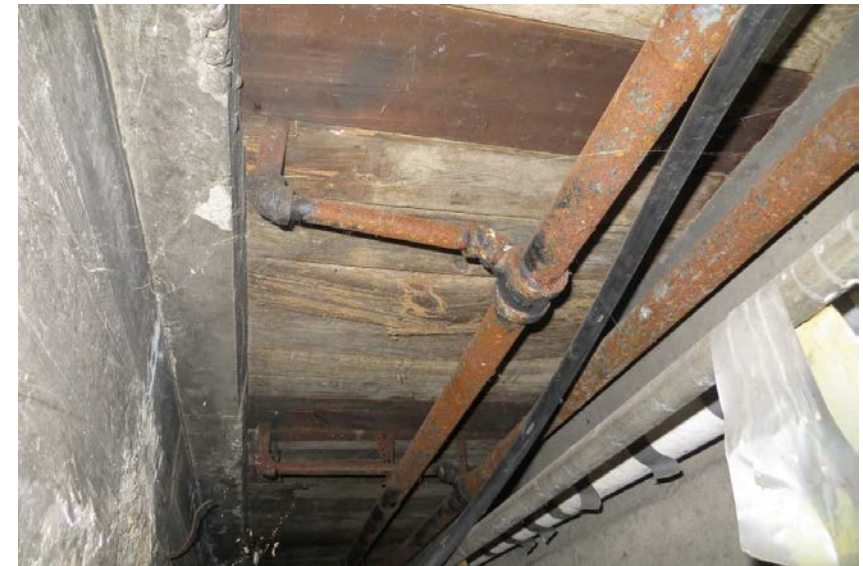
Based on the original drawings, the pipe trenches are 3'-0" wide and they are covered with concrete and a removable concrete lid in at least one place. From below, we were able to see wood sheathing or wood planks spanning across the pipe trenches. The wood we discovered could be supporting the floor above or it could be formwork that was left in place. We found a few planks visible from the basement openings that were broken. We recommend that this should be investigated to determine if any repairs are needed for the floor above the pipe trenches.

9. Pipe Trench Wood Plank Failure

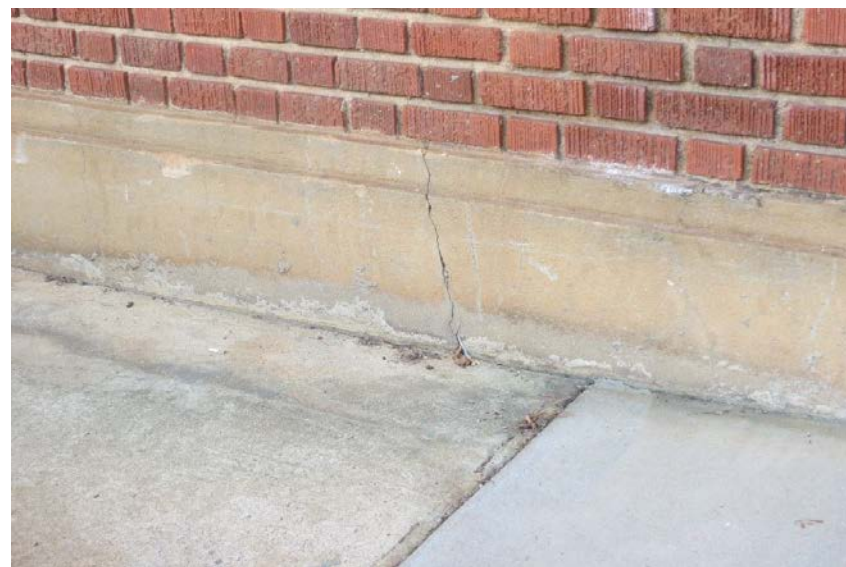
We did not see any significant cracks in the concrete for the Boiler Room basement walls, the Boiler Room basement ceiling/floor slab, the pipe trenches or the foundation walls. We did see a few vertical cracks in the concrete foundation walls on the east end of the building. These cracks did not continue into the brick masonry above and we did not see any evidence of settlement. In our opinion, these cracks are probably shrinkage cracks that have been there a very long time.

8. Typical Foundation Wall Crack at East End

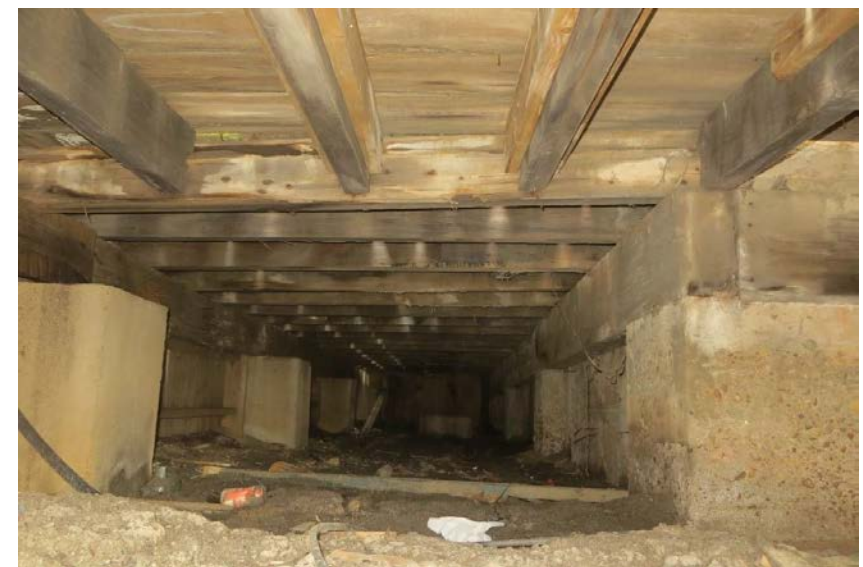
Much of the crawl space below the deck was not accessible during our site visit. However, we observed that many of the deck joists have rotten sections. As a result, these full-cut joists have been reinforced with modern lumber joists. Many of these reinforcements are not full length and may not be adequate to provide the 100 psf live load capacity required by our current building code. Also, the 51-inch tall aluminum handrails are not properly fastened down to the wood framing to provide the 200 pound load requirement found in our current building code. We recommend that a structural engineer investigate the deck framing and handrail attachments thoroughly and provide the necessary repair drawings to insure the public safety.

10. Wood Deck Full-Cut Joists with Modern Lumber Partial Reinforcement

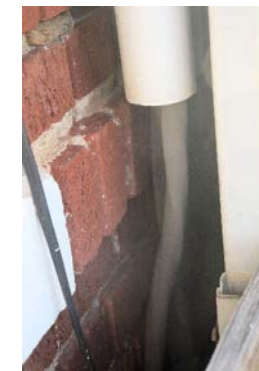
- i. The feeders consist of type SE cable which is partially installed in conduit on the outside of the building. There are no bushing on the conduit to protect the ends nor do those ends appear to be cut and trim properly to prevent abrasion of the cable. Some of the cables appear to be installed above return air plenum ceiling, which is not allow under the National electrical code.
- ii. The panelboards appear to be in relatively good condition.

- i. Replaced the feeders with conductor in conduit as required by code.

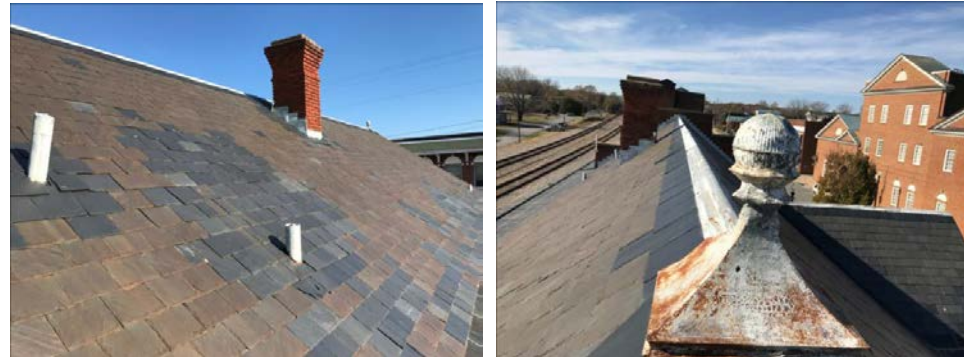
**Slate Roof**

**Main Slate Roof Areas:** Per my site visit the slate roof appears to be in pretty good shape. Although I don't know when the original roof was installed, there have been minor repairs and individual slate replacements noted by the different color of old vs new slate.

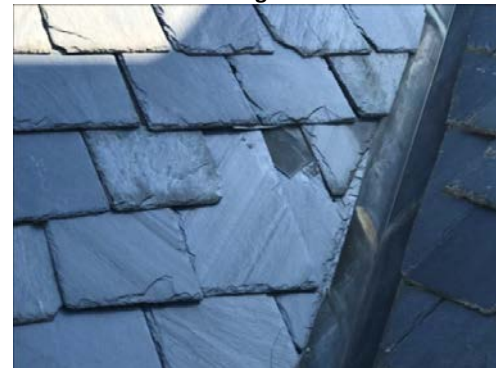
**Missing Slate**

**Missing or Damaged Slate:** During the course of my inspection I only noticed a couple damaged or missing slate. These are simple repairs so the slate roof is not in need of major work. Buckingham slate will last a very long time with routine maintenance, so there's no reason the roof cannot continue to effectively serve the train depot for many years.

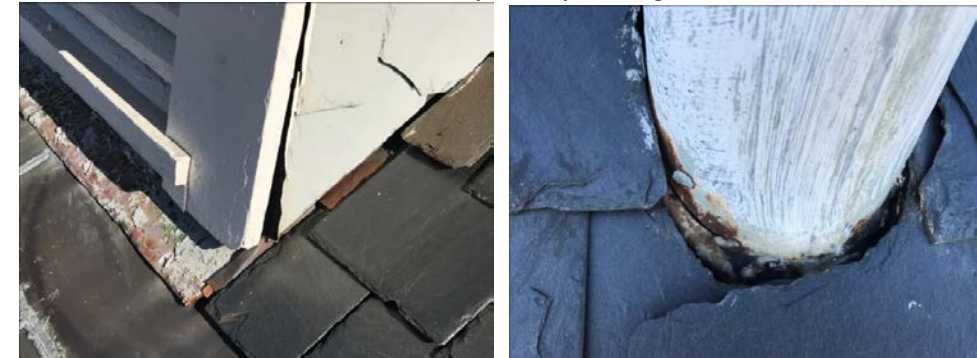
**Rusted Vent Pipe & Step Flashing**

**Vent Pipes & Step Flashing:** However, there are areas of the roof that will probably need addressing sooner. Some of the vent pipes and step flashing appear to be galvanized flashing that is rusting. There's no way for me to know when this flashing will play out or when a leak might develop; but I would recommend considering replacing with copper in the next 3-5 years.

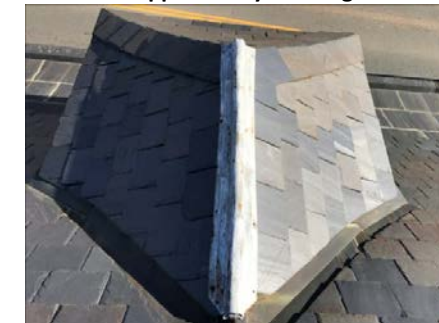
**Copper Valley Flashing**

**Valleys:** Please note - all valley flashings have been replaced with copper. These will not need to be replaced or repaired and should last a long time.

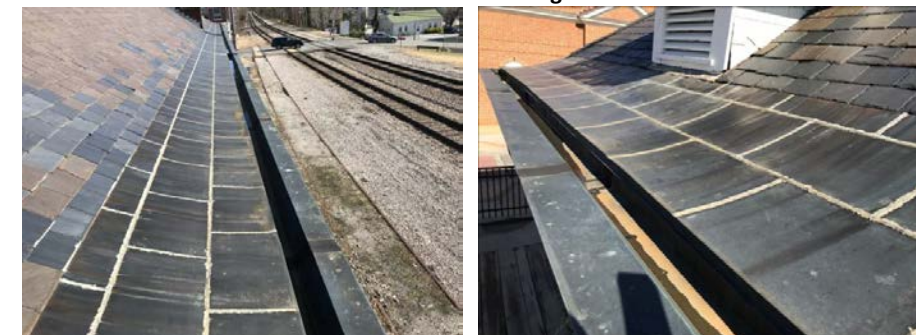
**Flat Seam Roofing**

**Flat Seam Roof Areas:** The curved eave and built-in gutter areas have been installed with flat lock (flat seam) copper. These areas appeared to be relatively new and in relatively good condition. However, there are concerns you should be aware of. First, we typically do not recommend flat lock on such large areas of roof. Expansion and contraction tends to put pressure on joints which could lead to cracks and/or issues down the road. We generally recommend an expansion joint for built-in gutter at least every 30 ft. Same with flat seam areas. The train station has some expansion, but not technically not enough. There's no way for me to know how well the joints were initially soldered or how long they will hold up. You may not have a problem for 15-20 years or a joint could develop a leak next year.

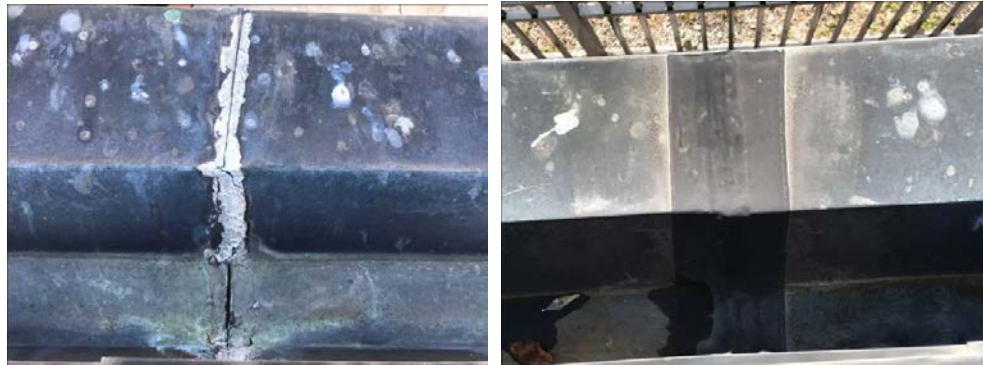
**Copper Built-In Gutter Joints**

**Copper Built-In Gutter:** All the joints in the copper built-in gutter have been stripped off with pressure sensitive EPDM (but one). This relates back to my point about expansion and contraction. These joints were stripped off probably because the joints started to crack and leak. The one joint that isn't stripped off needs to be (see below). The EPDM material can last 15-20 years so I don't think you need to do anything other than fix the one joint that isn't stripped off. I don't know if there are leaks at outlets or other areas. I didn't notice wet spots in the soffit when I was on site.

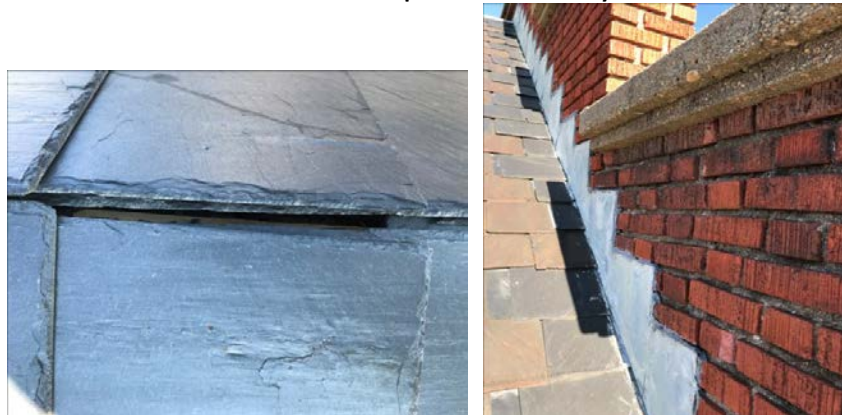
**Hip Area and Masonry Joints**

**Misc Items:** The ridge areas all have metal flashing which seems to be functioning well. Some of it may need painting again in the future to prevent deterioration. However, the hip areas do not have metal cap installed. Most of these areas have appropriate flashing underneath the slate but there are a couple spots without. I recommend fixing these spots as water could eventually work its way through underlayment and cause a leak. In older buildings sometimes masonry issues such as old brick and deteriorated masonry joints can cause leaks. I only mention to be aware, the wall pictured below is older but doesn't appear to be in poor condition.

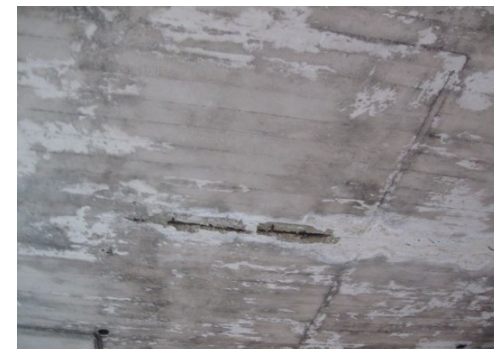
[5] Rebars in the reinforced concrete ceiling have rusted, causing the concrete to spall. The rebars must be cleaned of rust before the concrete can be patched.

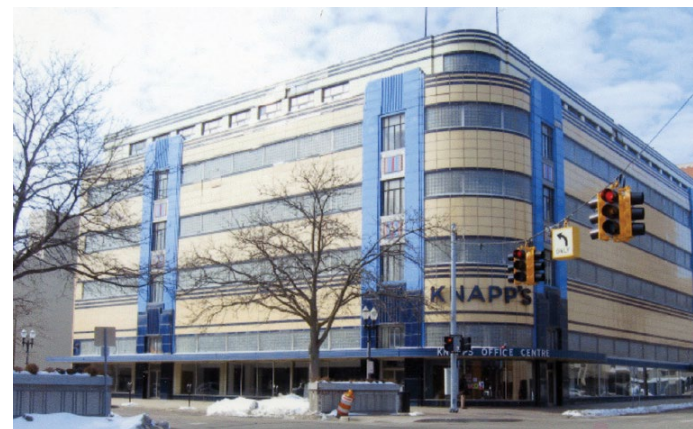
[7] (a) J.W. Knapp's Department Store, built 1937-38, in Lansing, MI, was constructed with a proprietary material named "Maul Macotta" made of enameled steel and cast-in-place concrete panels. Prior to its rehabilitation, a building inspection revealed that, due to a flaw in the original design and construction, the material was deteriorated beyond repair. The architects for the rehabilitation project devised a replacement system (b) consisting of enameled aluminum panels that matched the original colors (c). Photos and drawing (a-b): Quinn Evans Architects; Photo (c): James Haefner Photography.

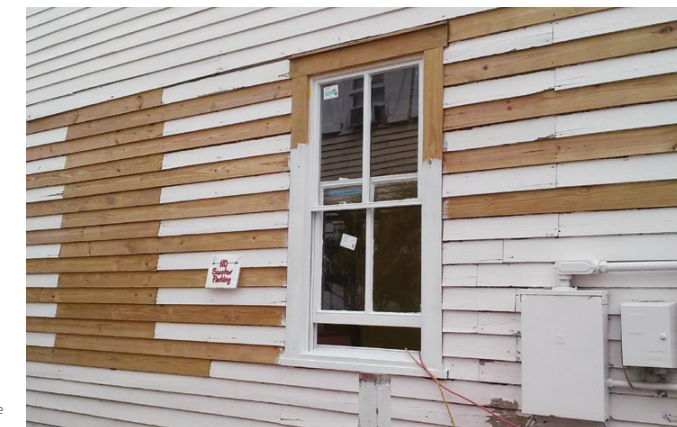
[8] Rotted clapboards have been replaced selectively with new wood siding to match the originals.

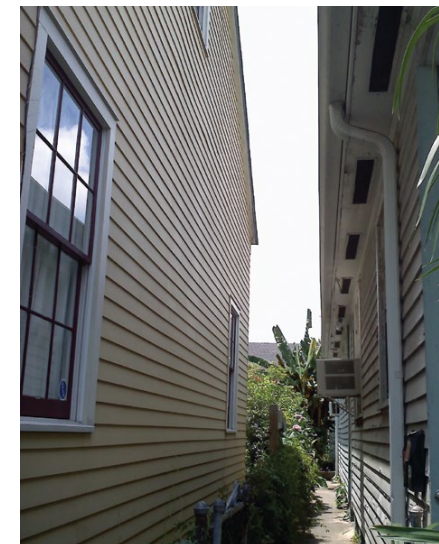
[9] Smooth-surfaced cementitious siding (left) may be used to replace deteriorated wood siding only on secondary elevations that have minimal visibility.

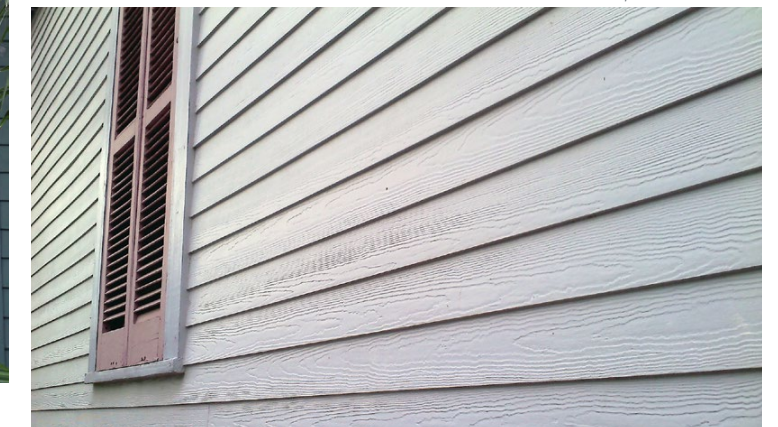
[10] Not Recommended: Cementitious siding with a raised wood-grain texture is not an appropriate material to replace historic wood siding, which has a smooth surface when painted.

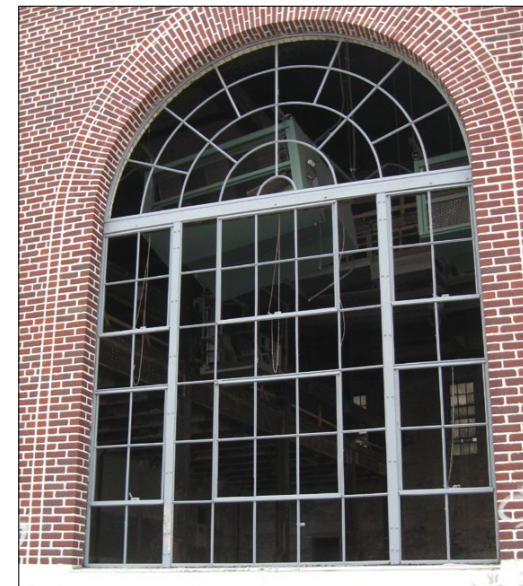
[12] This historic steel window has been cleaned, repaired, and primed in preparation for painting and reglazing.

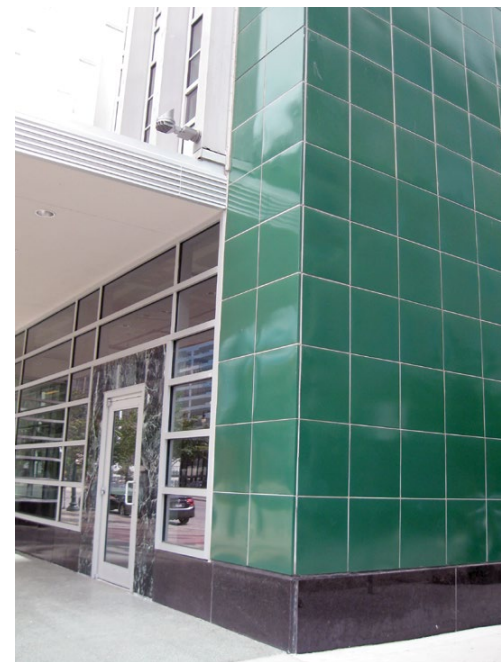
[15] New enameled-metal panels were replicated to replace the original panels, which were too deteriorated to repair, when the storefront of this early 1950s building was recreated.

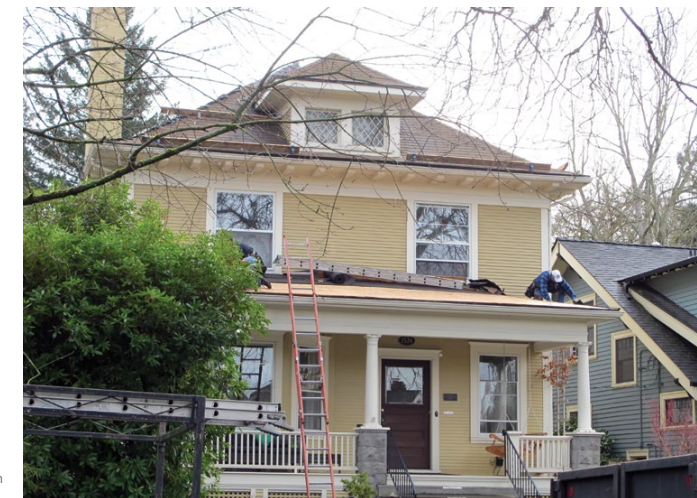
[16] The deteriorated asphalt shingles of this porch roof are being replaced in kind with matching shingles.

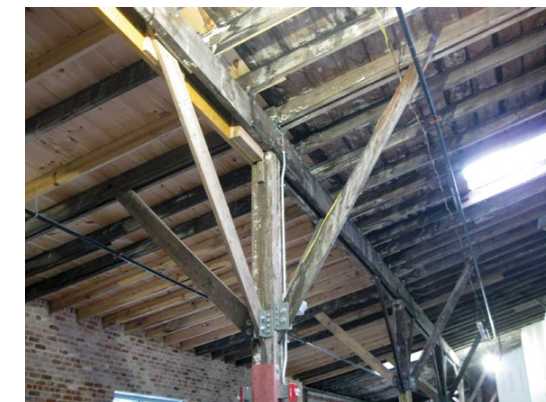
[17] New wood elements have been used selectively to replace rotted wood on the underside of the roof in this historic warehouse.

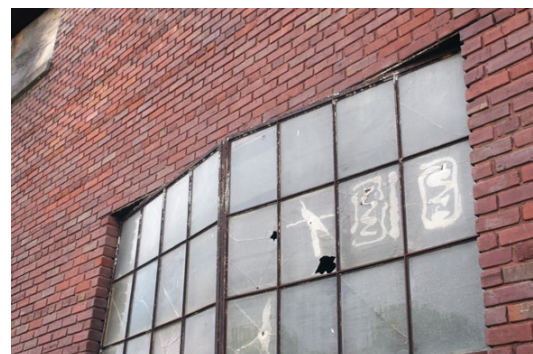
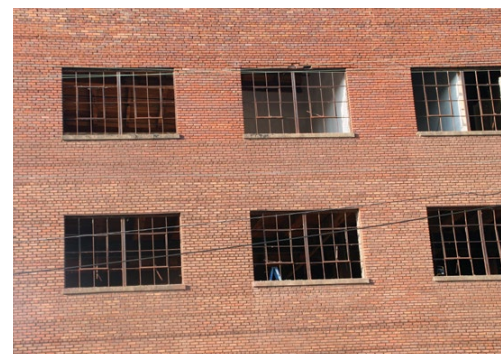
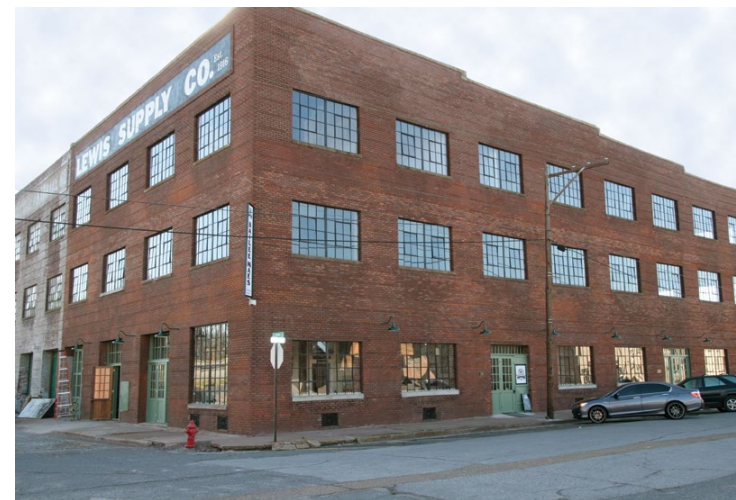
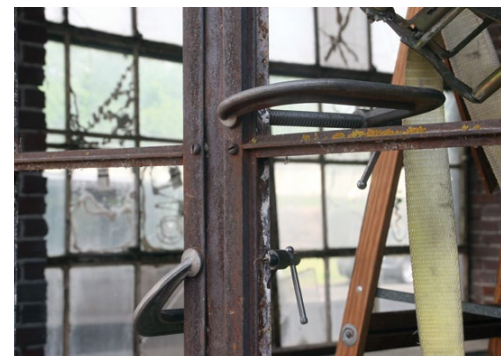
[20 a-d] The original steel windows in this industrial building were successfully repaired as part of the rehabilitation project (left).

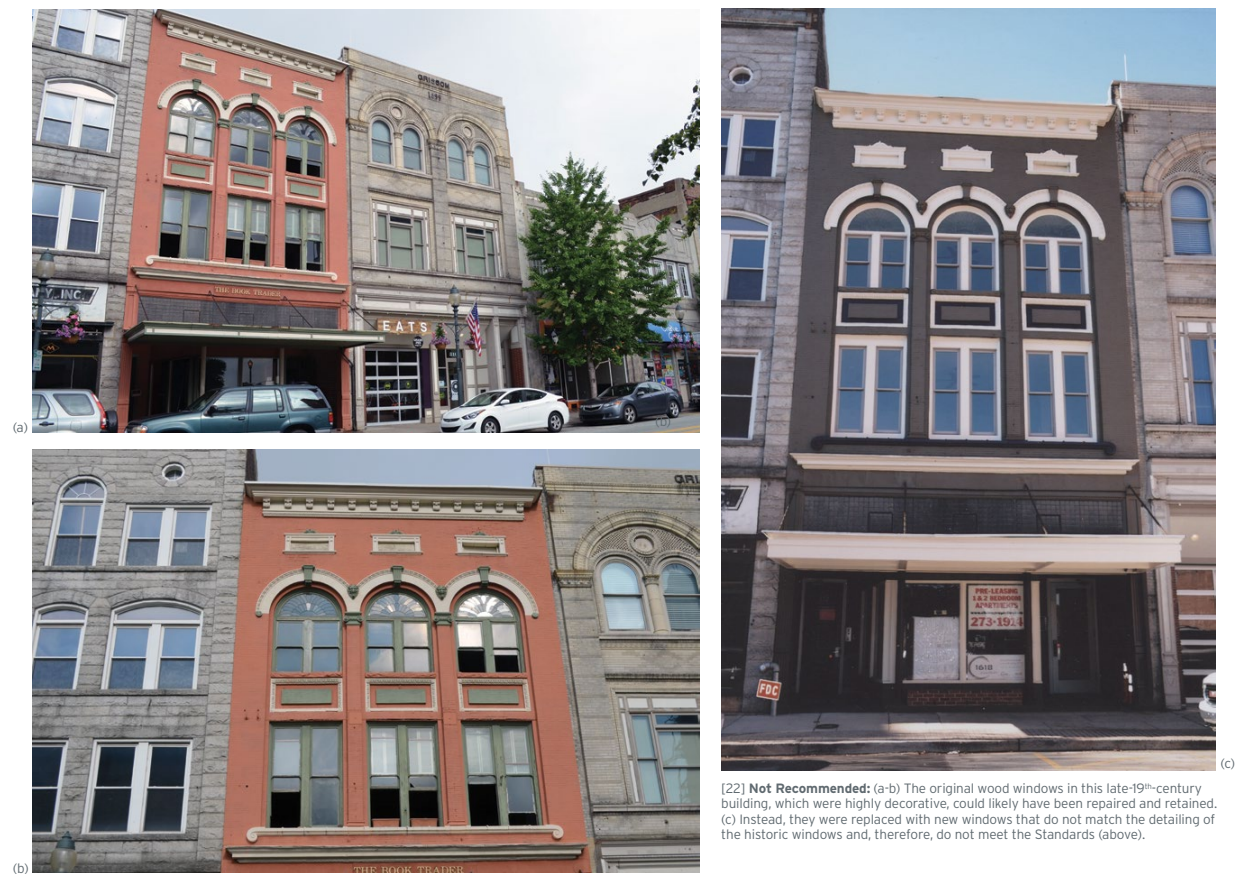
[22] **Not Recommended:** (a-b) The original wood windows in this late-19<sup>th</sup>-century building, which were highly decorative, could likely have been repaired and retained. (c) Instead, they were replaced with new windows that do not match the detailing of the historic windows and, therefore, do not meet the Standards (above).

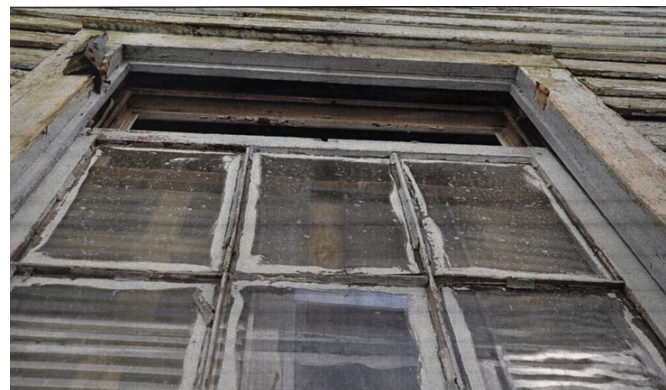
[23] (a) This deteriorated historic wood window was repaired and retained (b) in this rehabilitation project.

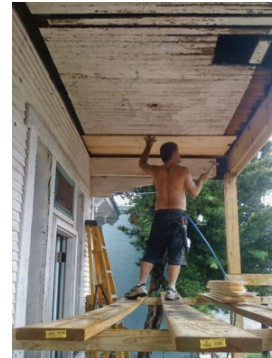
[24] Rotted boards in the beaded-board porch ceiling are being replaced with new matching beaded board.

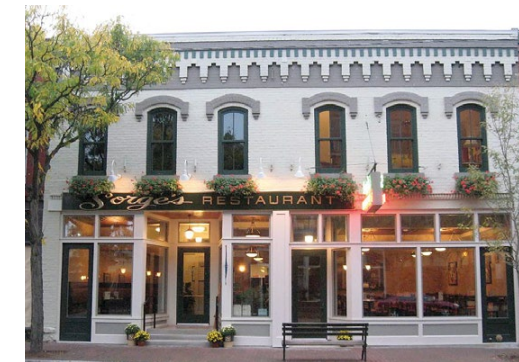
[28] This new storefront, which replaced one that was missing, is compatible with the historic character of the building.

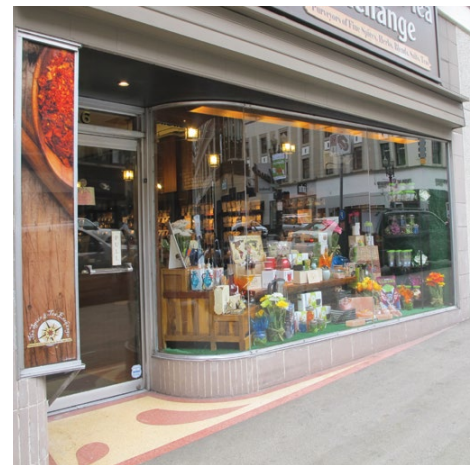
[27] This original c. 1940s storefront, with its character-defining angled and curved glass display window and recessed entrance with a decorative terrazzo paving, is in good condition and should be retained in a rehabilitation project.

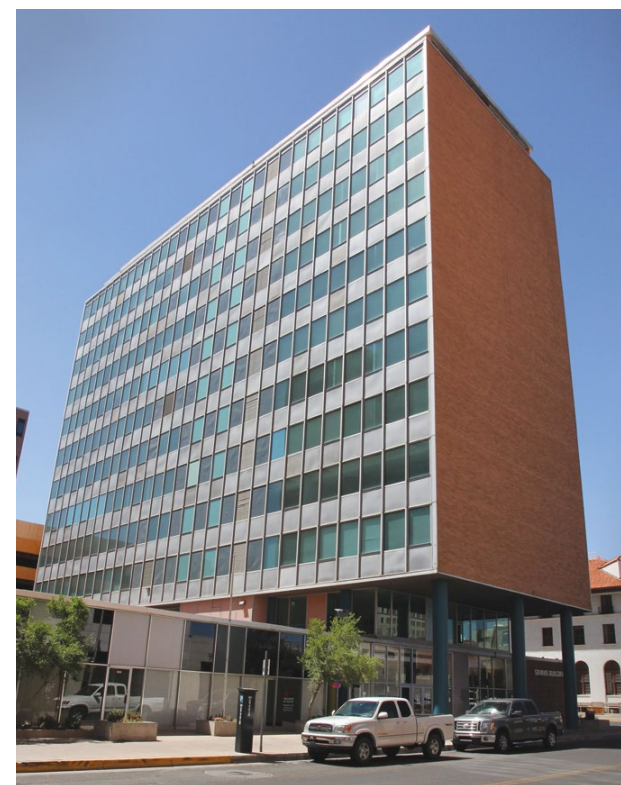
[30] Rather than replace the original curtain wall system of the 1954 Simms Building in Albuquerque, NM, with a different color tinted glass or coat it with a non-historic reflective film, the HVAC system was updated to improve energy efficiency. Photo: Harvey M. Kaplan.

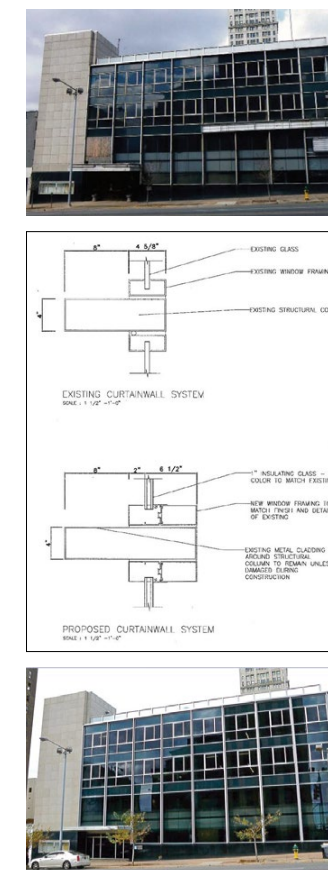
[31 a-c:] (a) The rehabilitation of the First Federal Savings and Loan Association building in Birmingham, AL, constructed in 1961, required replacing the deteriorated historic curtain wall system because the framing and the fasteners holding the spandrel glass and the windows had failed. (b) Comparative drawings show that the differences between the replacement system, which incorporated new insulated glass to meet wind-load requirements, and the original system are minimal. (c) The replacement system, shown after completion of the project, has not altered the historic character of the building.

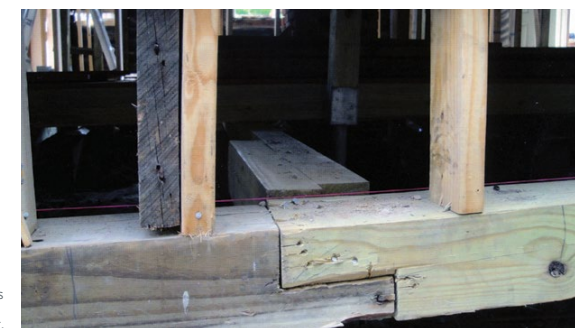
[33] Retaining as much as possible of the historic wood sill plate and replacing only the termite-damaged wood is always the preferred and recommended treatment.

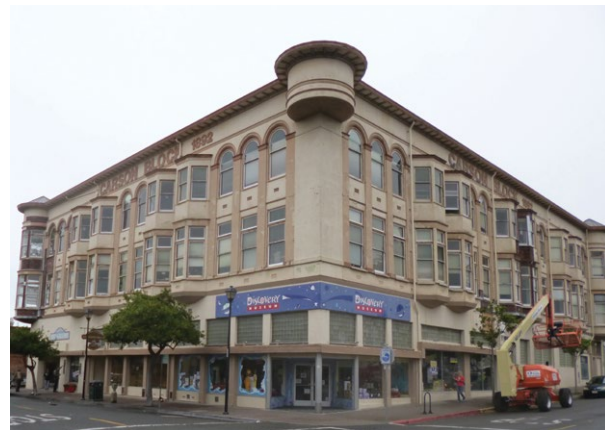
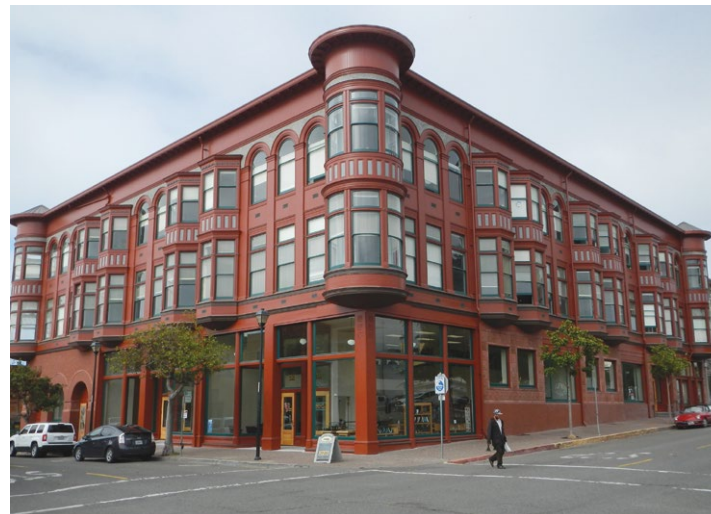
[32] (a-b) The rehabilitation of the 1892 Carson Block Building in Eureka, CA, for its owner, the Northern California Indian Development Council, included recreating the missing corner turret and sensitively introducing seismic reinforcement (c) shown here (opposite page) in a secondary upper floor office space. Photos: Page & Turnbull.

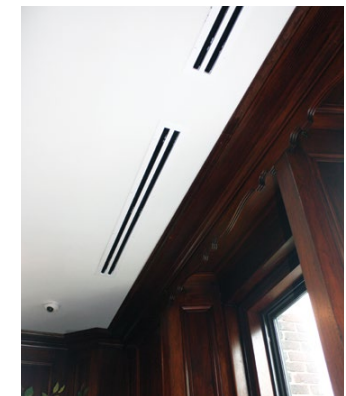
[34] The new ceiling ducts installed during the conversion of this historic office building into apartments are minimal in design and discretely placed above the windows.

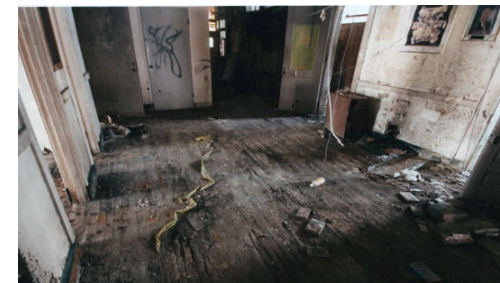
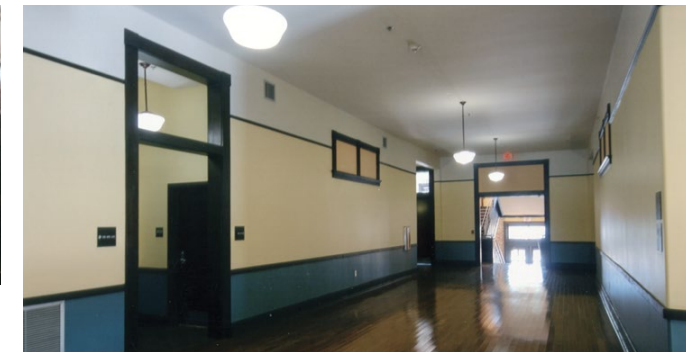
[35] (a) Although deteriorated, the historic school corridor, shown on the left, with its character-defining features, including doors and transoms, was retained and repaired as part of the rehabilitation project (b).

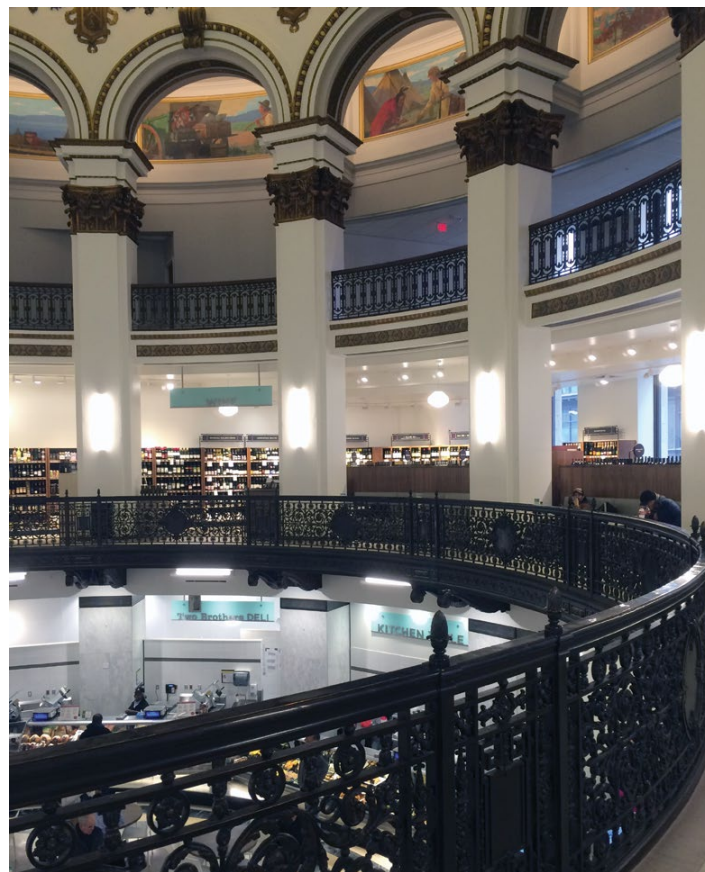
[36] The elaborate features and finishes of this historic banking hall in the Union Trust Company Building, in Cleveland, OH, were retained and repaired as part of its conversion into a food market.

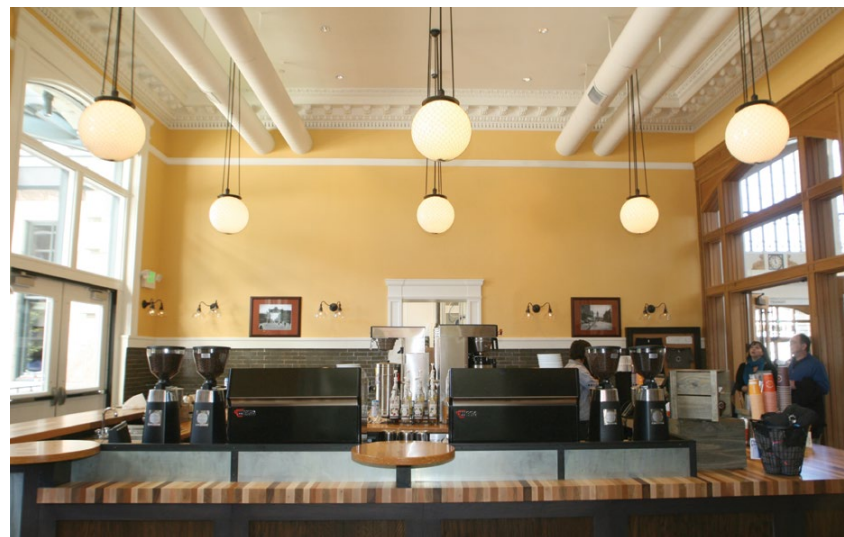
[37] Exposed and painted ducts were appropriately installed here in a retail space in Denver's historic Union Station after considering other options that would have impacted the ceiling height, or damaged or obscured the ornamental plaster crown molding. Photo: Heritage Consulting Group.

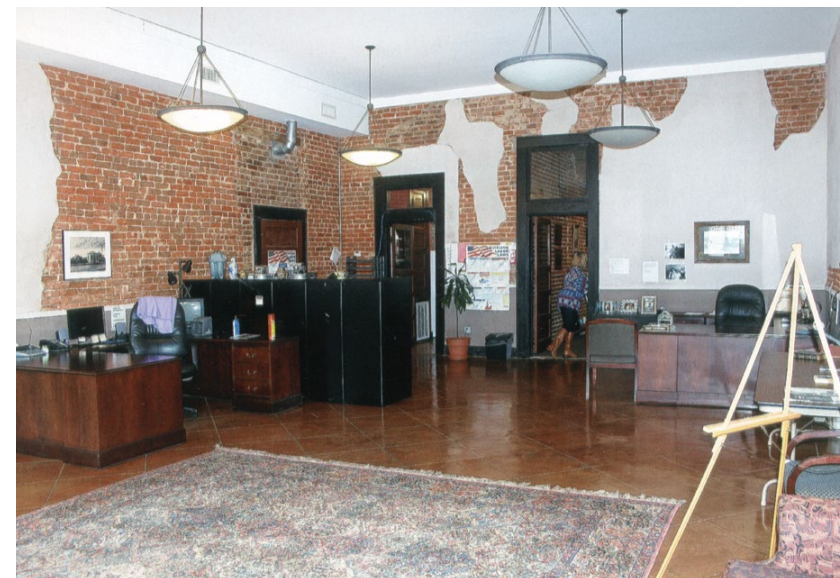
[41] Not Recommended: Leaving fragments of deteriorated or "sculpted" plaster is not a compatible treatment for either finished or unfinished interior spaces.

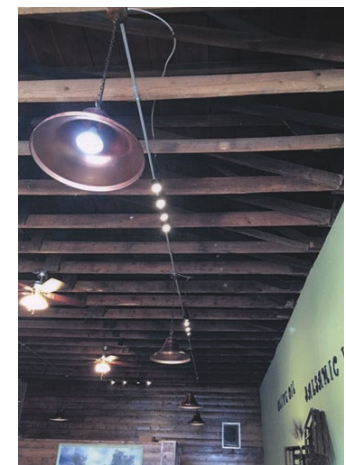
[40] Not Recommended: Removing a finished ceiling and leaving the structure exposed in a historic retail space does not meet the Standards for Rehabilitation.

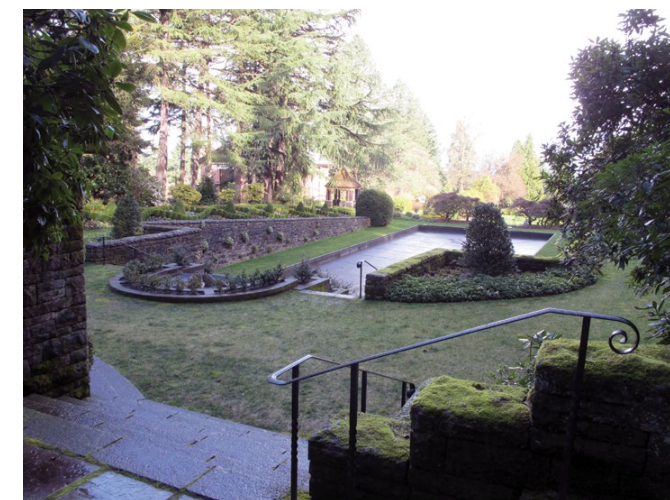
[42] This garden is an important character-defining landscape feature on this college campus.
